2013 CAT AP1000E ASPHALT PAVERS

INSPECTION DETAILS

Inspection Type	Consignment
Inspection Form	Standard
Inspection #	10176228
Inspection Status	Inspected
Created	01/20/25 17:25:53
Updated	01/22/25 10:29:01
Created By	Fuller, Scott U.
Inspector	Fuller, Scott U.
Reviewers	Fuller, Scott U.
Salesperson	Judd, Dillon
Last Preventative Maintenance	Jun 29, 2024
Serial #	T1F00209
SMU / Hours	9,749
Location	Las Vegas, NV, United States

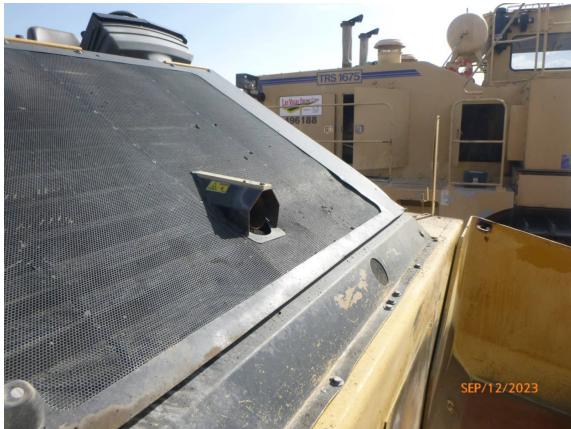
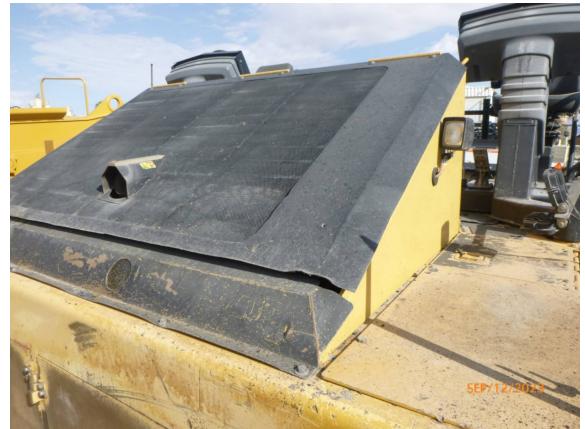
Eng. Enclose Hood / Stack

Engine hood has some sheet metal damage.

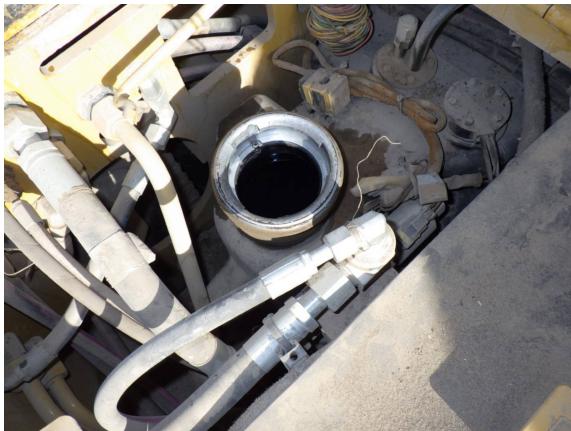
Fuel Tank

Missing fuel fill screen.

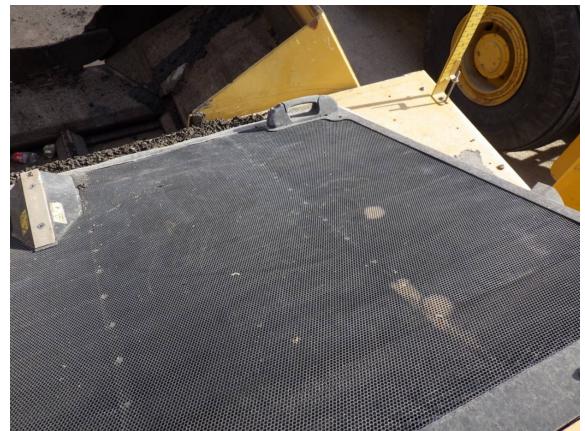
Radiator Grill & Shroud

Grill has multiple dents.

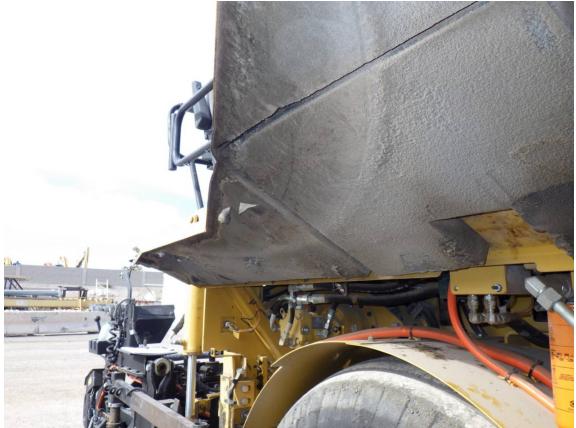
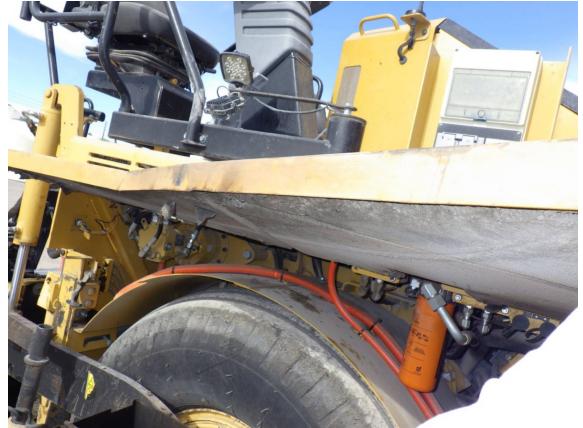
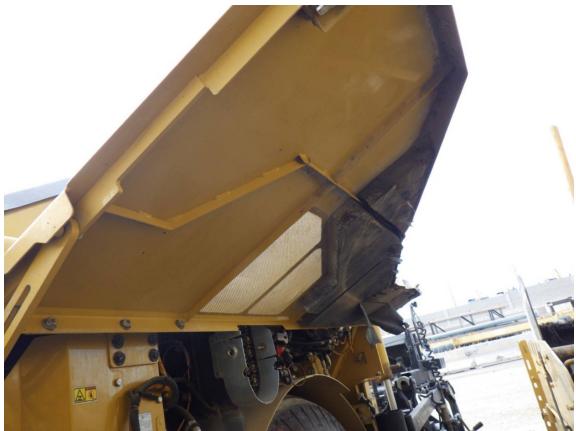
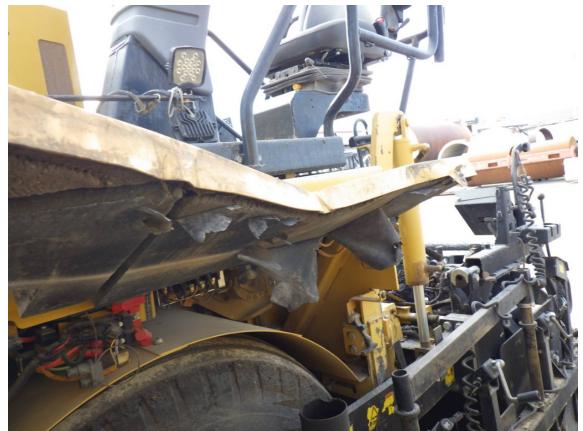
Sheet metal

Both side access doors have some damage on bottom edges, and torn noise reduction panels.

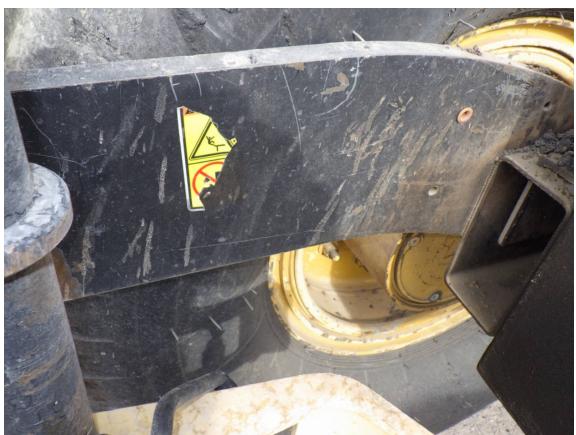
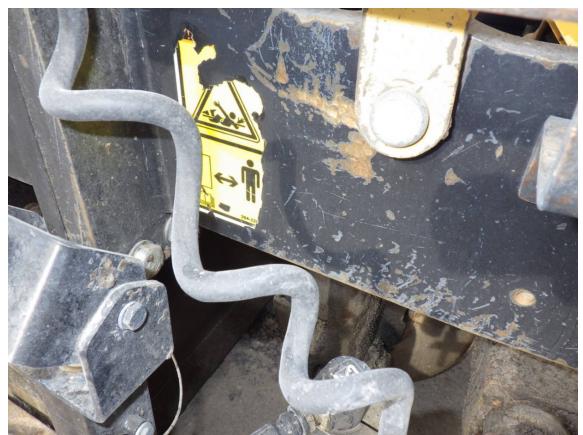
safety decals

Several safety labels are peeling. replace missing and damaged decals

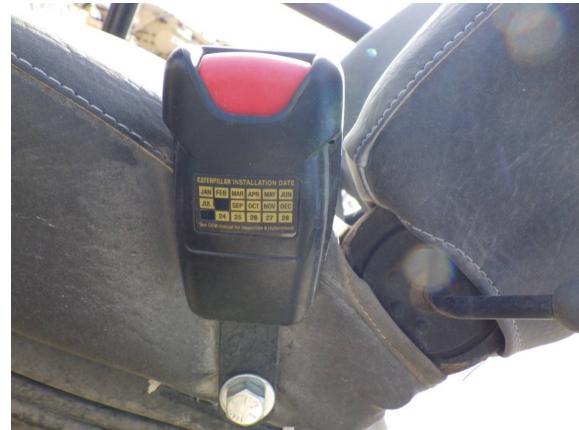
Seat Belt

Both seat belts installed Aug.
2023

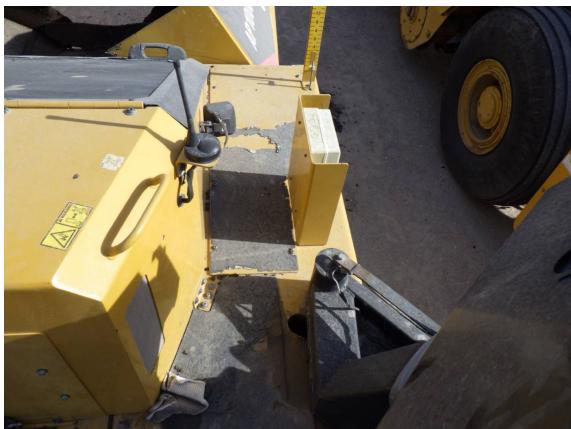
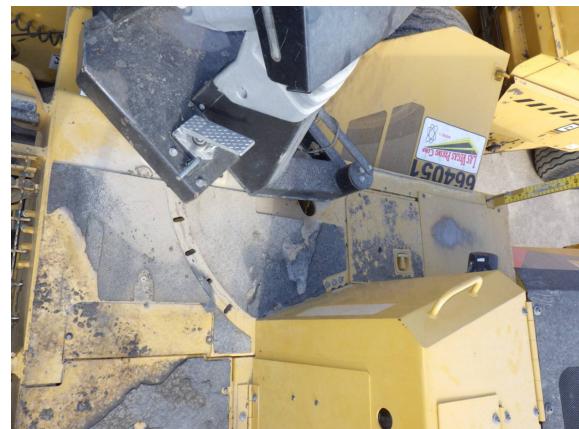
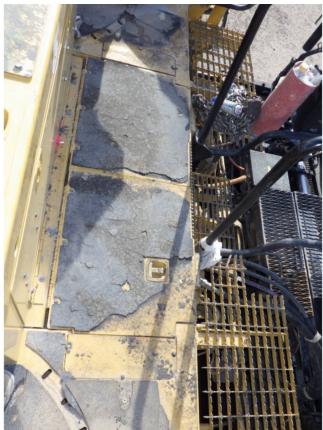
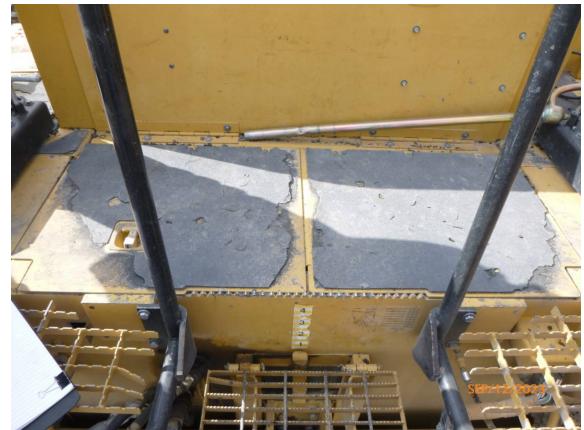
Platform

All Traction tape is torn / worn. -
replace all floormats/traction
panels

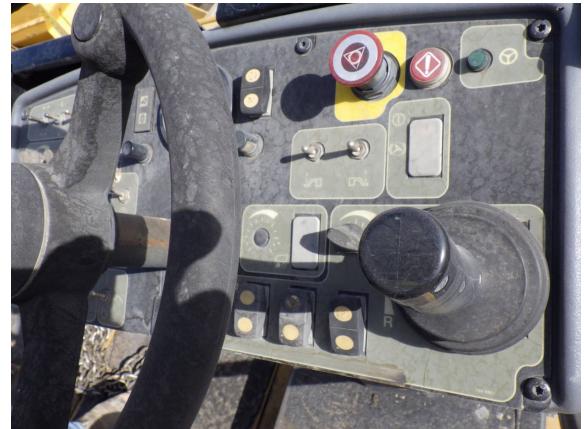
Switches

Several rocker switches are faded.

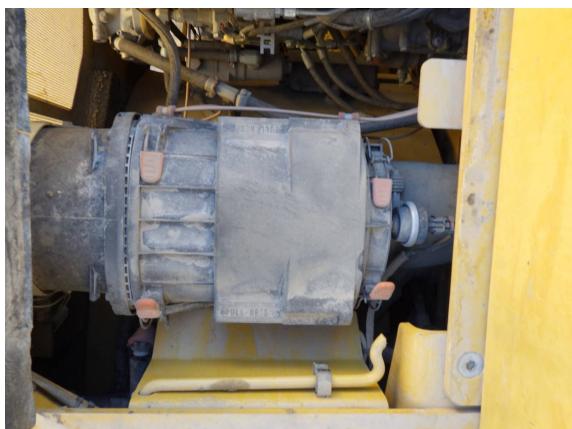
Air Cleaners

Air box cover has 3 of 4 clamps that are bent and dont clamp down. - replace cover

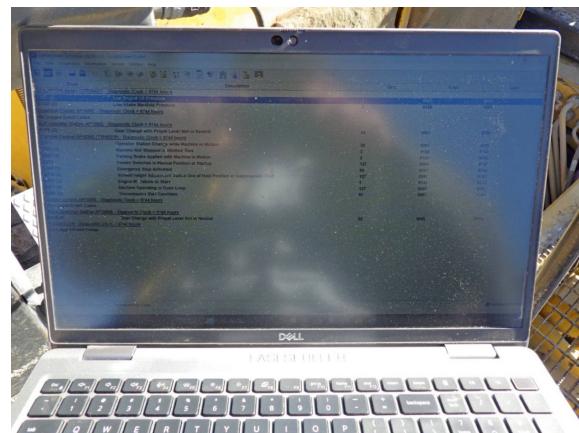
ECM downloaded?

Has multiple logged fault codes

- see PSR

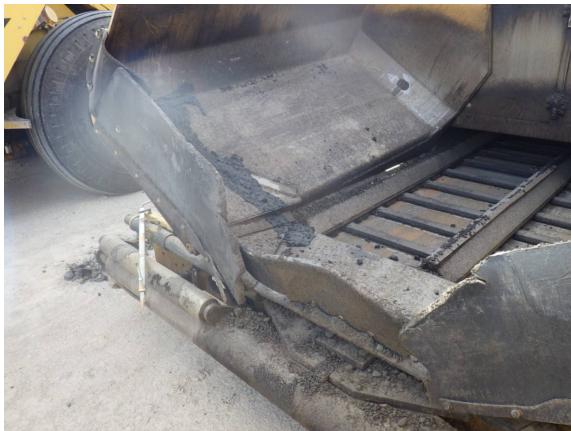
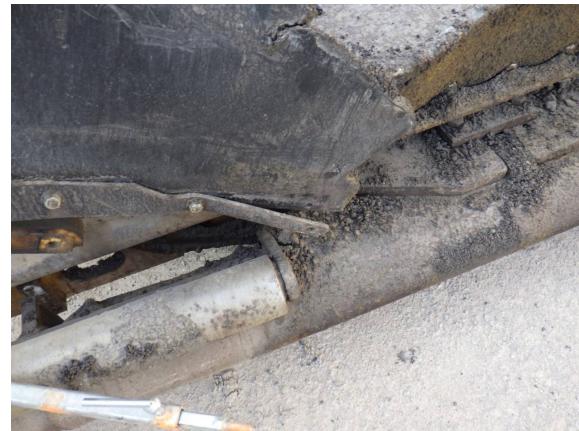
flashing

Flashing has tears/damage.

Repair bent plate.

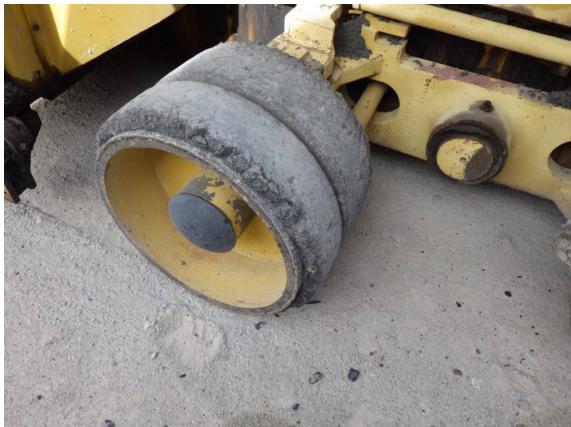
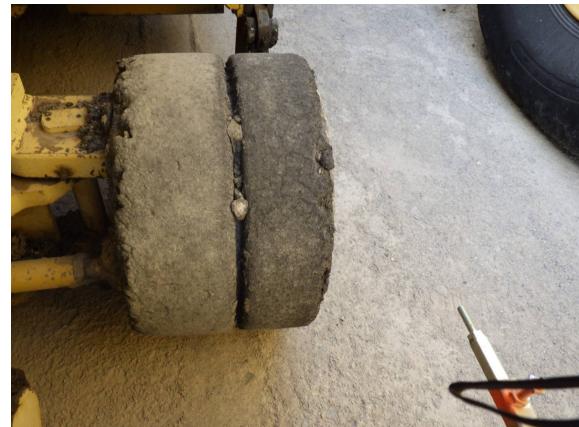
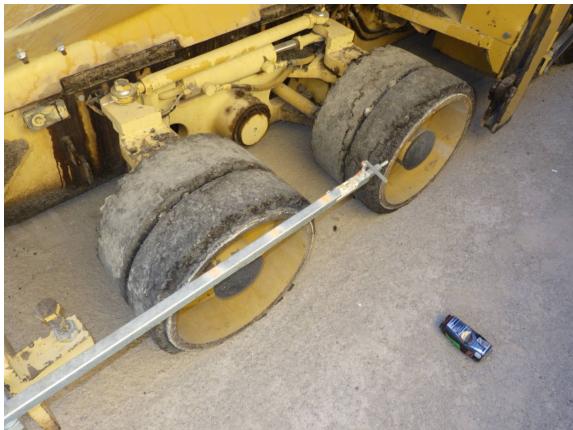
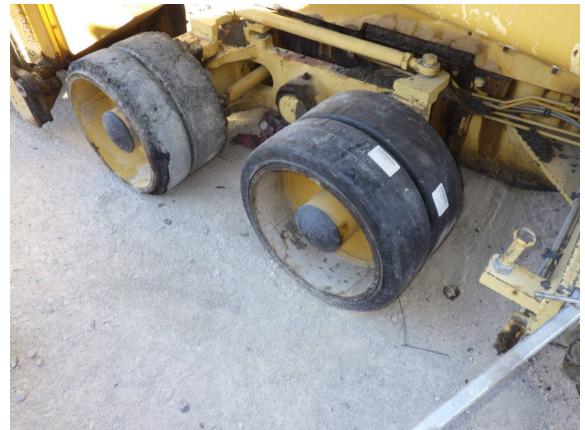
Front Bogies

Bogies have multiple chunks and cuts. 2 of 8 tires have been replaced. Replace others.

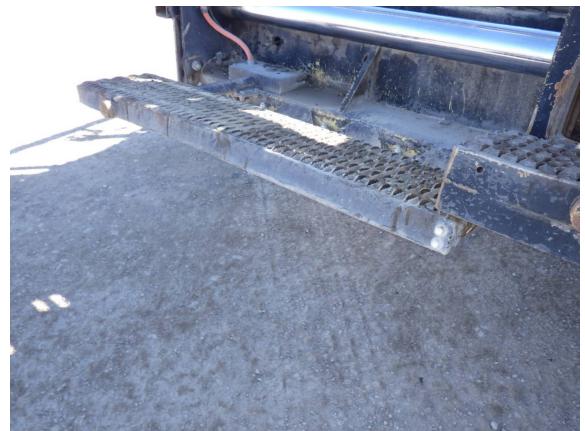
Notes - PAVER / SCREED / CONVEYOR

AS3301C Screed. Left step is bent.
