## 2007 CAT 140HNA MOTOR GRADERS

### INSPECTION DETAILS

Inspection Type	Consignment
Inspection Form	Standard
Inspection #	10188464
Inspection Status	Created
Created	03/12/25 17:27:53
Updated	03/12/25 20:48:33
Created By	Hallett, John L.
Inspector	Hallett, John L.
Salesperson	Harman, Nate
Transmission Serial #	EDB06915
Engine Serial #	3PD19752
Serial #	CCA03647
SMU / Hours	18,234
Location	Goodyear, AZ, United States

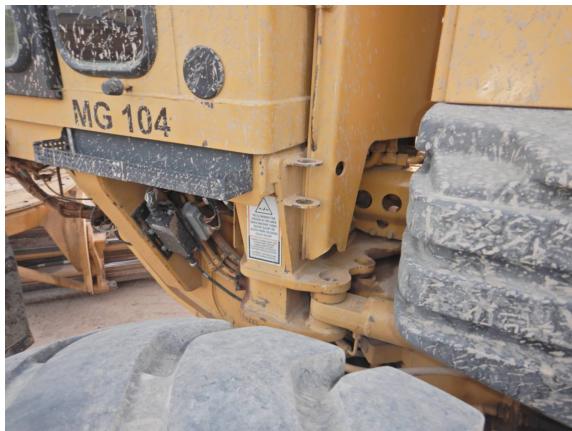
Safety Locks / Pins

Pin is missing.

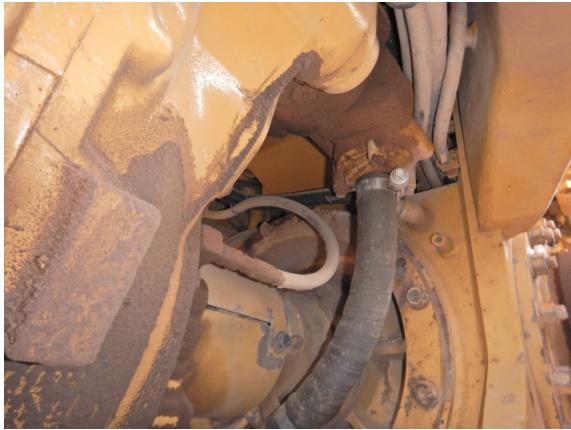
#### Pump - TRANSMISSION

Pump leaks at mount seal.

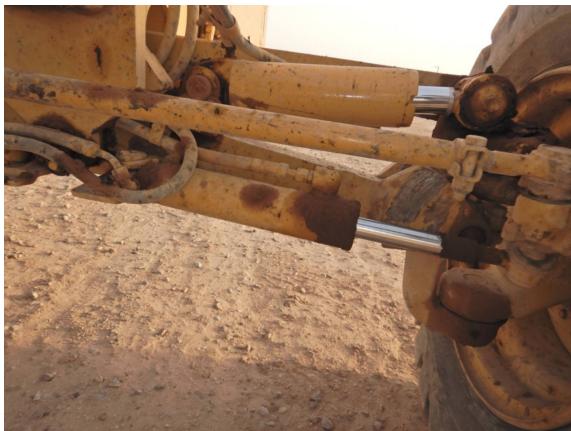
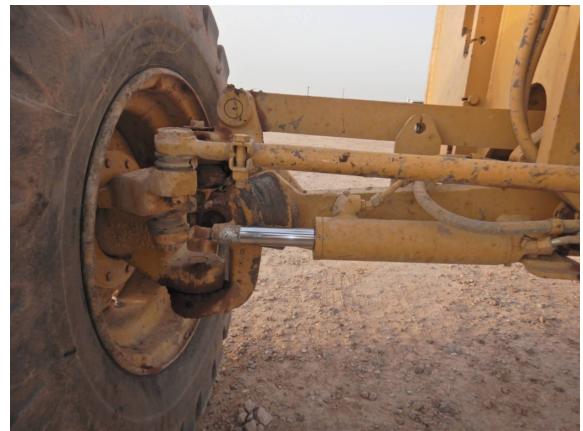
### Steering Cylinder

Right steer cylinder leaks

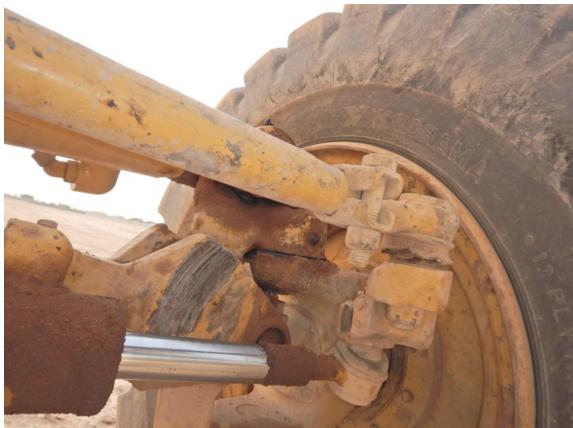
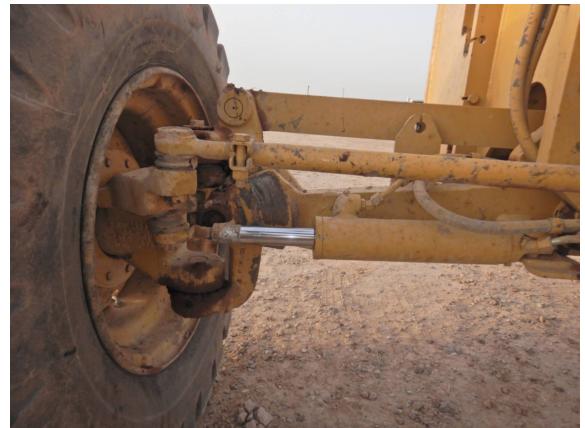
## Tie Rods / Rod Ends

Boots torn links loose

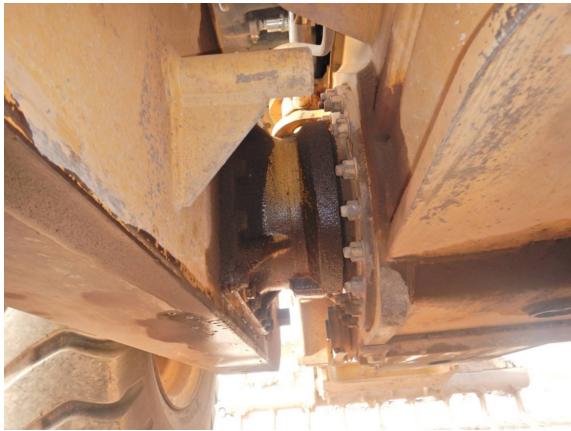
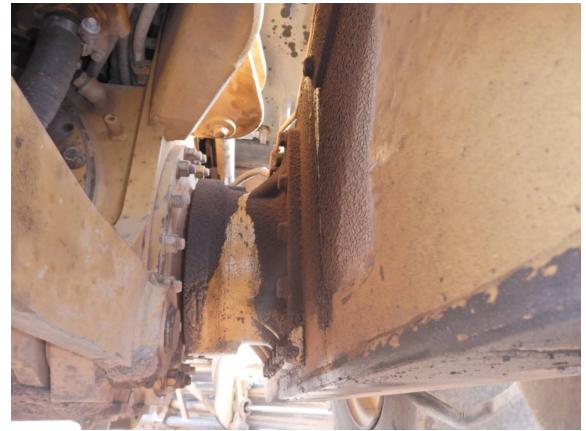
### Tandem Housing / Drive Chains

Housing leaks oil. No chain slap  
heard in tandem housings

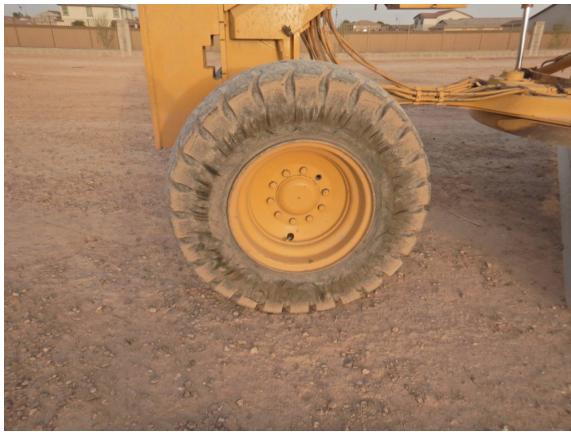
### Wheel Lugs & Rims

Missing wheel bolt

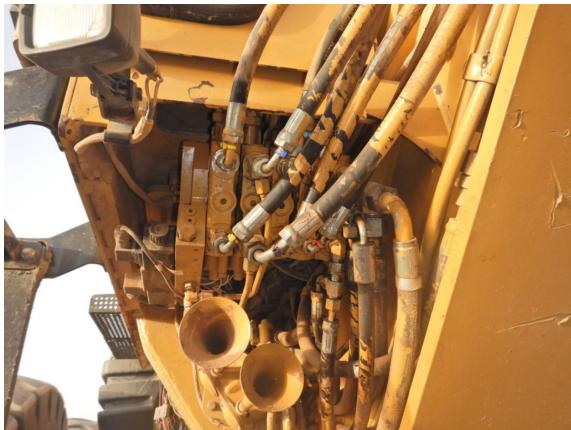
## Hydraulic Valves

Left valve bank leaking oil
