2020 CAT
14013
MOTOR GRADERS

INSPECTION DETAILS

Inspection Type	Marketing
Inspection Form	Standard
Inspection #	10181517
Inspection Status	Completed
Created	02/11/25 16:36:59
Updated	03/06/25 11:21:26
Created By	Calderas, Marco
Inspector	Calderas, Marco
Reviewers	Calderas, Marco
Salesperson	Schultis, Derrick R.
Stock #	E201798
Serial #	N9400359
SMU / Hours	5,242
Location	Eloy, AZ 85131, United States

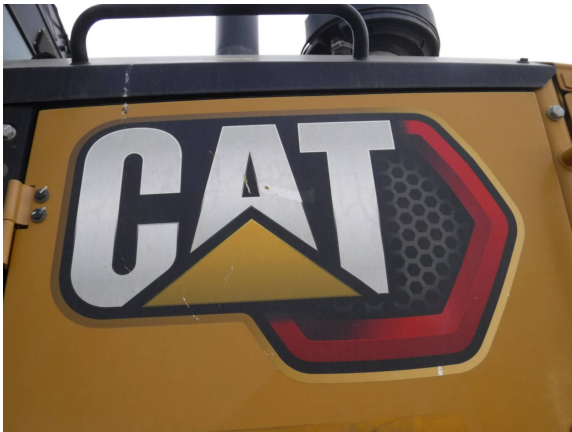
Decals

hood decals are peeling.

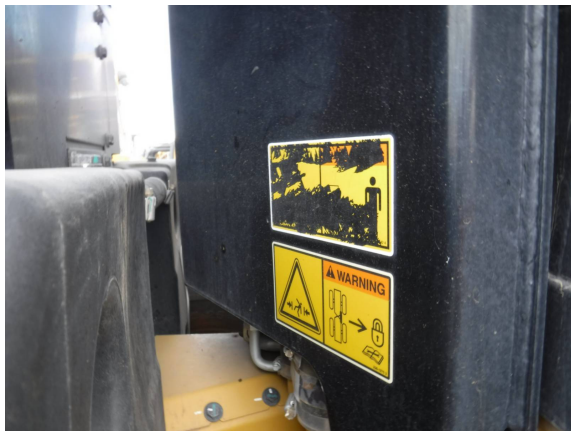
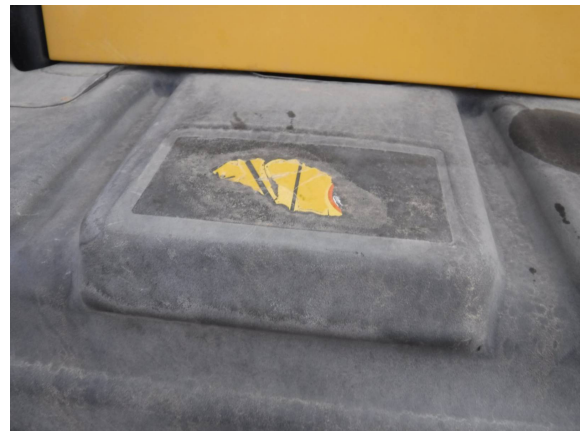
Safety Decals Legible
NO
safety decals are torn

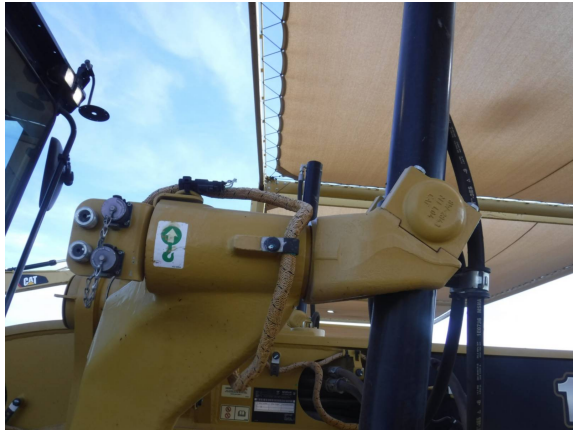
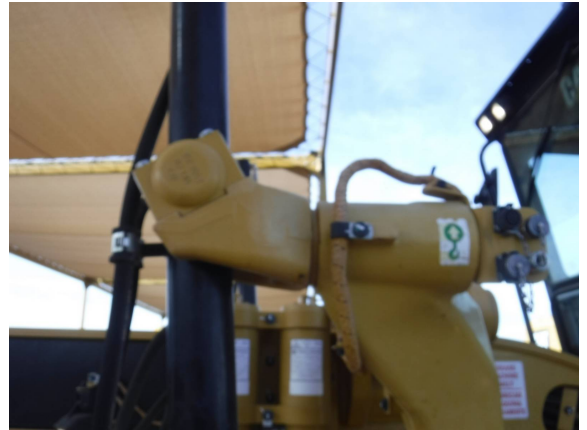
Cylinder Mounts / Pins

●●
cylinder yoke mounts have movement

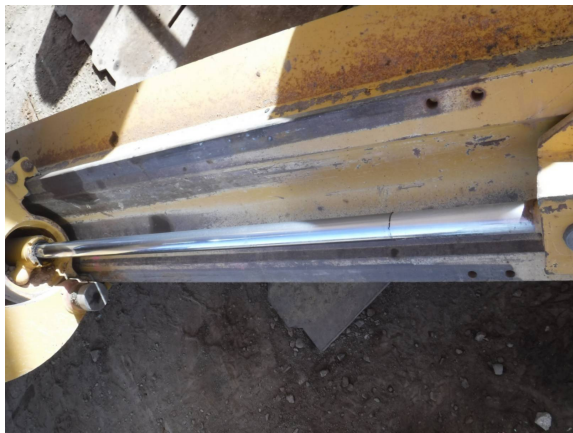
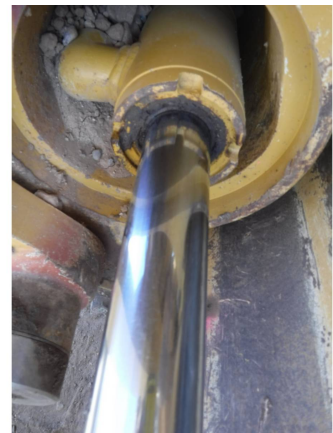
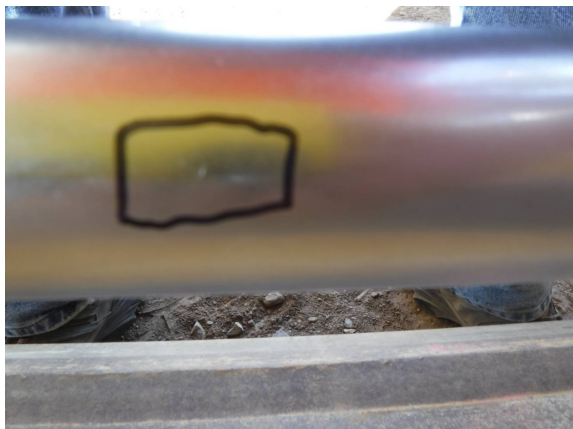
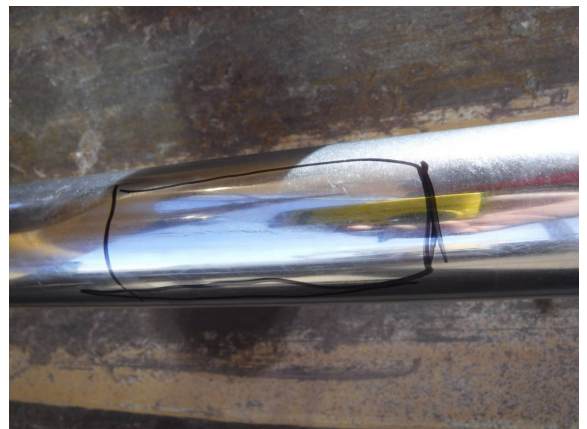
Side Shift Cylinder

●●
side shift cylinder is wet and chrome on rod has scratches

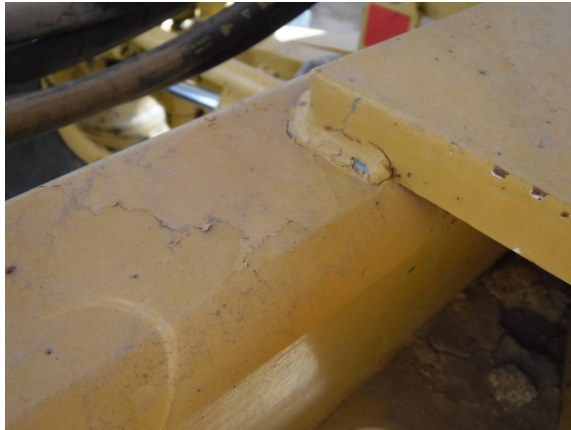
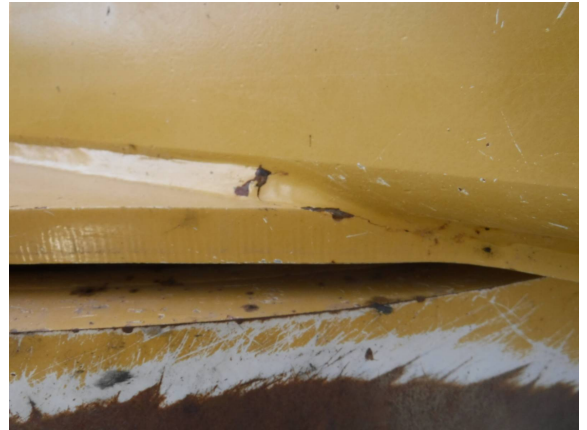
Circle Frame

●●
circle frame has cracks on left
and right side

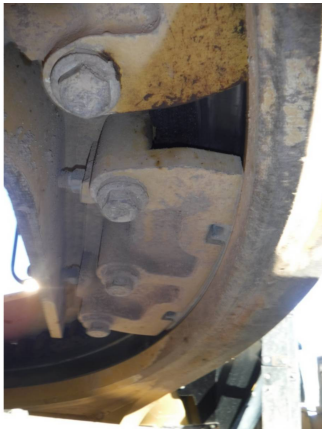
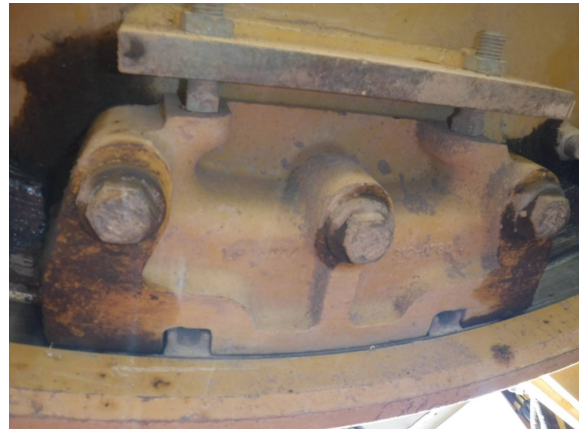
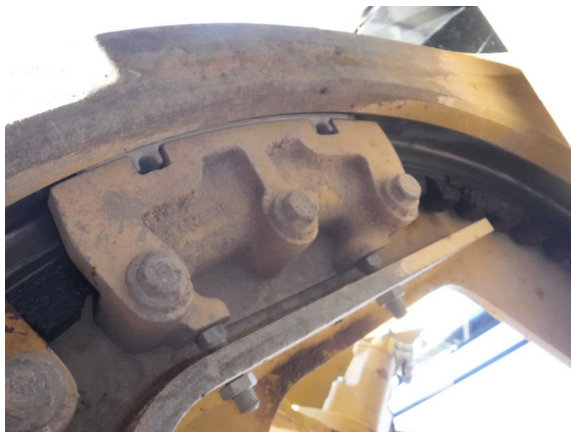
Circle Shoes / Inserts

●●
circle shoe inserts are worn

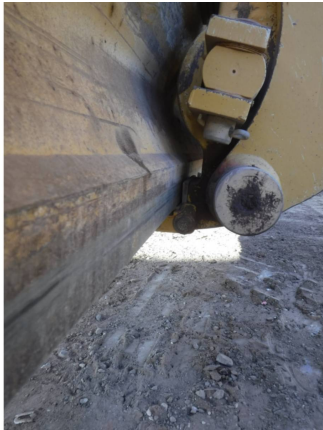
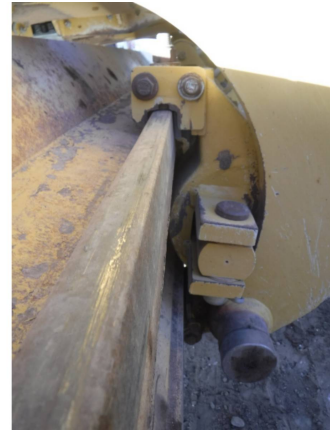
Moldboard Tip Brackets / Inserts

●●
moldboard inserts are worn.

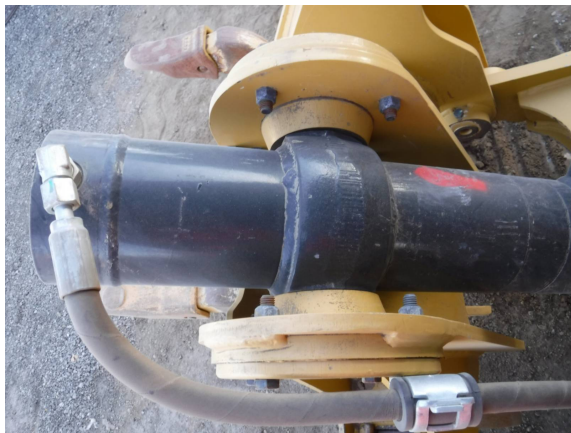
Pins / Bushings

●●
bushings on cylinder have movement

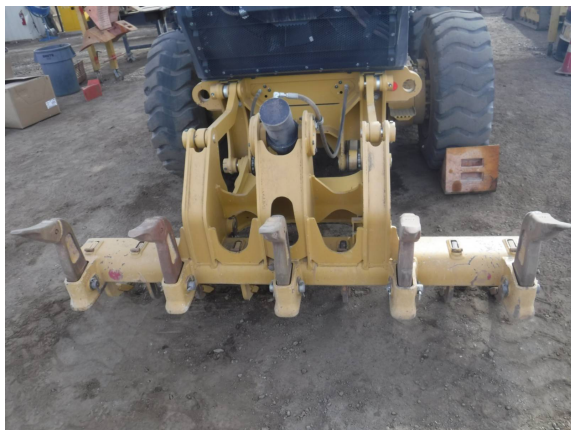
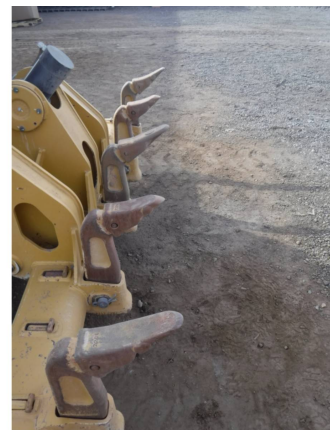
Shanks / Ripper (GET)

●●
2 ripper G.E.T are worn

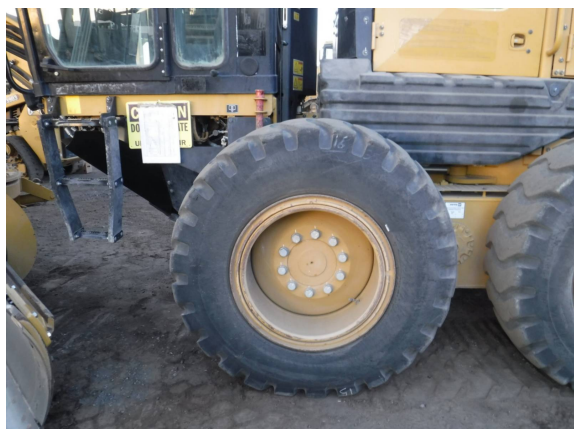
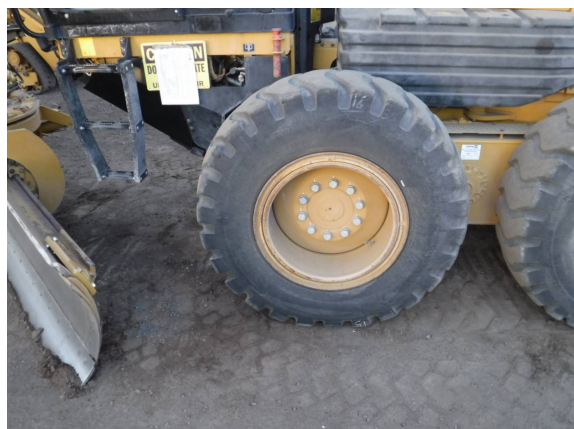
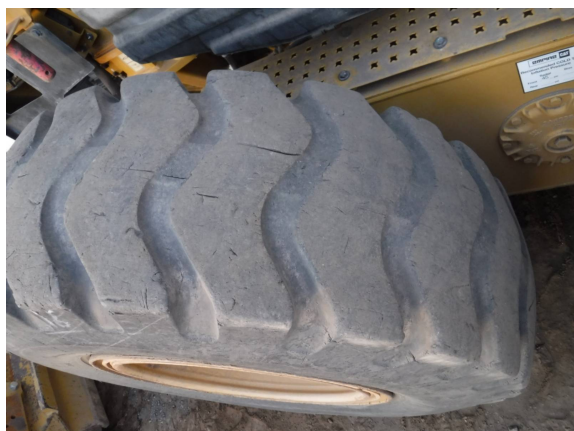
Make / Serial#	Tread Depth in 1/32"	% Life Remaining	Recapped	Tread Cuts/Chunks	Side Cuts Section
Left Center	Maxum	16	48	NO	YES	YES

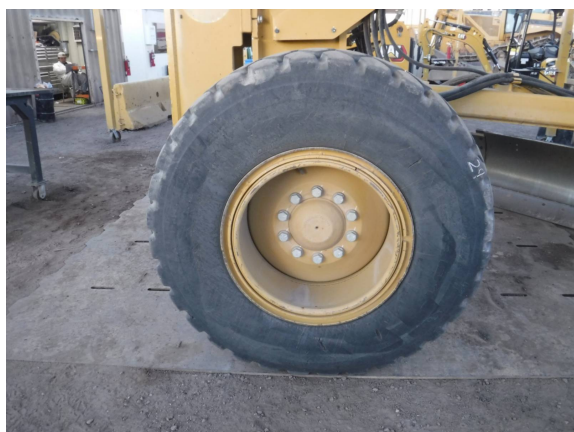
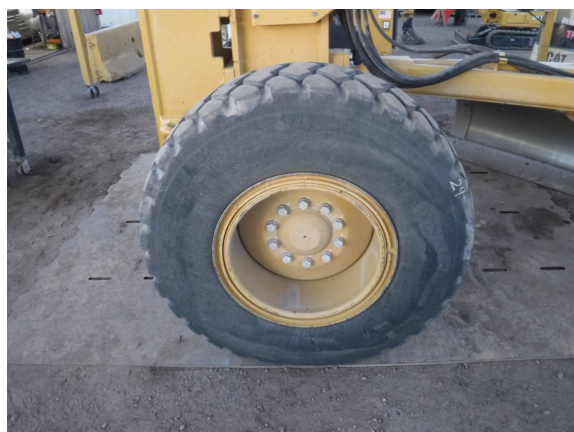
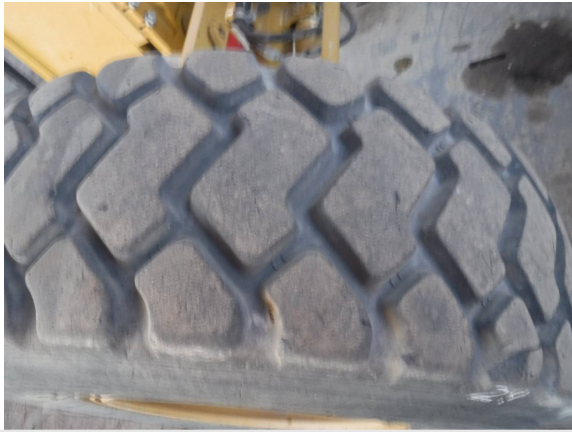
Make / Serial#	Tread Depth in 1/32"	% Life Remaining	Recapped	Tread Cuts/Chunks	Side Cuts Section
Left Front	Maxum	29	87	NO	YES	YES

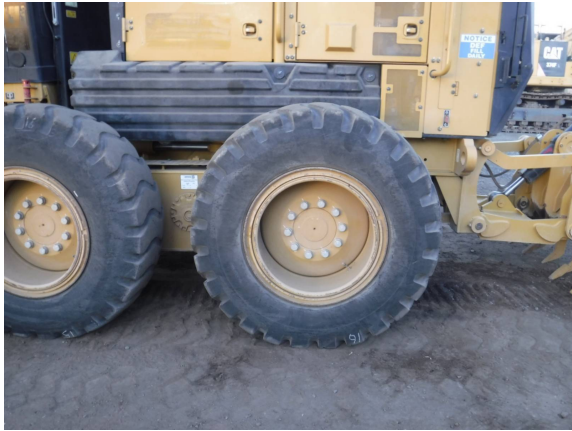
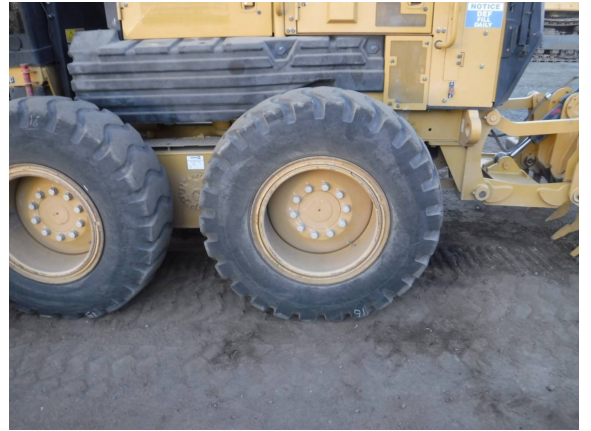
Make / Serial#	Tread Depth in 1/32"	% Life Remaining	Recapped	Tread Cuts/Chunks	Side Cuts Section
Left Rear	Maxum	16	48	NO	YES	YES

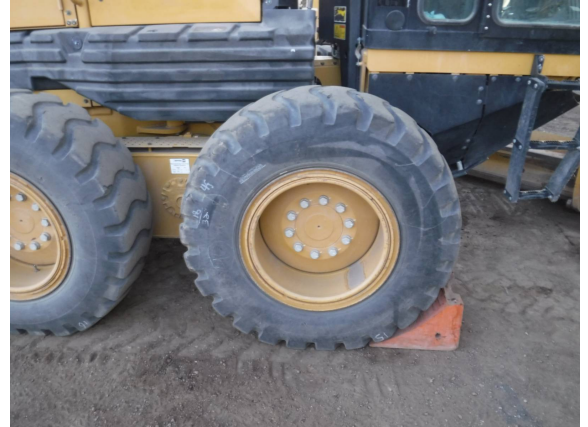
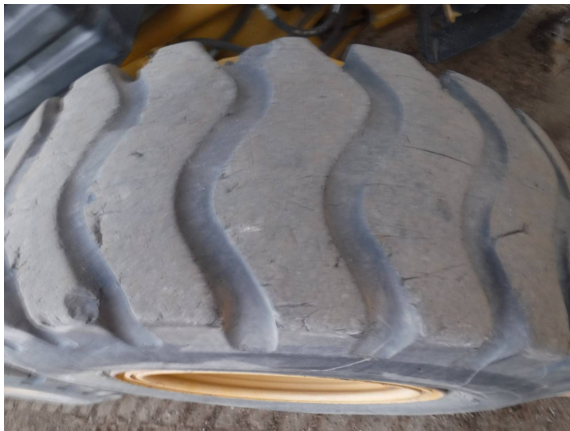
Make / Serial#	Tread Depth in 1/32"	% Life Remaining	Recapped	Tread Cuts/Chunks	Side Cuts Section
Right Center	Maxum	15	45	NO	YES	YES

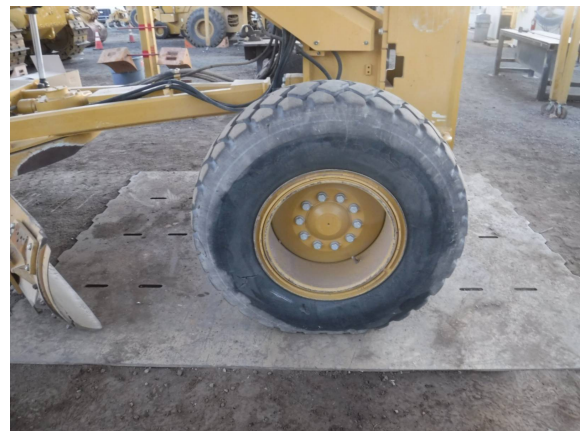
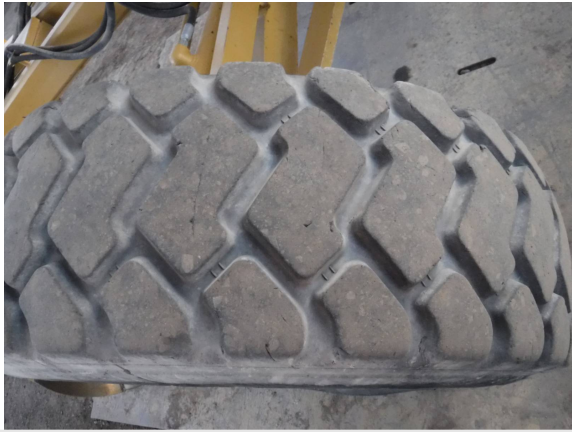
Make / Serial#	Tread Depth in 1/32"	% Life Remaining	Recapped	Tread Cuts/Chunks	Side Cuts Section
Right Front	Maxum	29	87	NO	YES	YES

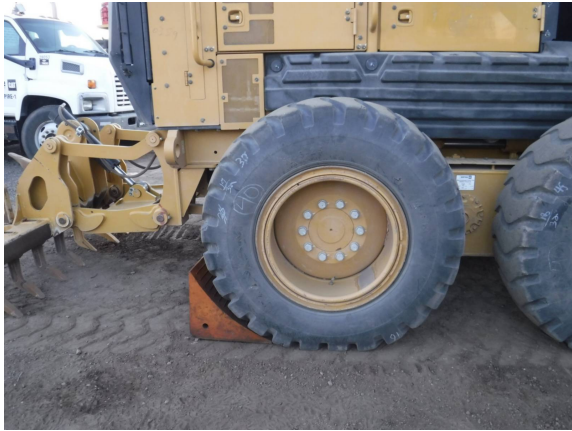
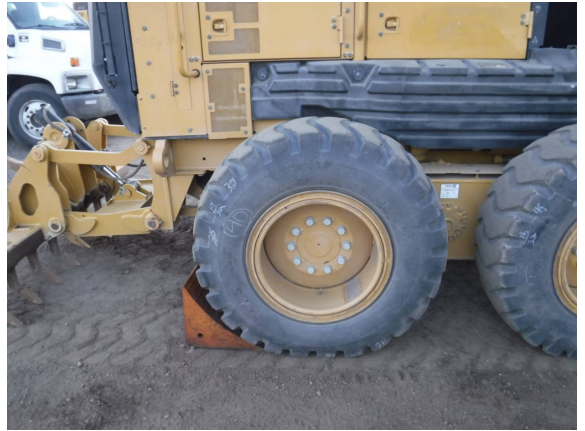
Make / Serial#	Tread Depth in 1/32"	% Life Remaining	Recapped	Tread Cuts/Chunks	Side Cuts Section
Right Rear	Maxum	16	48	NO	YES	YES
