2013 FREIGHTLINER 2K WATER TRUCKS

INSPECTION DETAILS

| Inspection # | 10204894 |

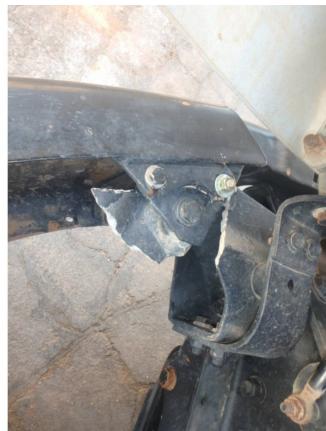
Bumper

Front left bumper mount is broken

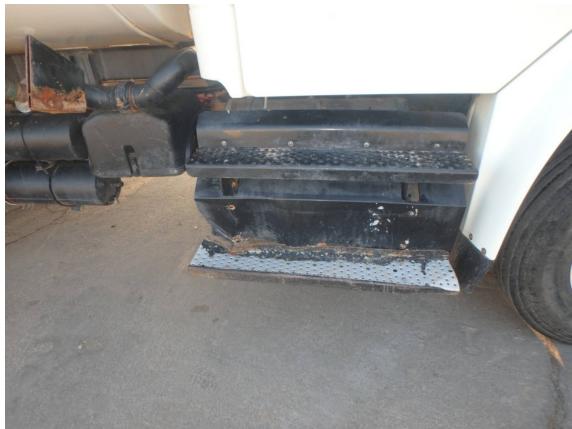
Sheet Metal

Lower right cover over DPF is bent (Functional)

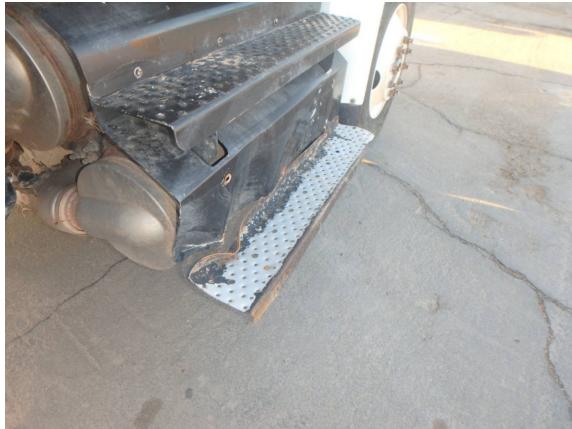
Steps / Ladder

Right step bent (Functional)

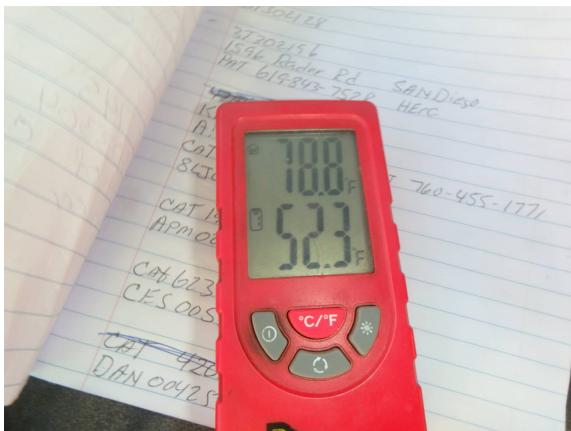
Air Conditioner

Vent temperature 52° Ambient
temperature 78°

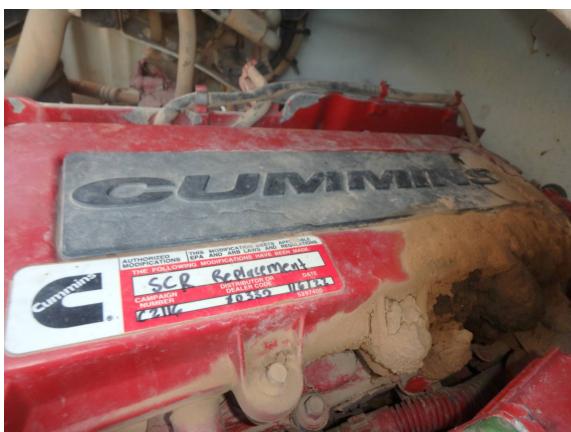
Oil Leaks

Valve cover is leaking left rear
coner

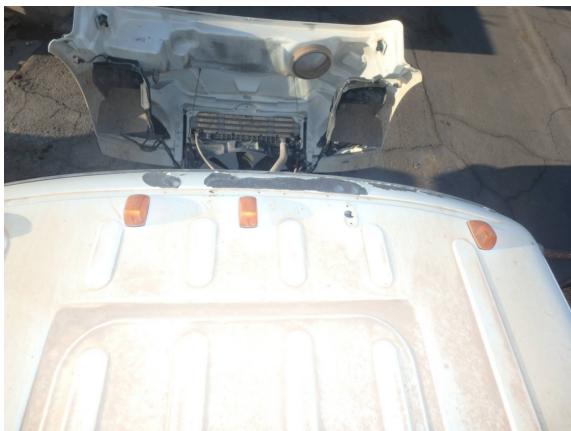
Lighting

Missing one marker light on cab

Missing one marker light on
cab

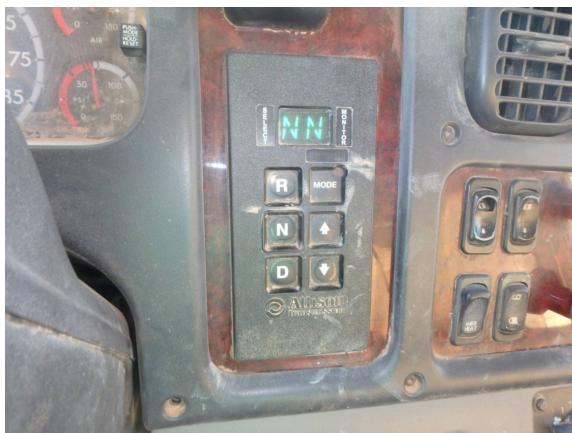
Transmission - Type

Allison automatic

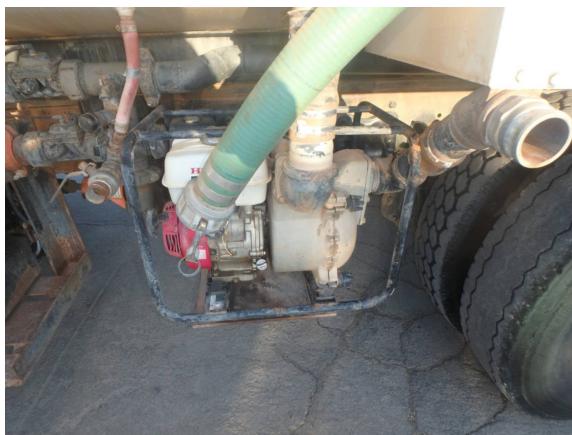
Self Loading Tank

Honda trash pump WT30X
