2014 CAT 328DLCR TRACK EXCAVATORS

INSPECTION DETAILS

Inspection Type	Trade
Inspection Form	Standard
Inspection #	10211343
Inspection Status	Completed
Created	06/23/25 13:10:34
Updated	06/26/25 12:10:25
Created By	Calderas, Marco
Inspector	Calderas, Marco
Reviewers	Calderas, Marco
Salesperson	Schultis, Derrick R.
Serial #	RMX00885
SMU / Hours	7,271
Location	Eloy, AZ, United States

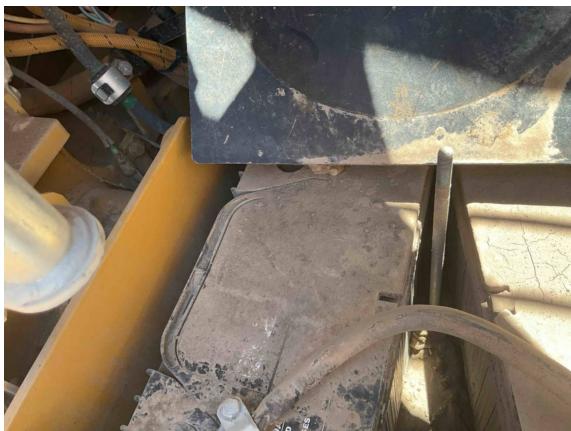
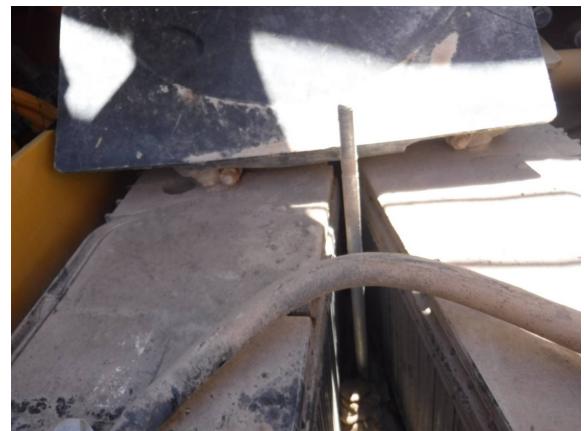
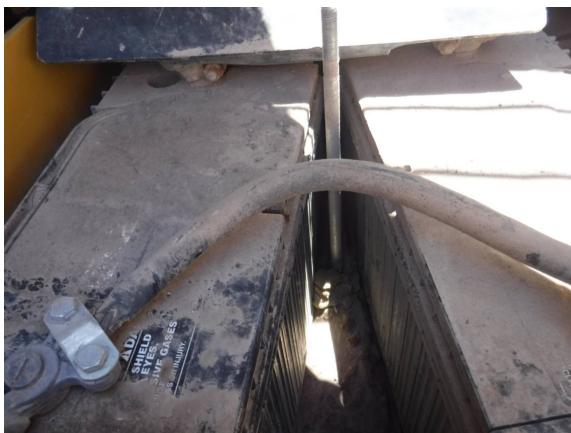
Crankcase Guard / Battery Box

Battery bracket holder and cover bolt nut is missing.

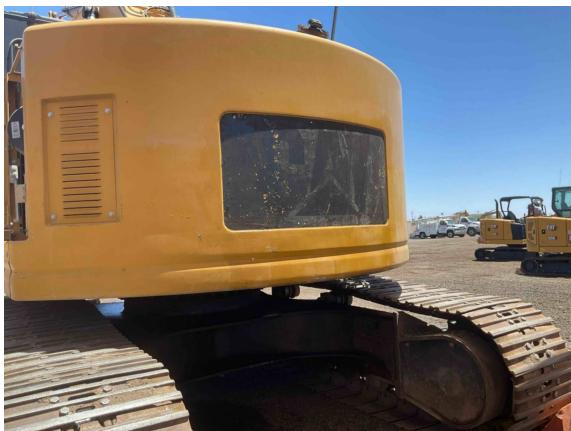
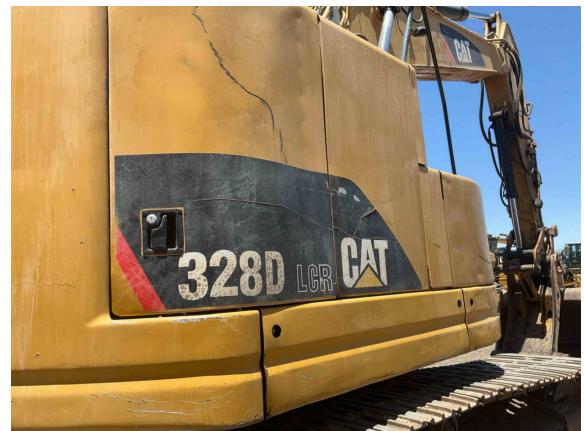
Decals

Rear decal is missing and right side decals are scratched

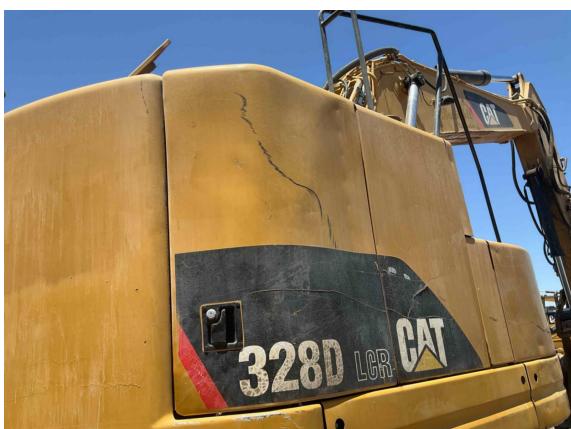
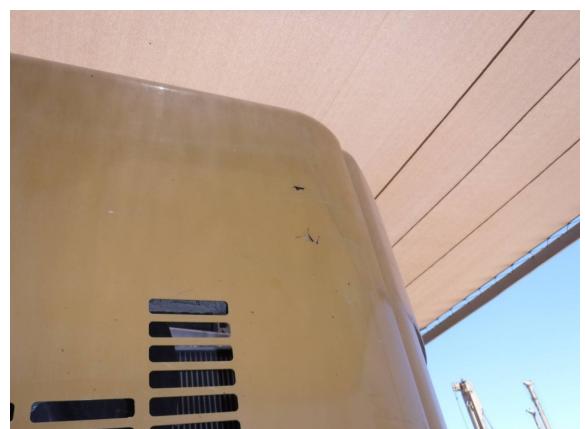
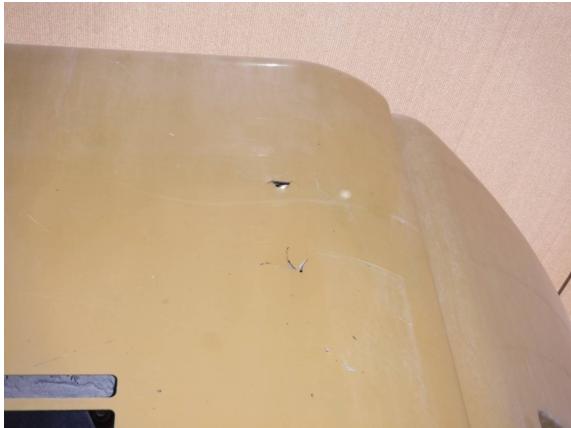
Sheet Metal

Right side hydraulic door compartment is missing door stop and left side door has holes.

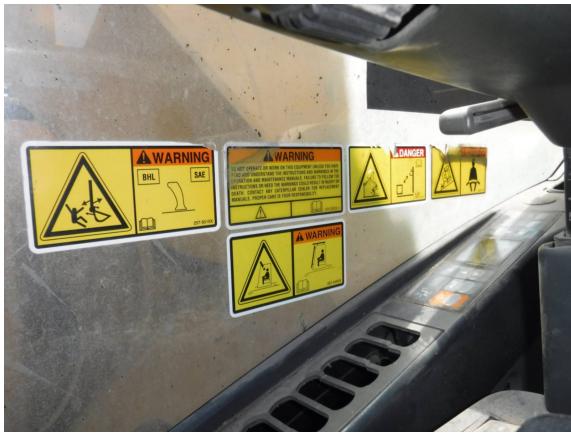
Dash Console

Missing dash console blanks.

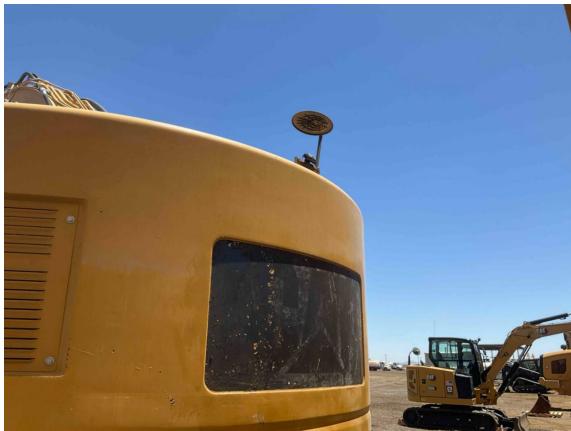
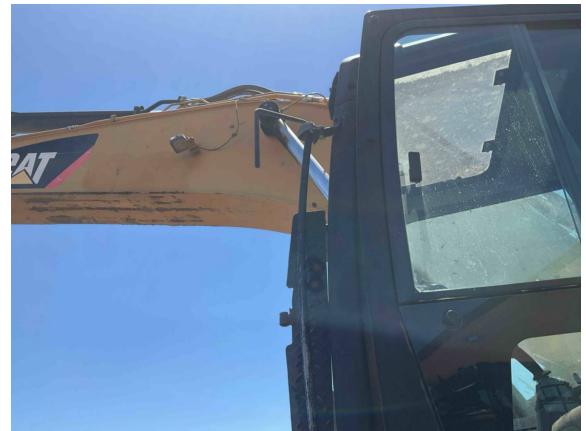
Mirrors

Both left and rear mirrors are missing

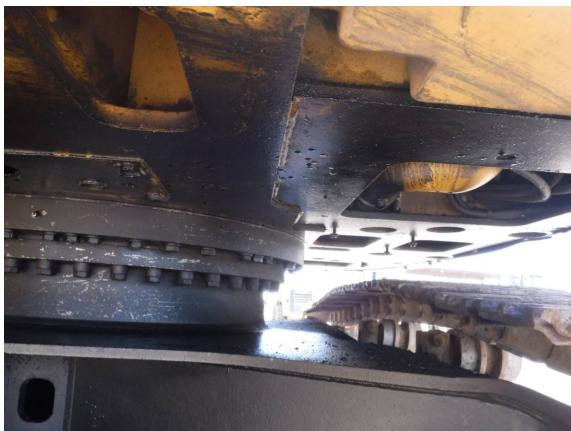
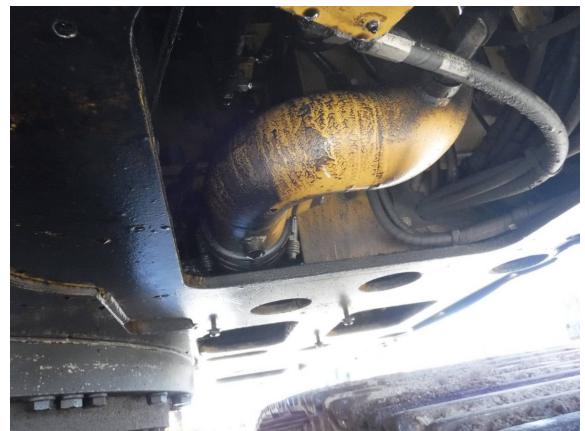
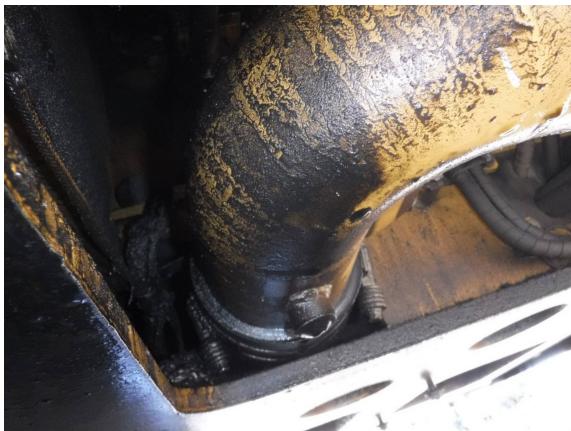
Pans/Guards

●
Right rear engine cover is missing

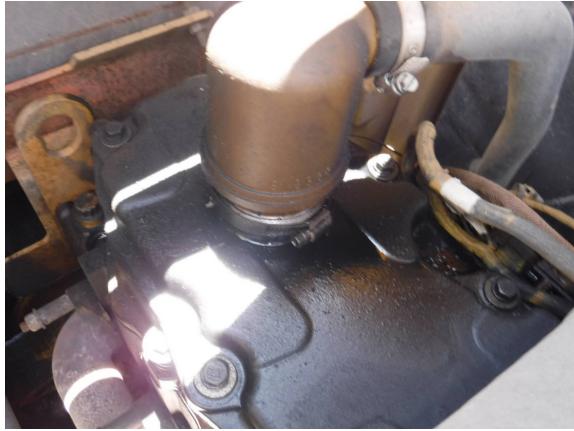
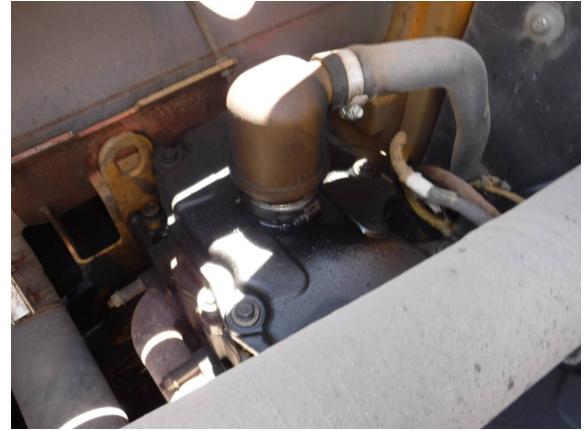
ENGINE BREATHER AS.

Engine breather crankcase have oil leak.

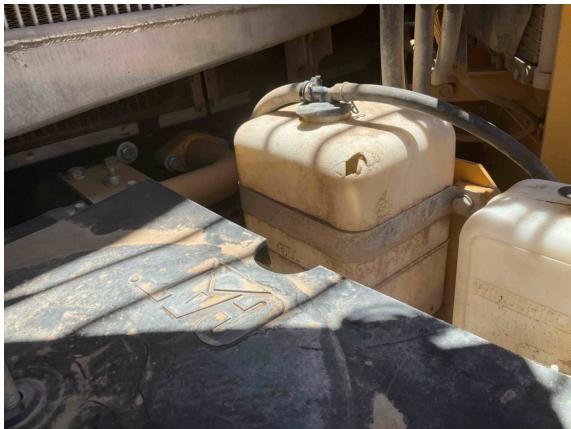
Anti-Freeze Level / Color /

Coolant reservoir is cracked
(red)

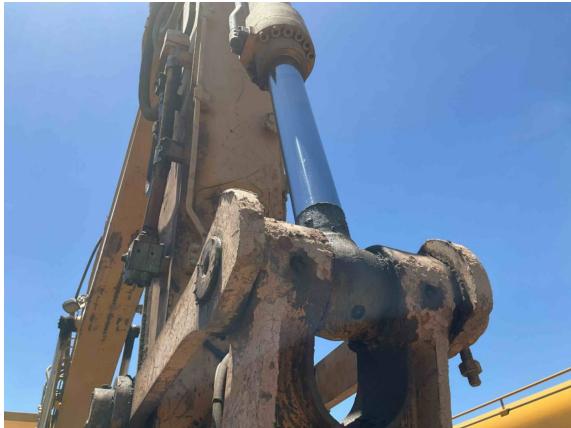
Bucket Cylinder

Has leaks on hea rod seals

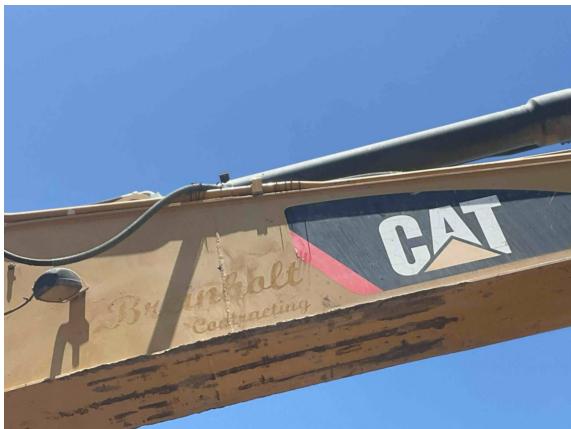
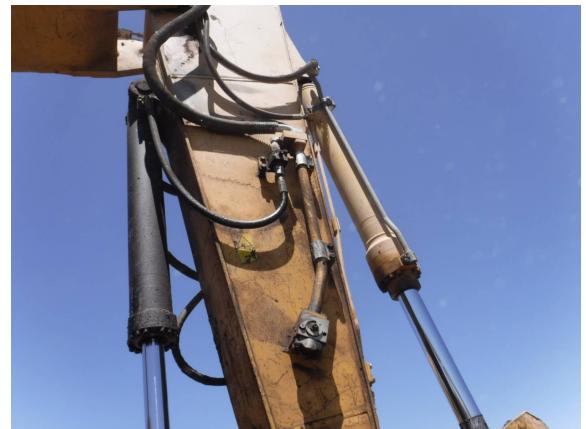
Hose Lines

All lines are tied with zip- ties
and lines are leaking oil

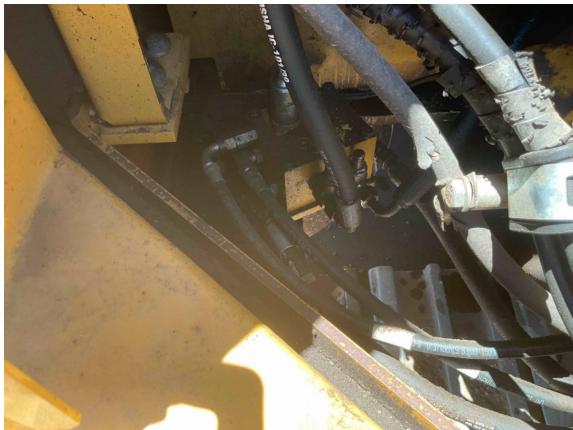
Pump Drive

Has leaks

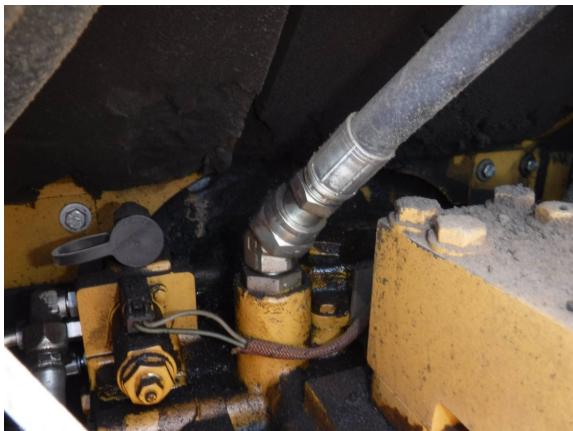
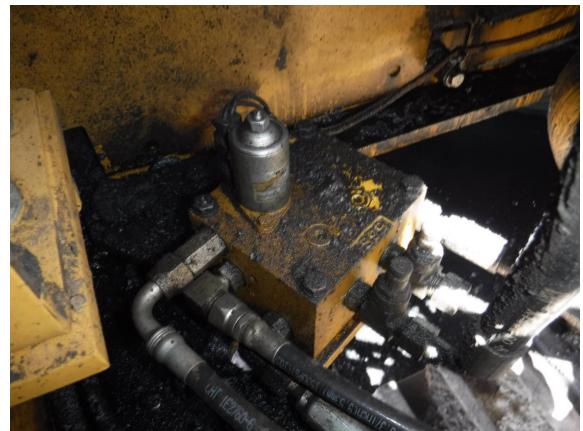
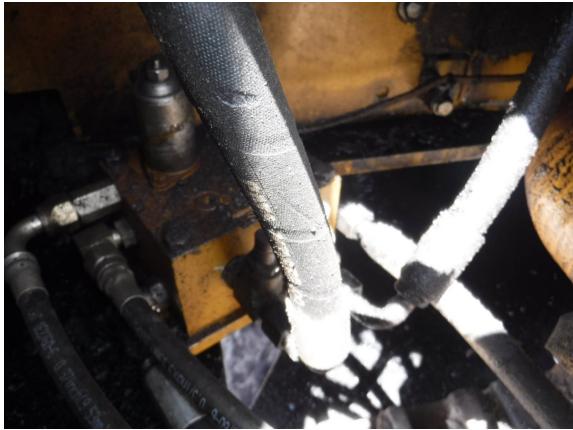
Pumps & Valves

Has leaks

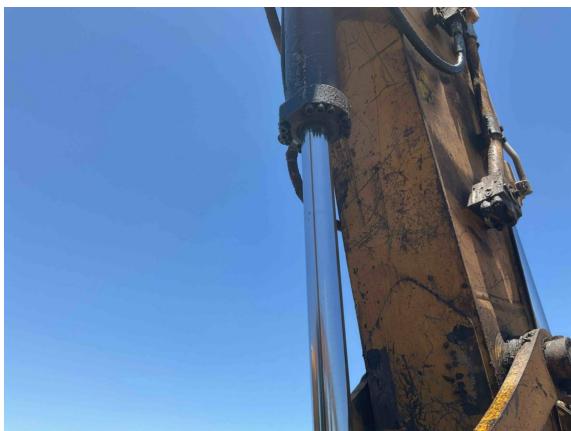
Thumb Cylinder

Is leaking at head rod seals

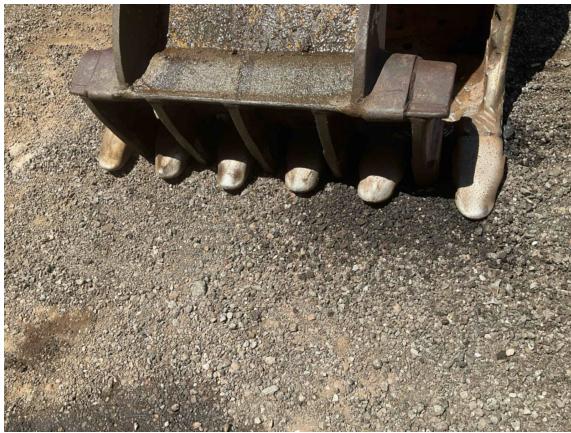
Teeth / Adapters

Theet are worn out

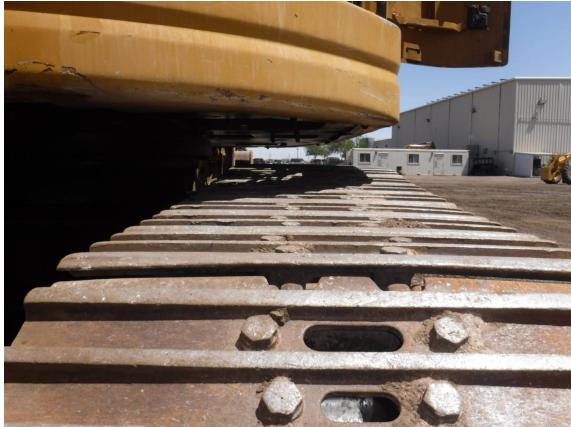
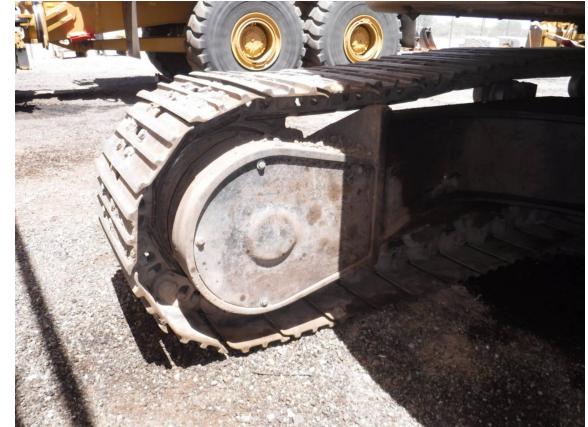
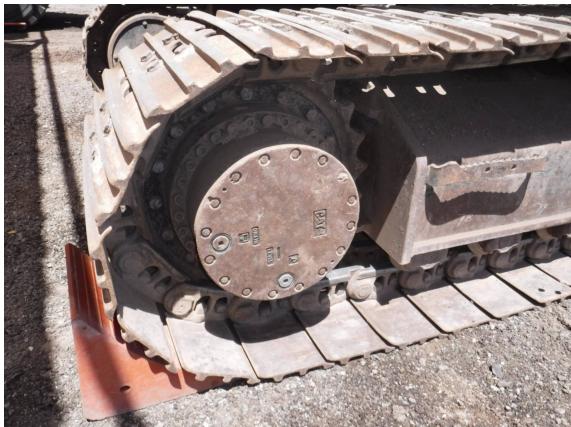
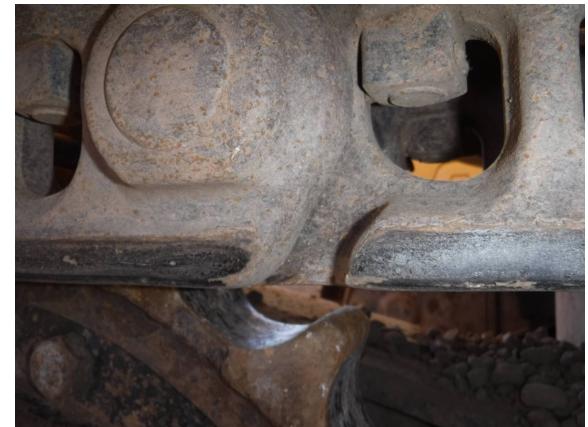
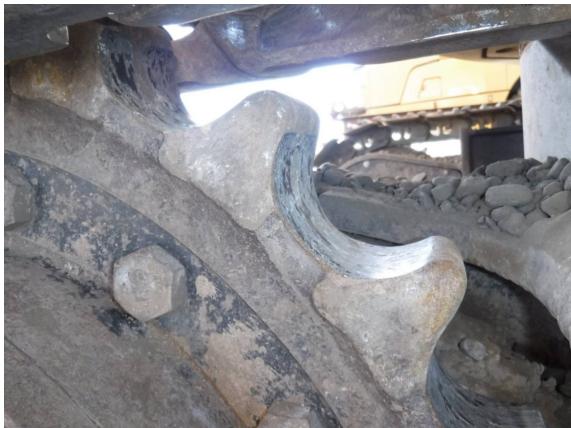
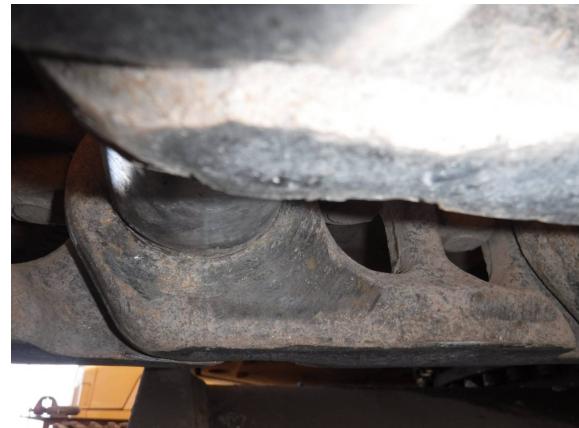
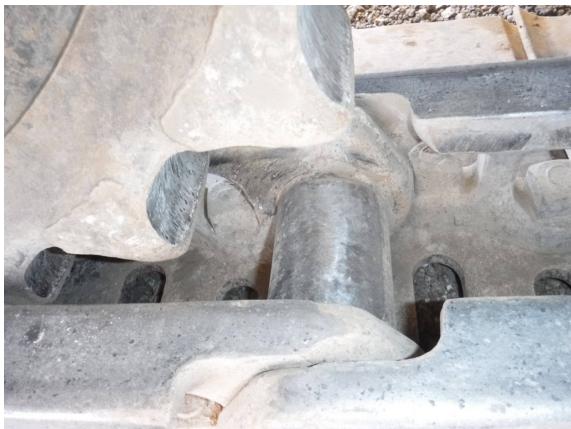
Track Frame - Left

Has multiple broken pads and
cease pins

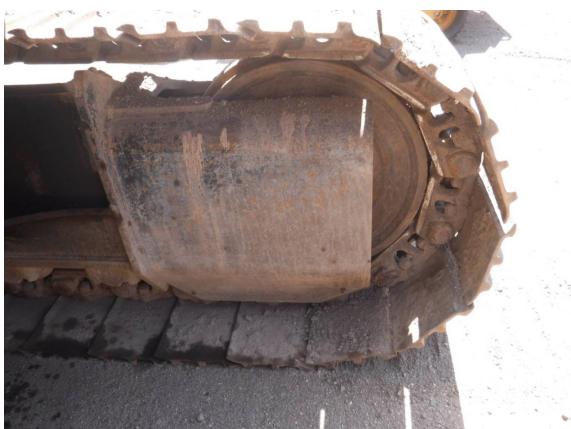
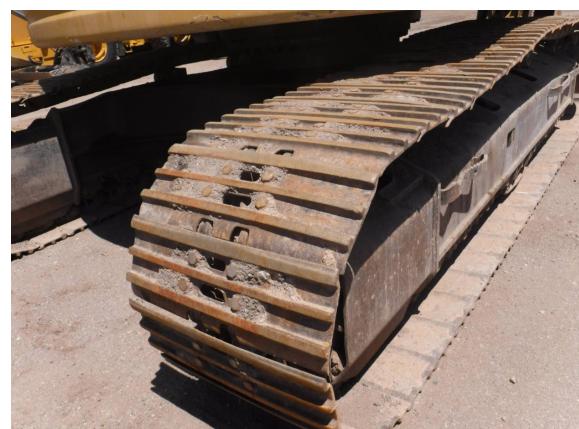
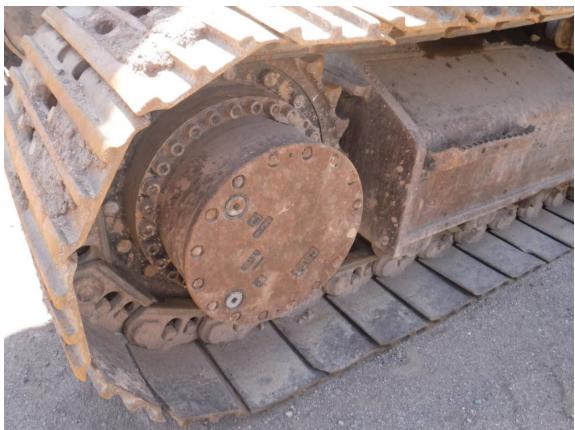
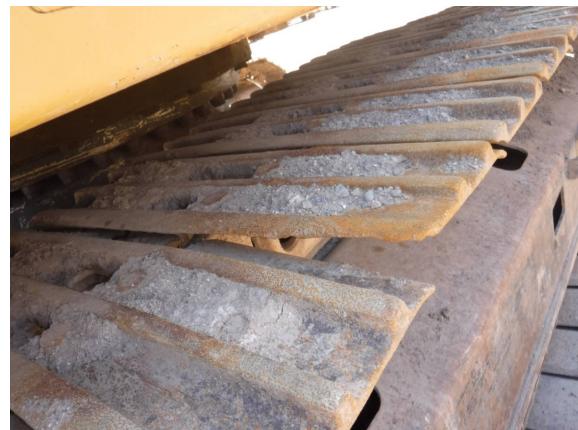
Track Frame - Right

- Has multiple broken pads and
cease pins

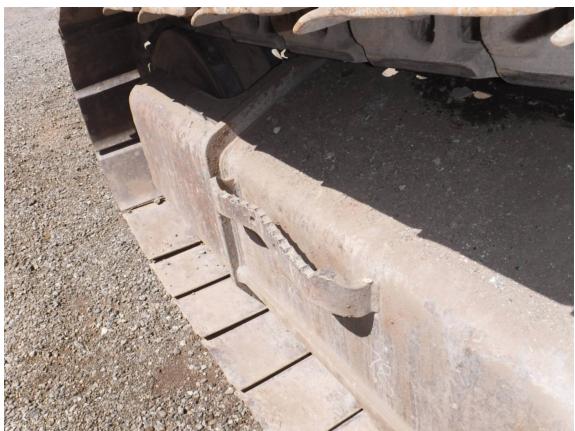
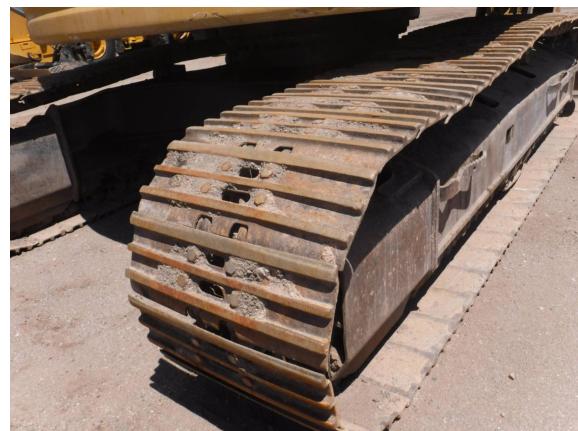
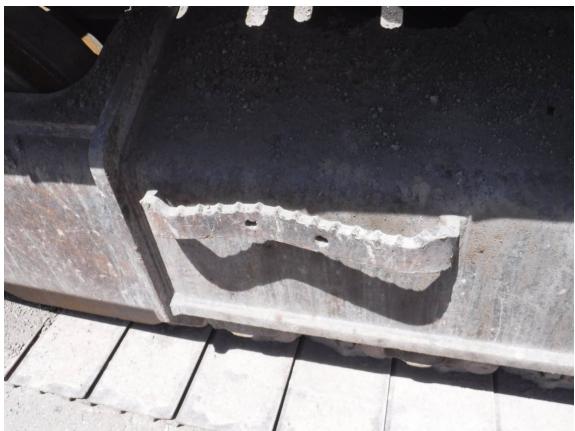
Track Frame Steps

5 Out of 6 steps are bent.(weld repairs)
