2020 CAT 14015 MOTOR GRADERS

INSPECTION DETAILS

Inspection Type	Marketing
Inspection Form	Standard
Inspection #	10210754
Inspection Status	Completed
Created	06/19/25 18:19:38
Updated	07/07/25 10:22:20
Created By	Garcia, Jr
Inspector	Garcia, Jr
Reviewers	Calderas, Marco
Salesperson	Schultis, Derrick R.
Stock #	E205360
Serial #	EB200214
SMU / Hours	7,518
Location	Eloy, AZ, United States

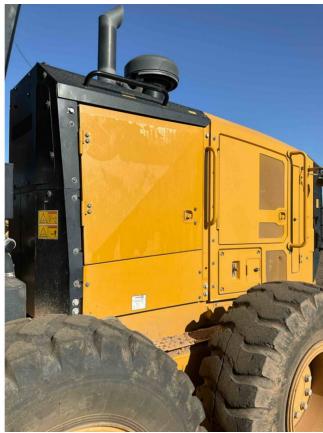
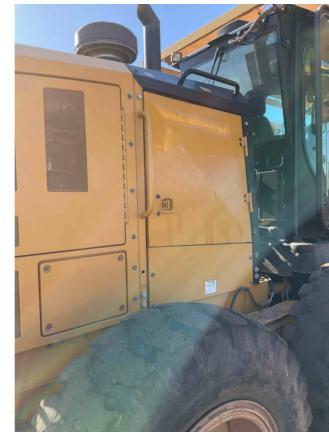
Decals

Missing decals on left and right rear sections of engine compartments

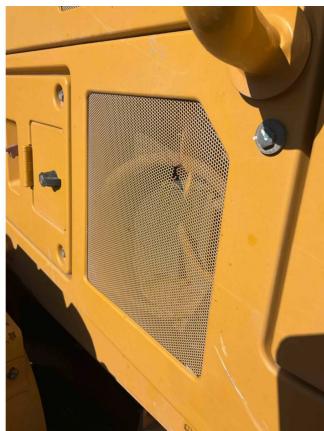
Engine Enclosures

Left rear section has damaged screen

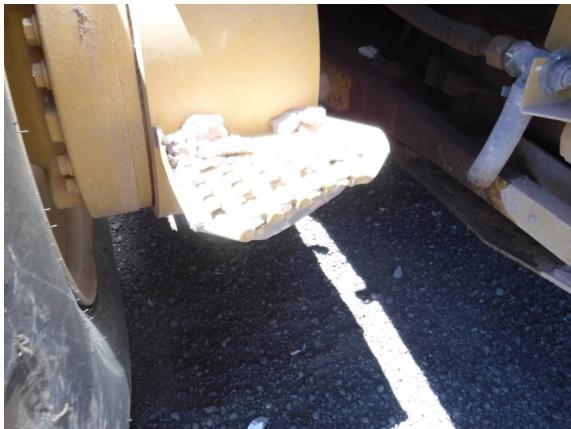
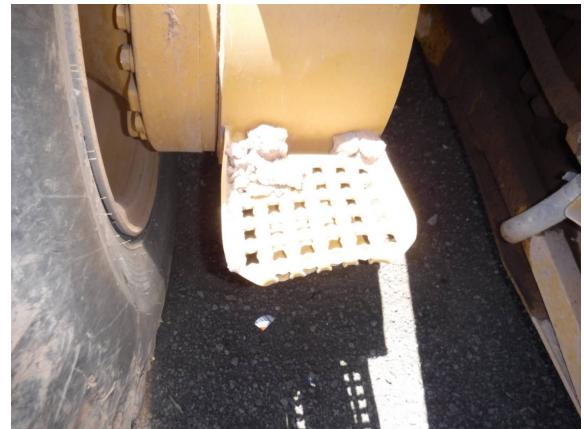
Sheet Metal

Left rear step on tandem housing is bent

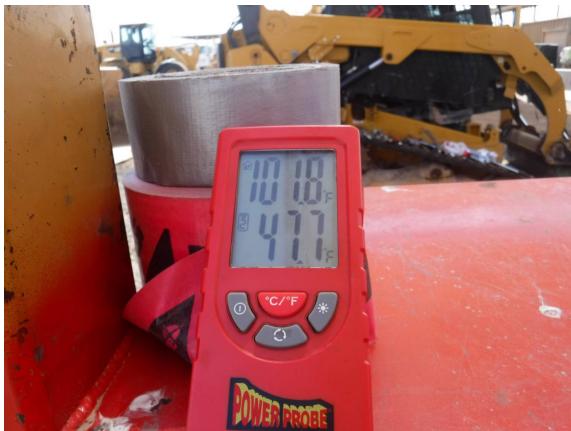
Air Conditioner

Ambient temp at 101.8F and
vent temp at 47.7F

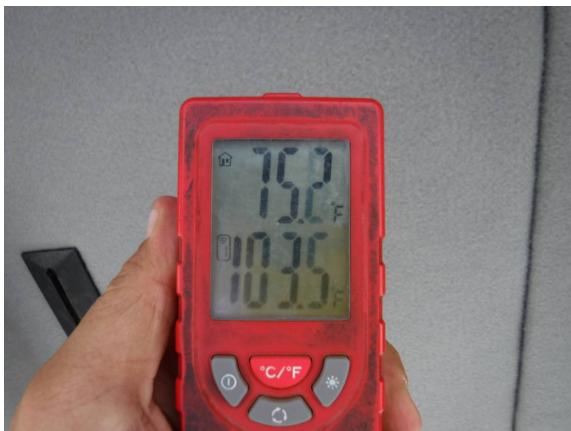
Heater / Defroster

75 ambient temp and 103 vent
temp

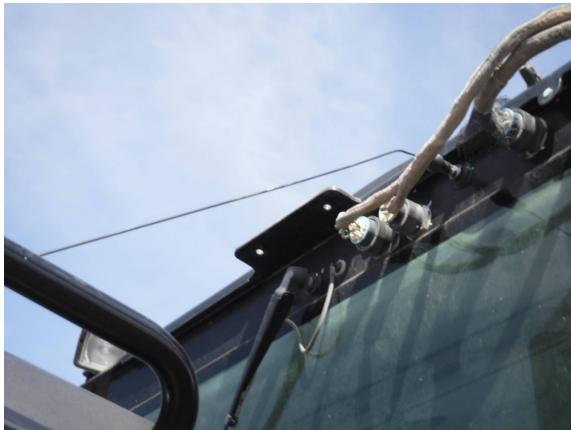
Radio

ANTENNA IS BENT AND
DAMAGED

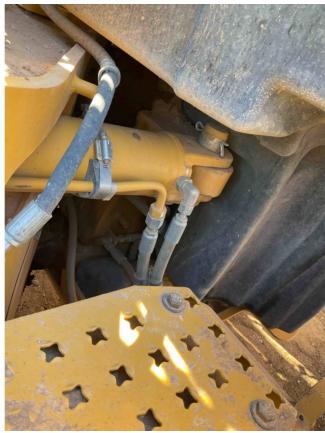
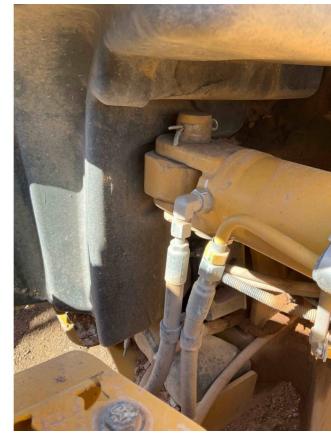
Steering Cylinder

Both rear steering cylinders have movement at pins and bushings.

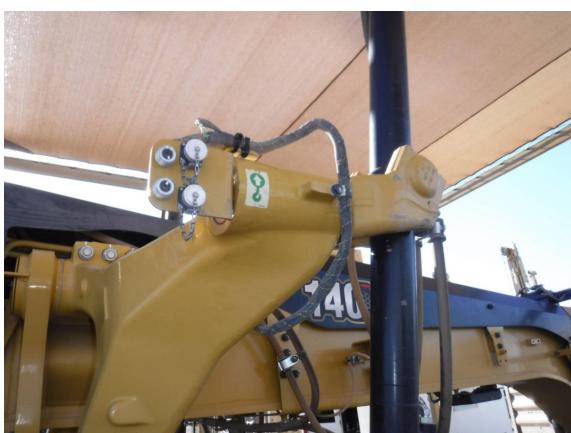
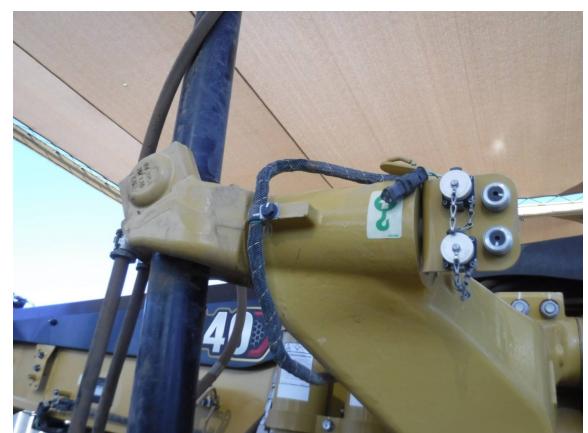
Cylinder Mounts / Pins

Has movement

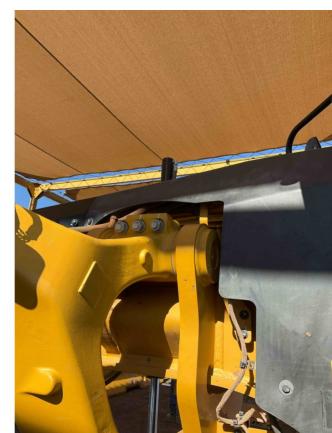
Hydraulic Lines / Fittings

Has wet lines under front cover.

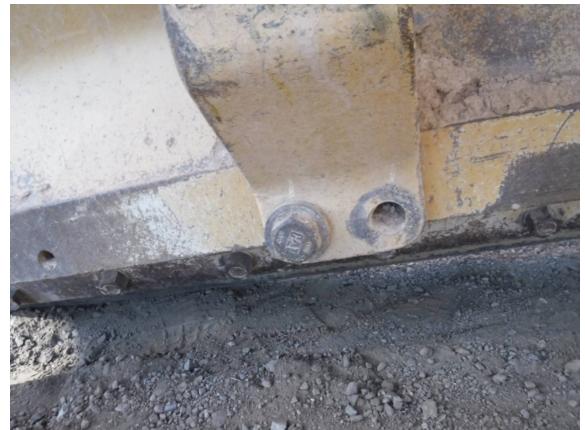
Side Shift Cylinder

Has oil residue at hoses.

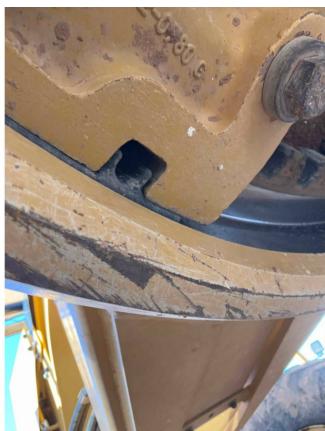
Circle Shoes / Inserts

Worn

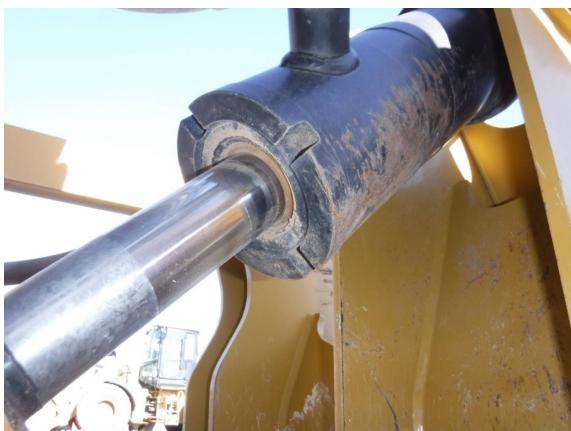
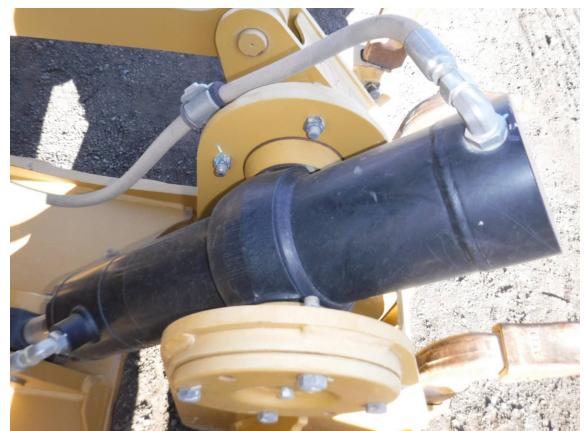
Cylinders

Trunnion mounts have movement

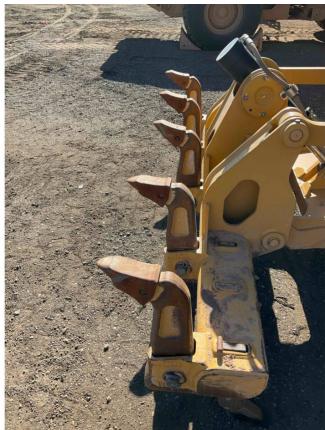
Shanks / Ripper (GET)

Worn

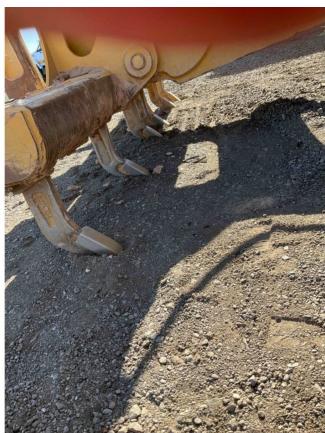
Shanks / Scarifier (GET)

Worn. Missing 4 shanks

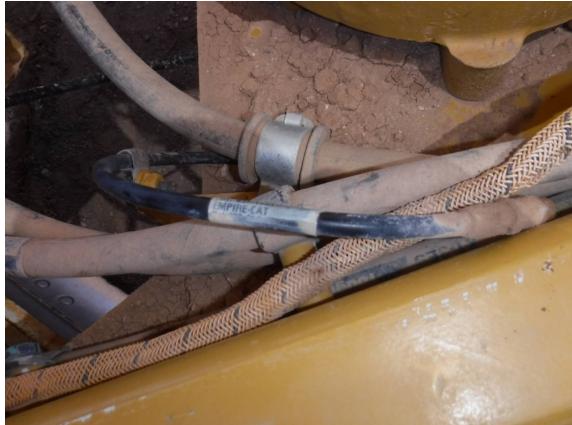
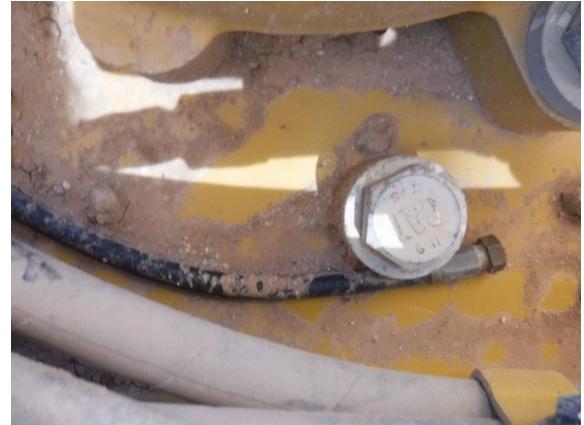
Notes - HYDRAULICS

HAS LOOSE GREASE LINE NOT
HOOKED UP ON CIRCLE

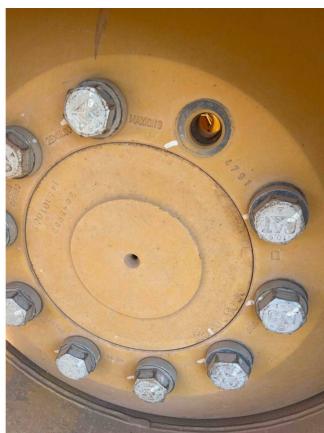
Notes - TIRES

Left rear missing lug bolt

QUOTED ABOVE
