2024 CAT
42007XE
BACKHOE LOADER

INSPECTION DETAILS

| Inspection # | 10234325 |

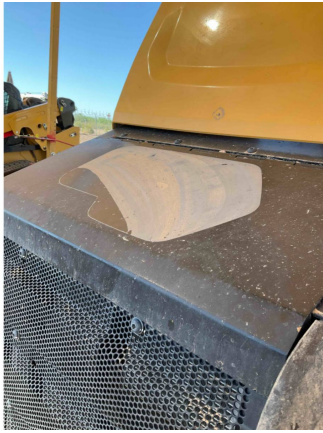
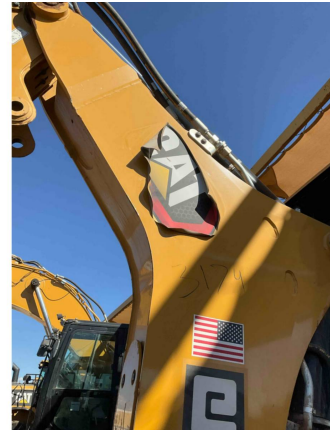
Decals

Peeling on right side of boom
and missing on hood (cover
under the service letter
PS55342) Warranty

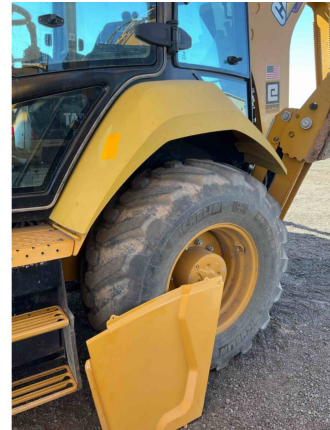
Fenders

Discolored

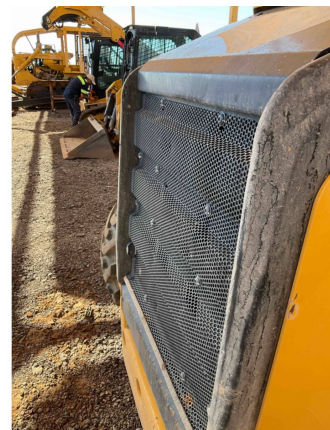
Radiator Grill

Has small dents and rips

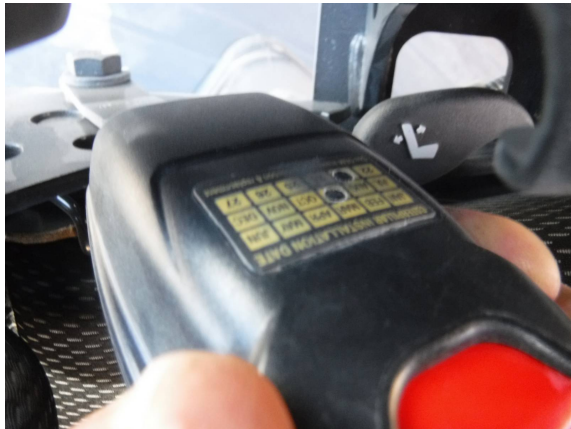
Seat Belt / Date

SEPTEMBER 2023

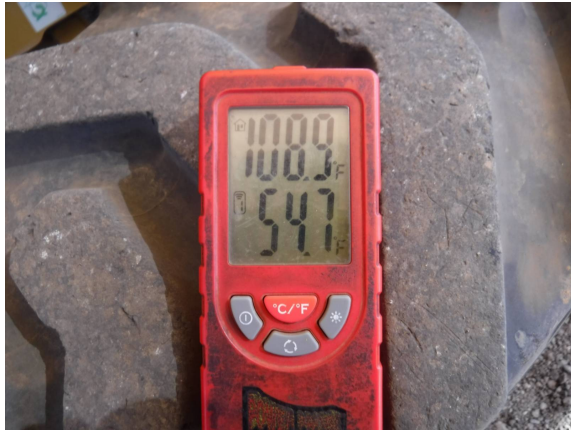
Air Conditioner

108 ambient temp and 54 vent
temp

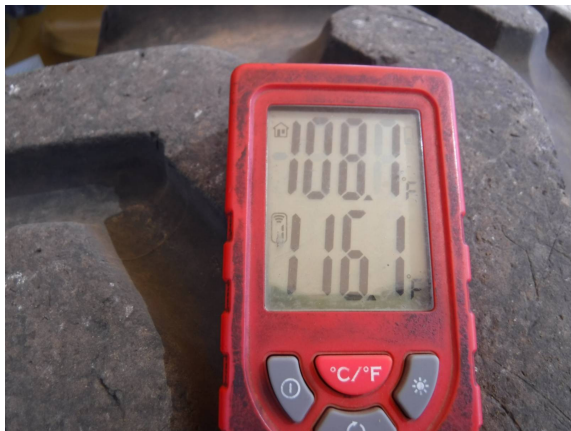
Heater / Defroster

108 ambient temp and 116 vent
temp

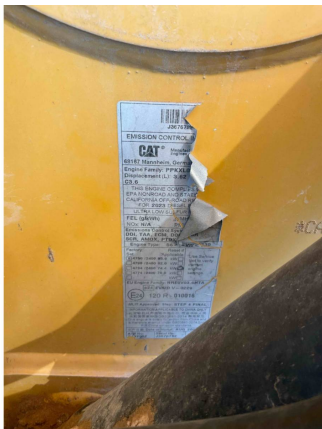
Emissions Decal Legible

Cracked and peeling

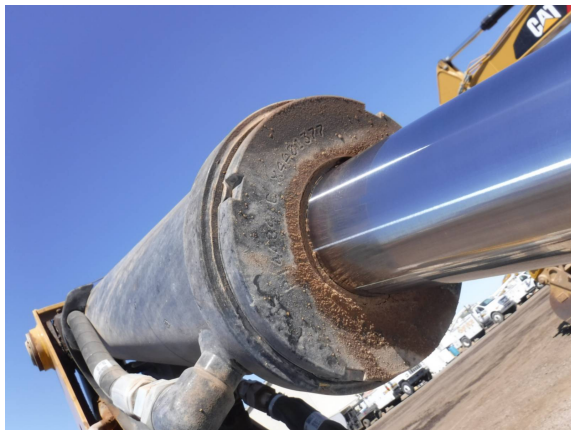
Boom Cylinder

Has grease residue

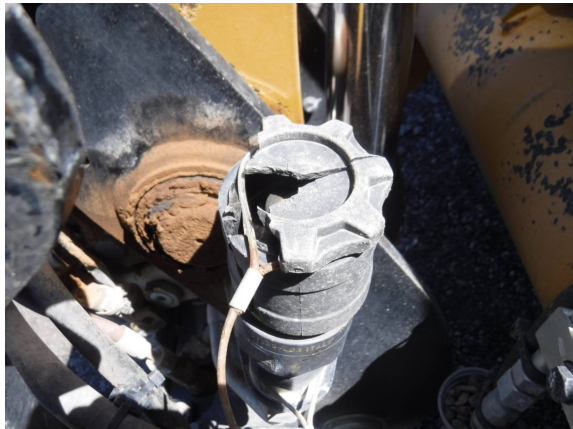
Front Loader Auxiliary

Cap is cracked on left side front auxiliary fitting.

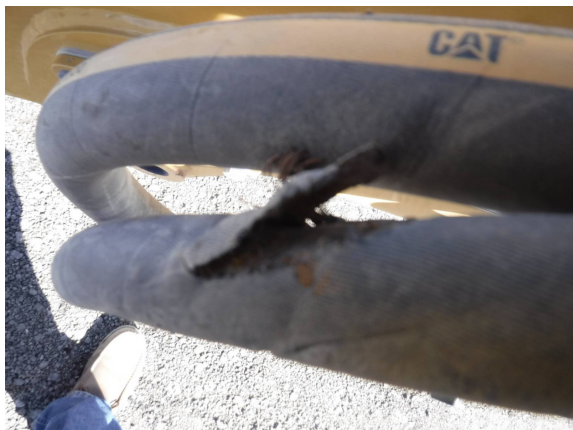
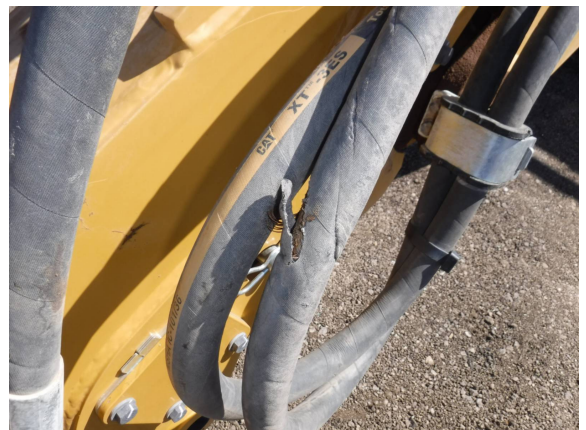
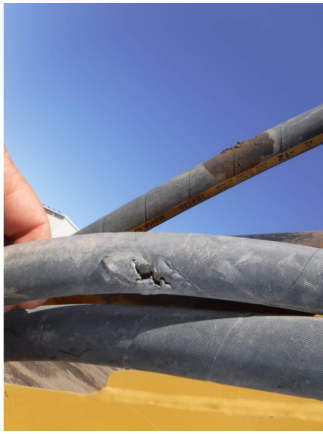
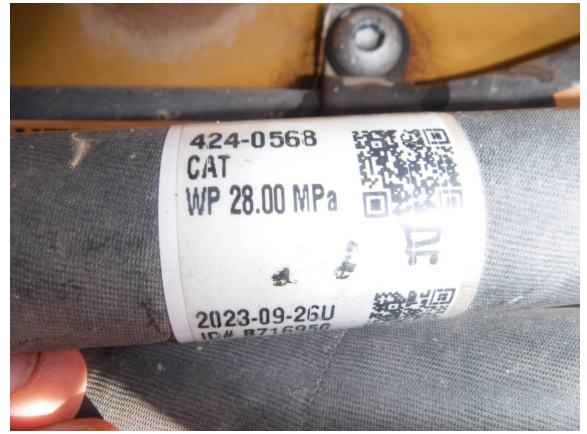
Hose Lines

Has rips and cuts on hydraulic line on right side of boom

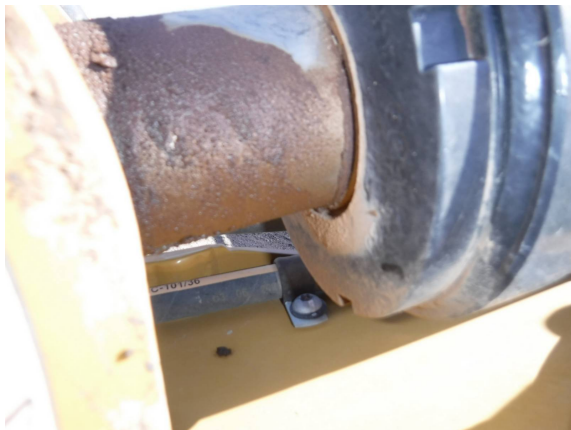
Stick Cylinder

grease residue present

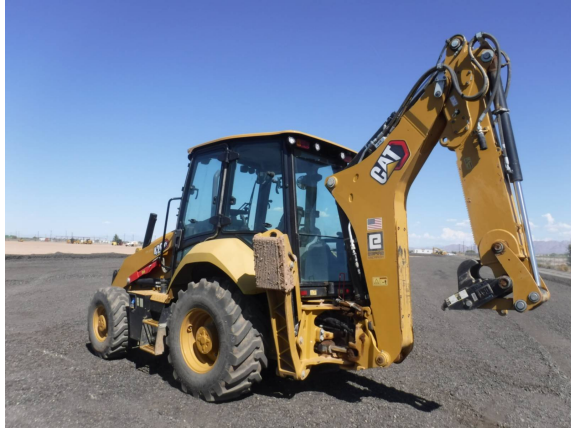
E Stick Condition

Needs adjusted

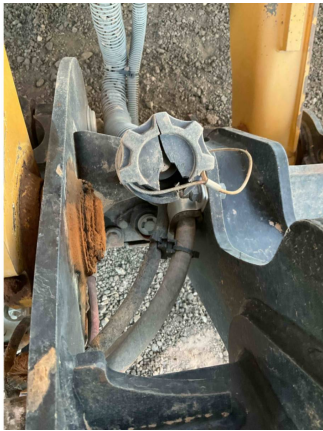
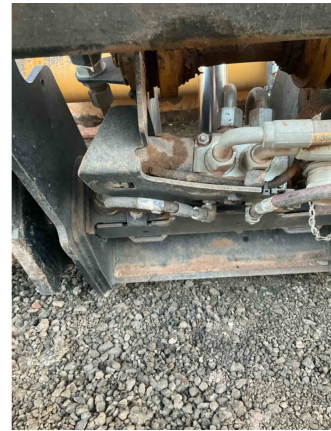
Front Bucket Quick Coupler

Has cracked retainer, and bent bracket.
