2007 CAT
345CL
TRACK EXCAVATORS

INSPECTION DETAILS

| Inspection # | 10205878 |

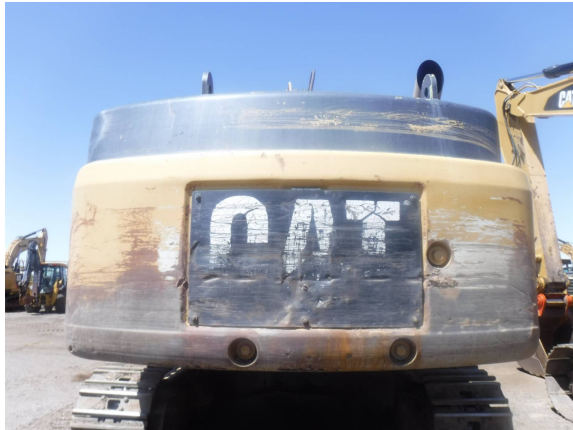
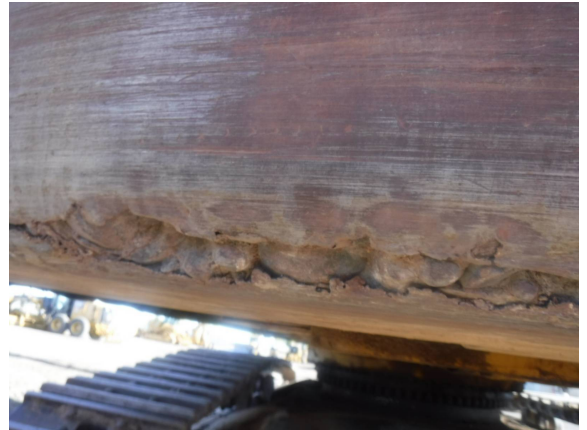
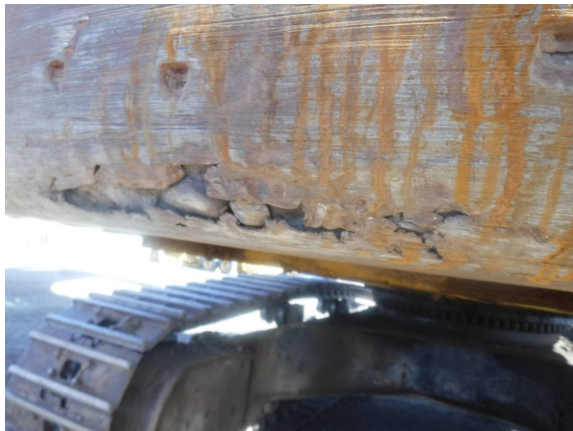
Counterweight

Paint is faded and bottom edge is
worn through

Paint is faded and bottom edge
is worn through

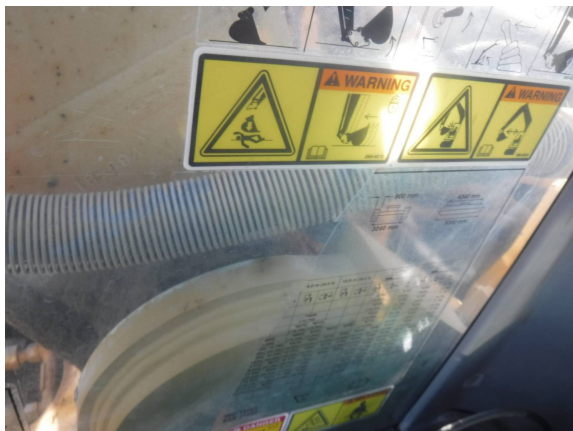
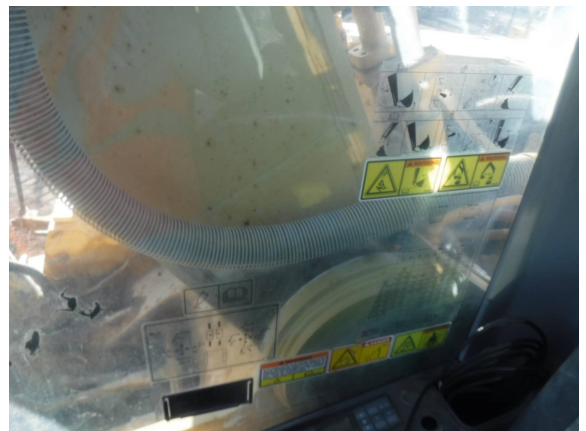
Safety Decals Legible

Chart on right window is torn in half.

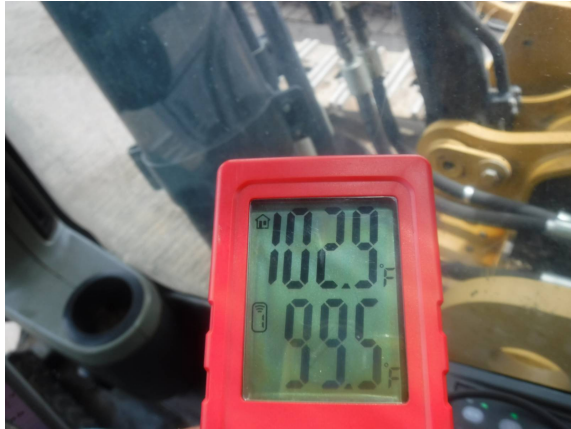
Air Conditioner

●
A/C is not working. Ambient
Temp at 102° and Temp at Vent
99°

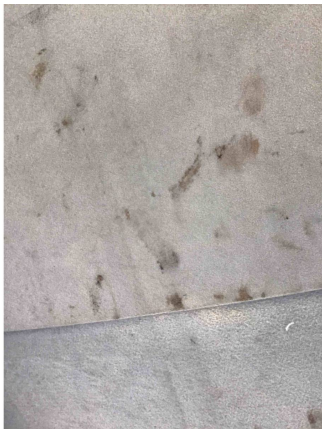
●●
Headliner is stained

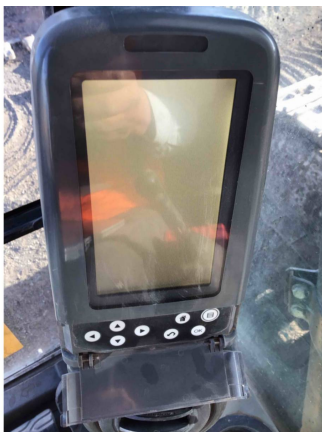
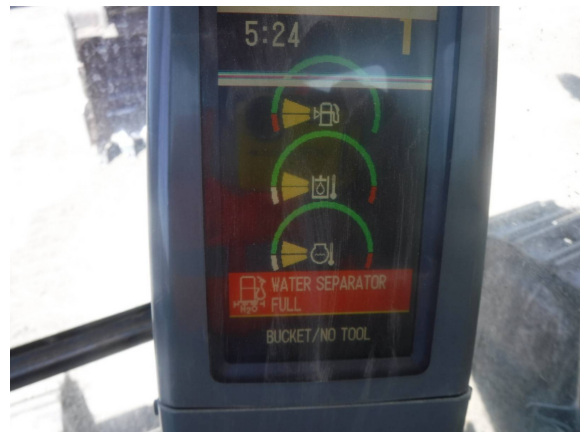
Monitoring Display

●
Display intermittently turns off.

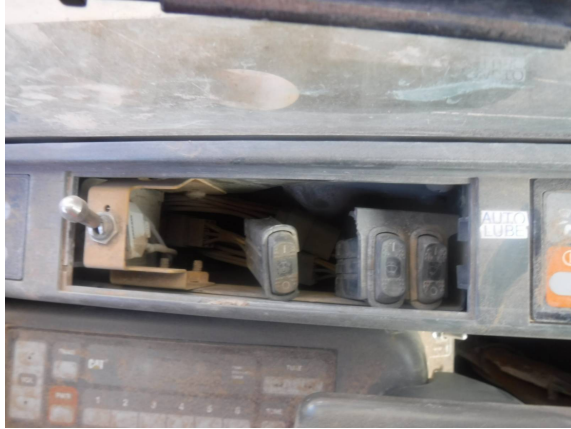
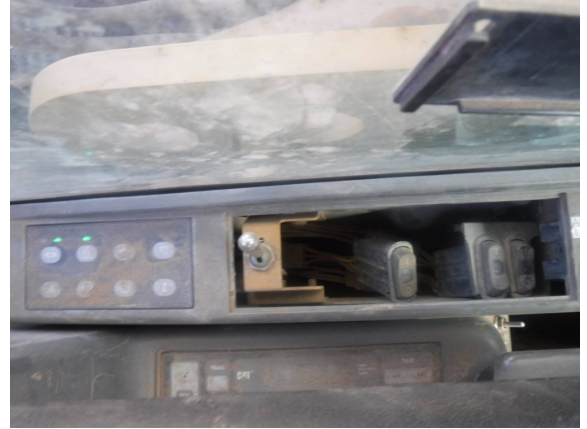
Switches

● Switch panel is broken

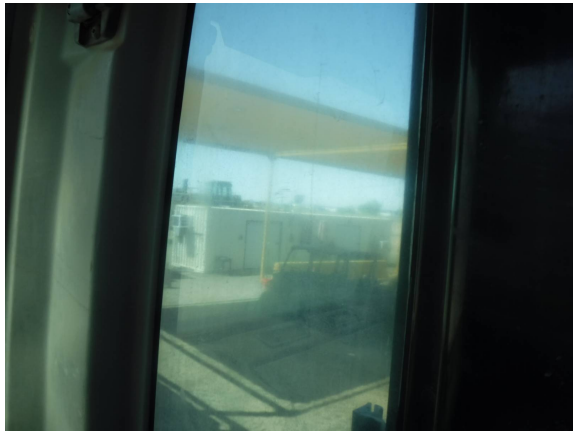
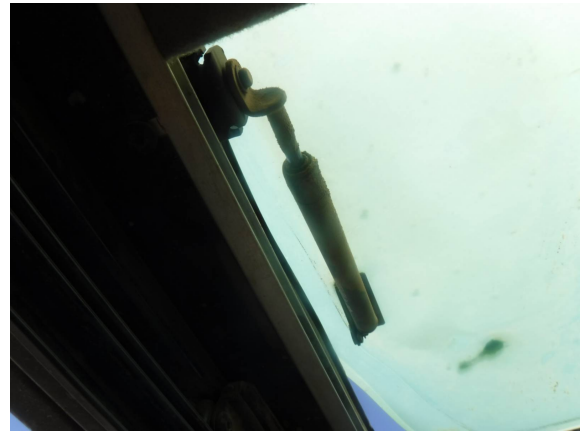
WINDOW

● Rear windows and sunroof window are faded and hard to see through. Sunroof window struts are not working.

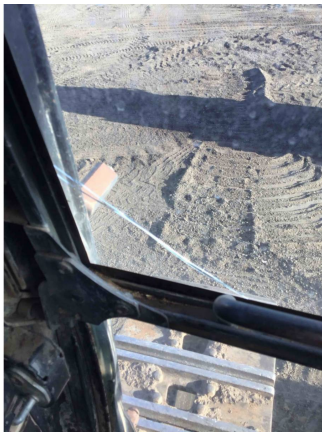
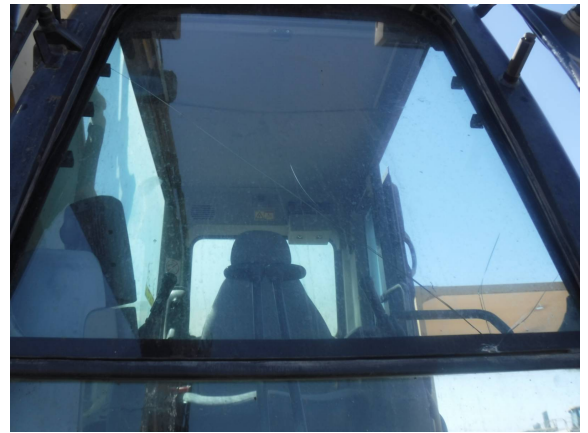
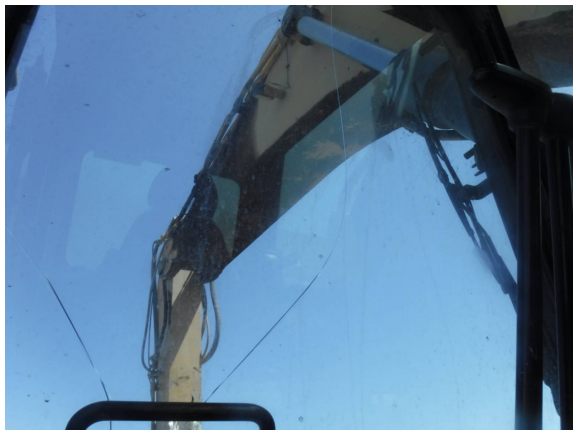
Windows

● Front window is cracked.

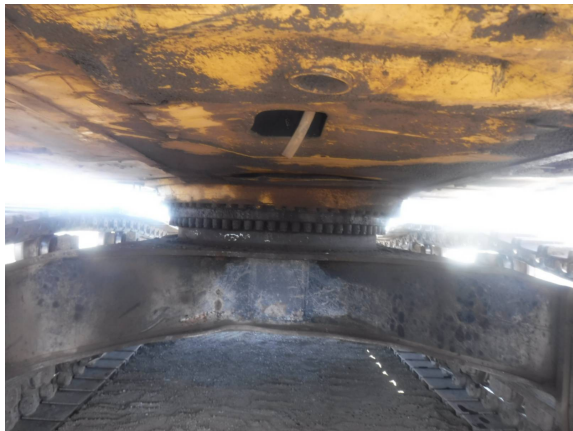
Oil Leaks

area along crack case guard is wet.

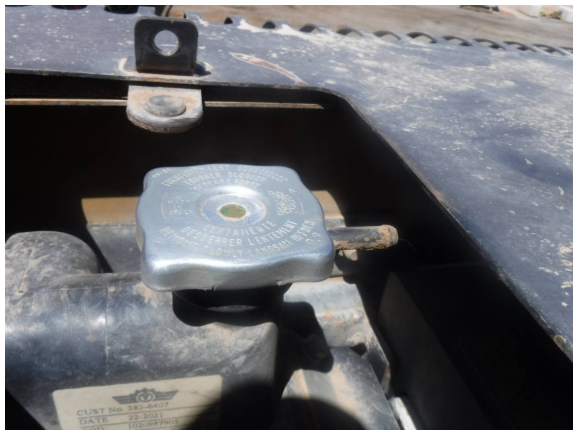
Hoses / Tubes

Coolant reservoir hose is missing.

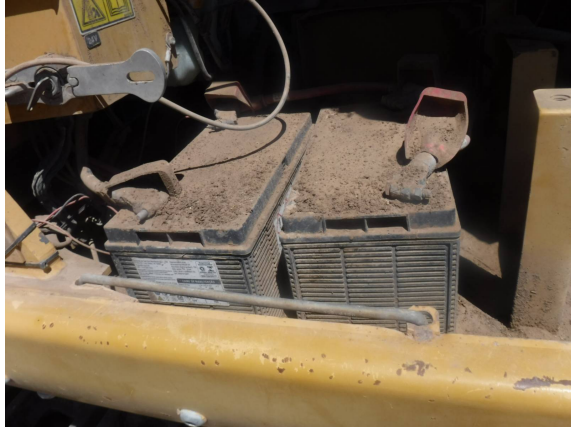
Batteries / Cables / Master
Disconnect

●
Missing hold down bracket and
hardware

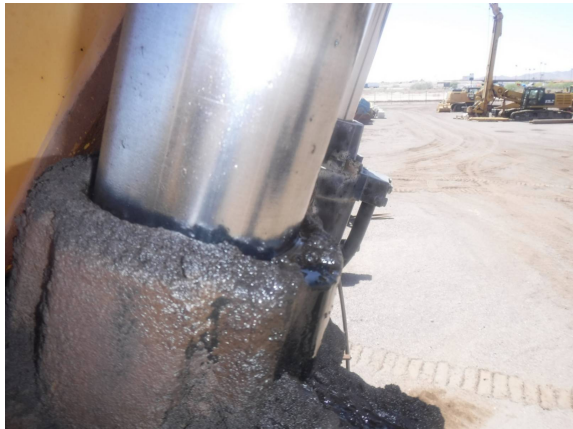
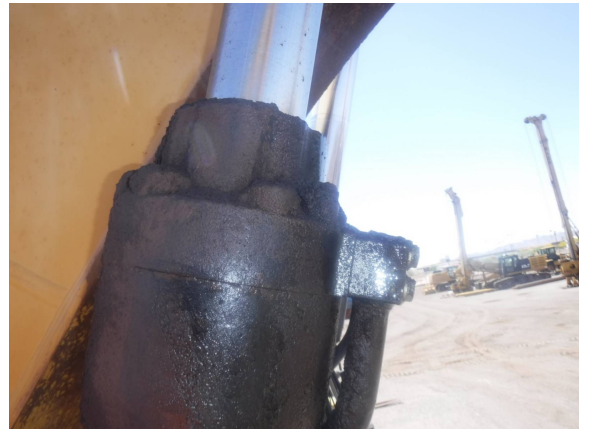
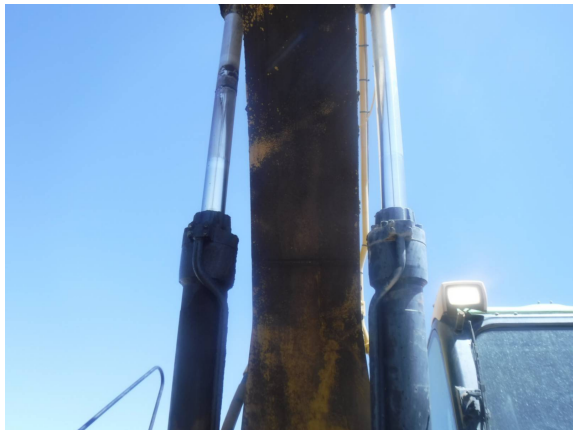
Boom Cylinder

Right cylinder leaks

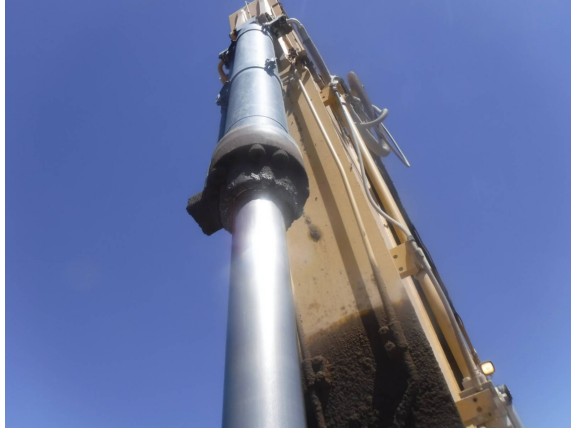
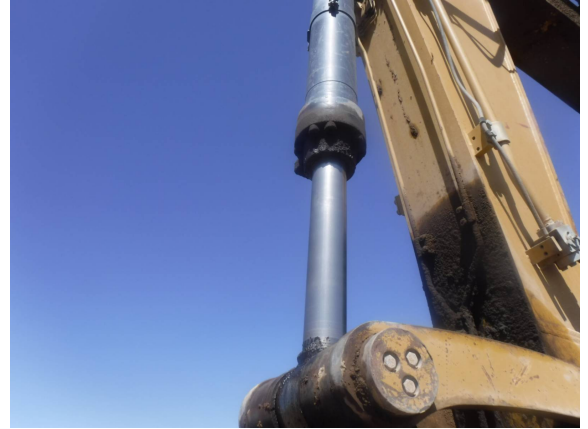
Bucket Cylinder

● Bucket cylinder leaks

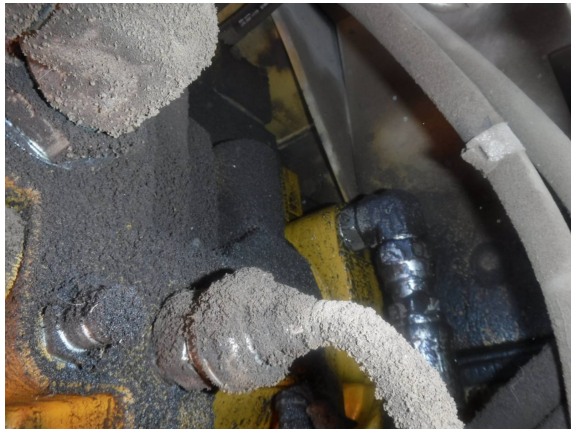
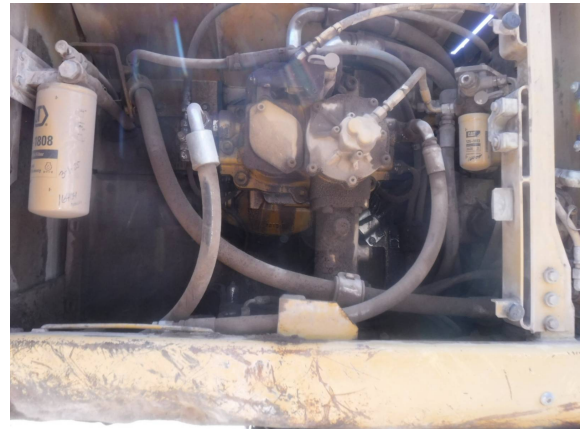
Hose Lines

● hoses are wet in hydraulic compartment

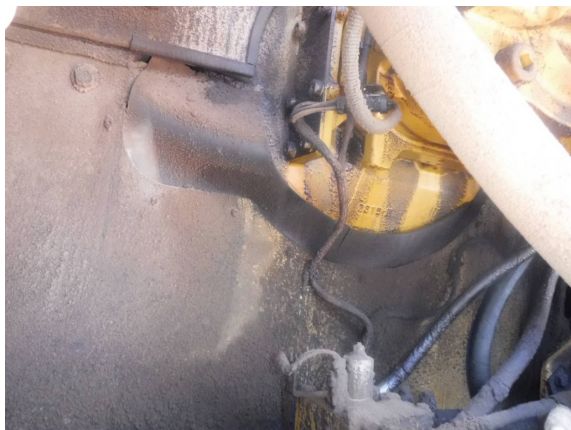
Pumps & Valves

● leak around pump area.

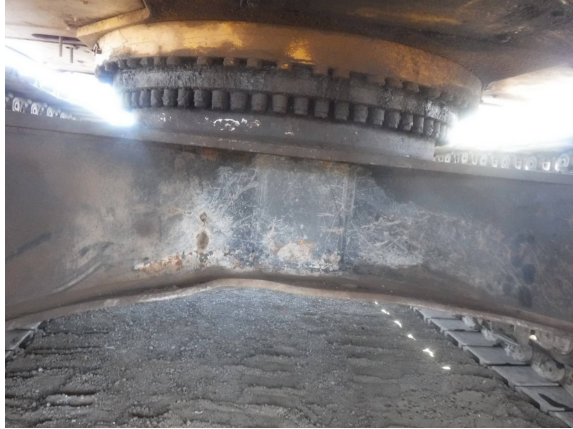
Rotex

●●
noise while rotating

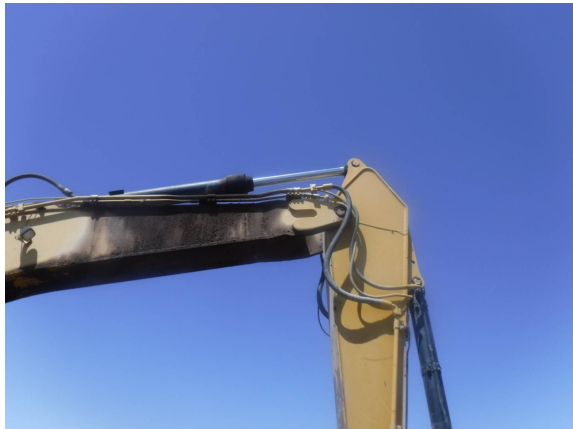
Stick Cylinder

●
Stick cylinder leaks

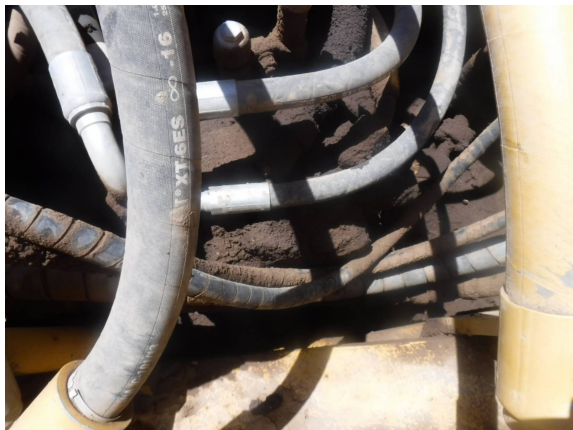
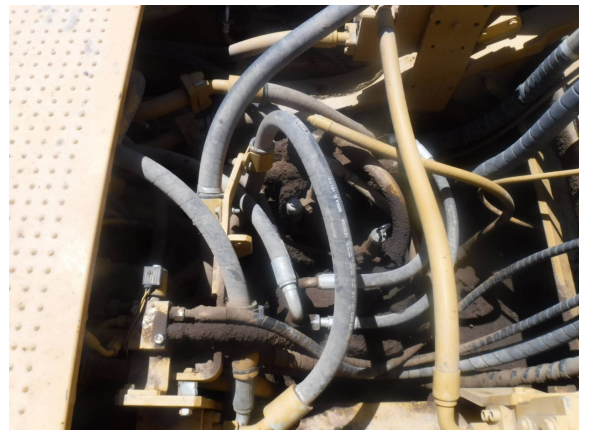
Swing Motors

●
leaks around swing motor

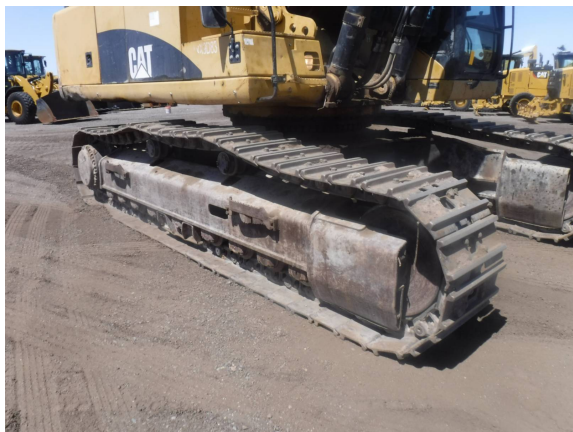
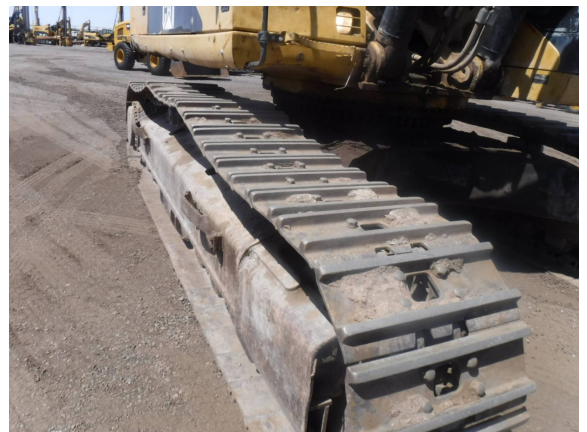
Track Frame - Right

Steps are bent

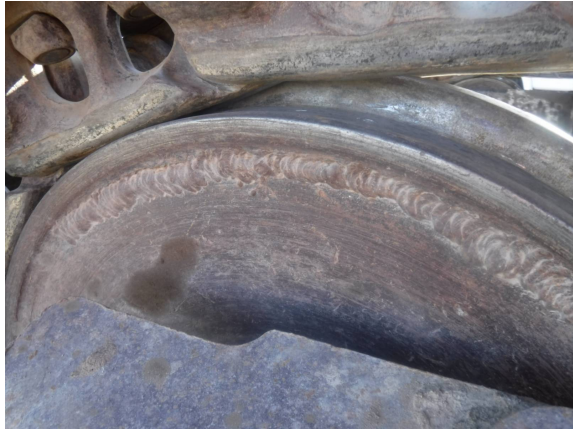
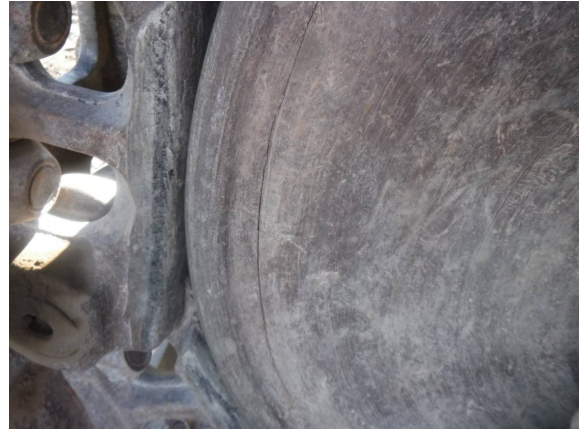
Idlers have movement. Left idler is cracked and has weld repair.

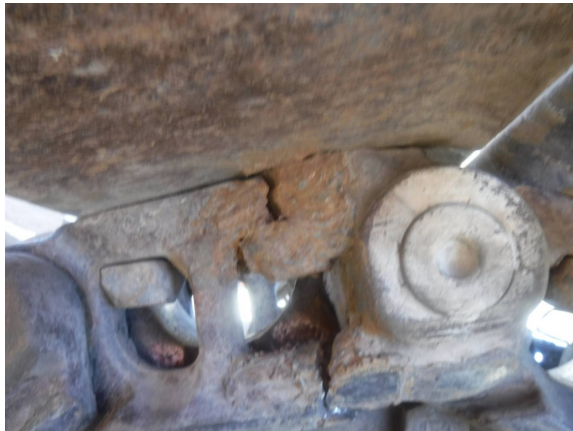
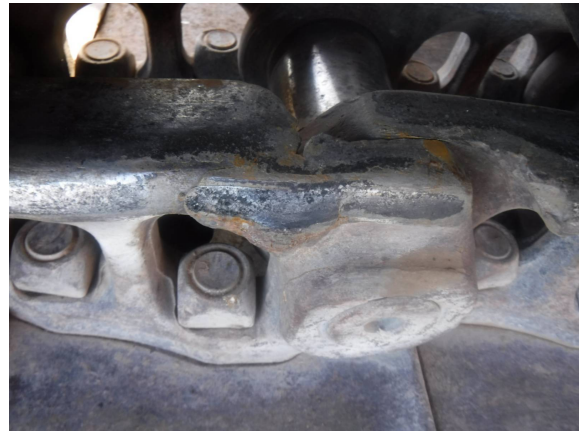
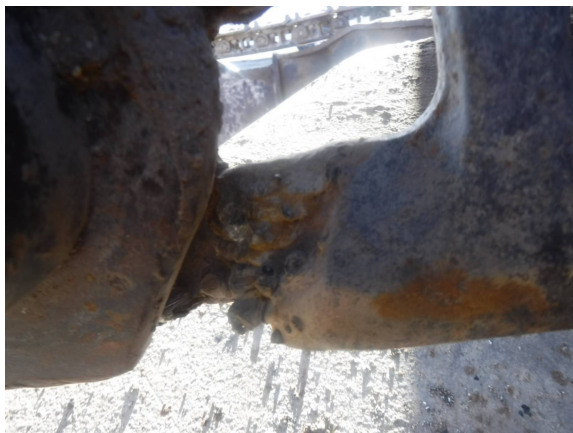
Links

Cracked link on right side. Weld repairs on links. Nine on right side and two on left side.
