2012 CAT 994H WHEEL LOADER

INSPECTION DETAILS

Inspection Type	Consignment
Inspection Form	Wheel Loaders
Inspection #	10220941
Inspection Status	Inspected
Created	08/05/25 09:19:15
Updated	08/08/25 22:21:05
Created By	Akutey, Solomon
Inspector	Akutey, Solomon
Reviewers	Akutey, Solomon
Serial #	DWC00300
SMU / Hours	33,249
Location	Mexico

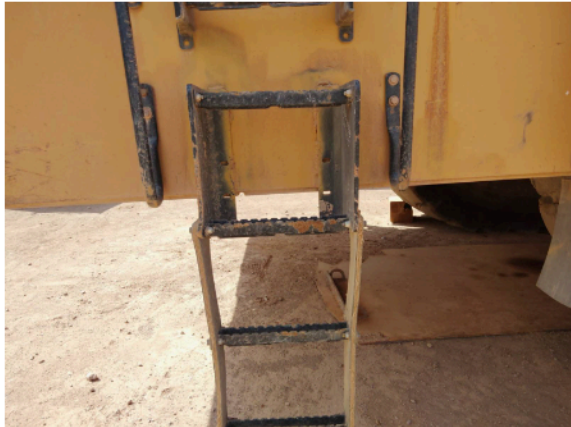
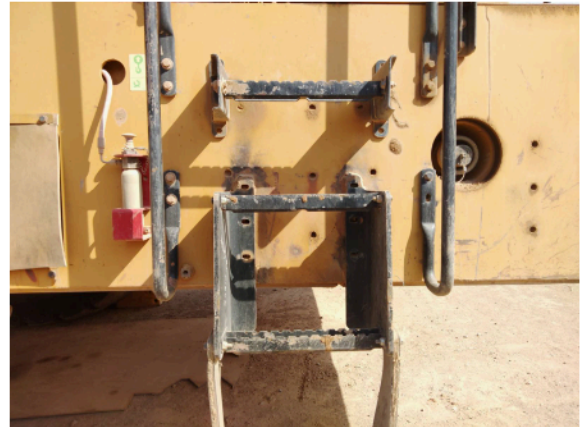
Steps / Ladder

Both welded to counterweight

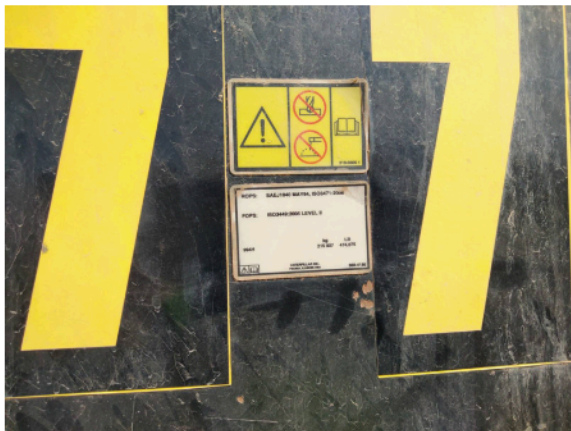
ROPS Certification Label

YES

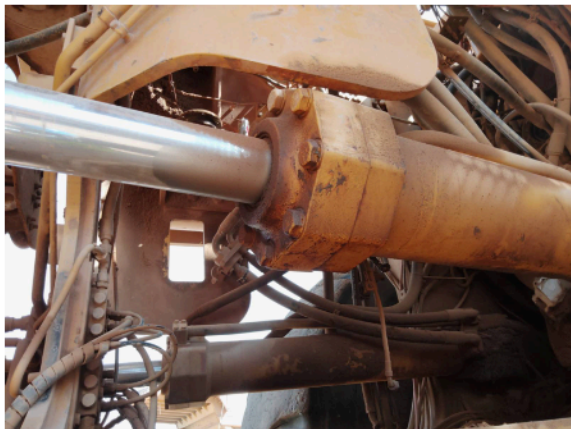
Steering Cylinder Pins & Bushings

Left cylinder starting to leak

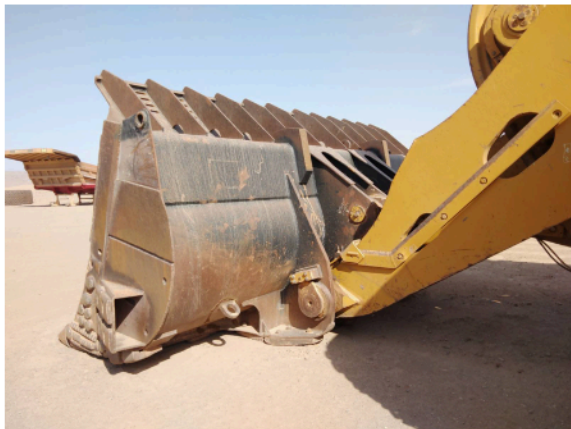
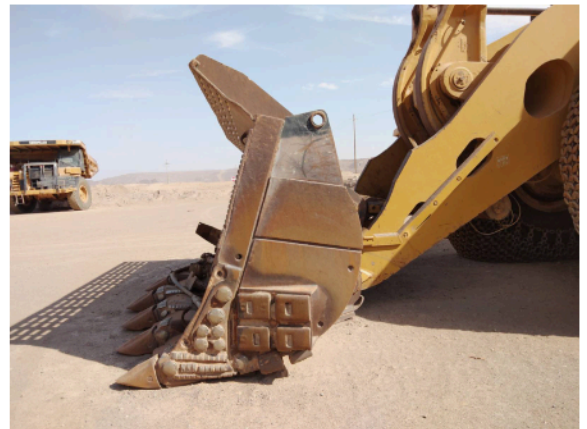
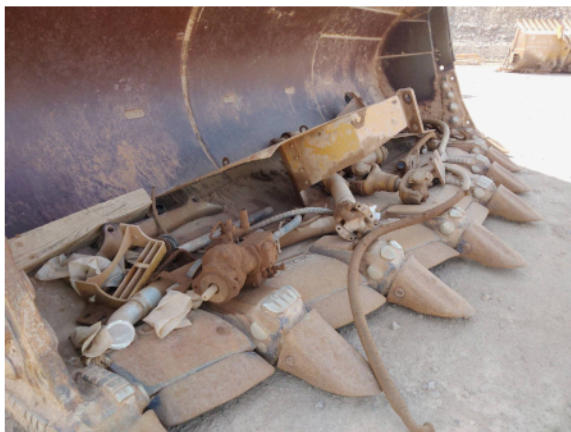
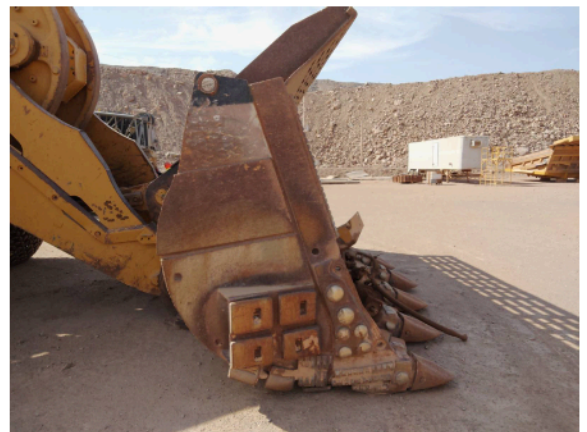
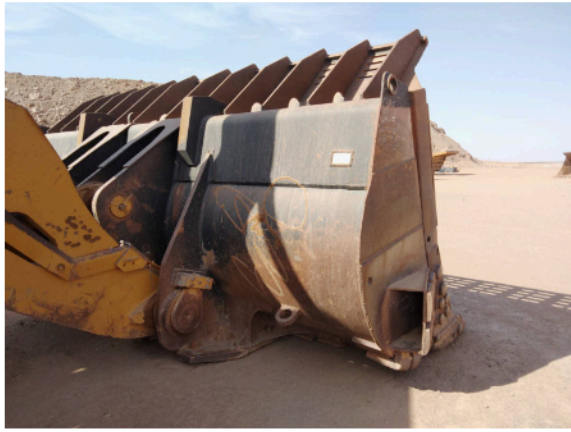
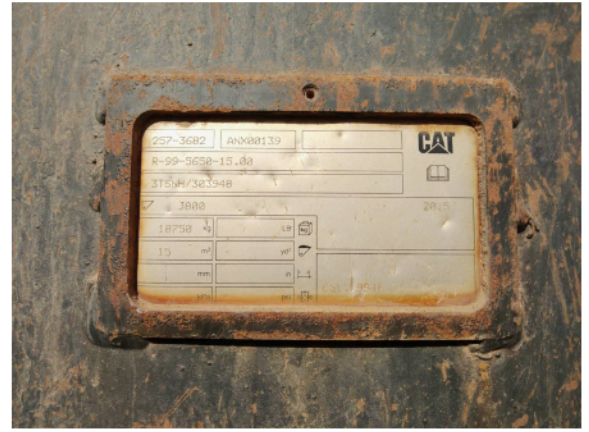
Notes - BUCKET

Pump, drive shaft in the bucket

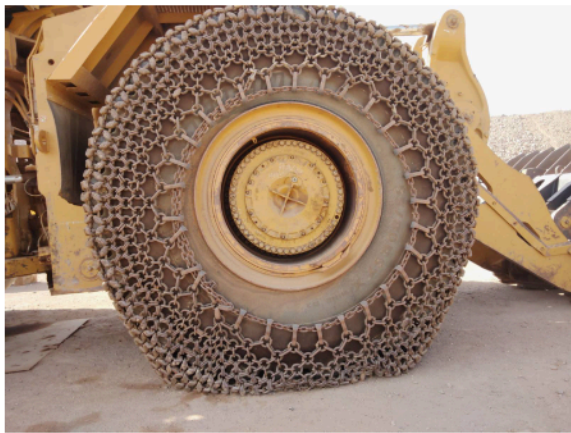
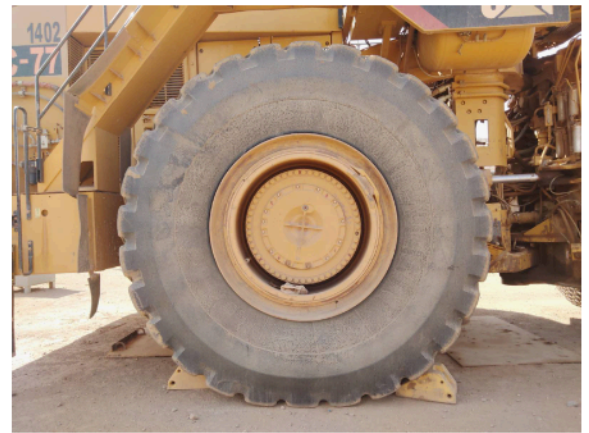
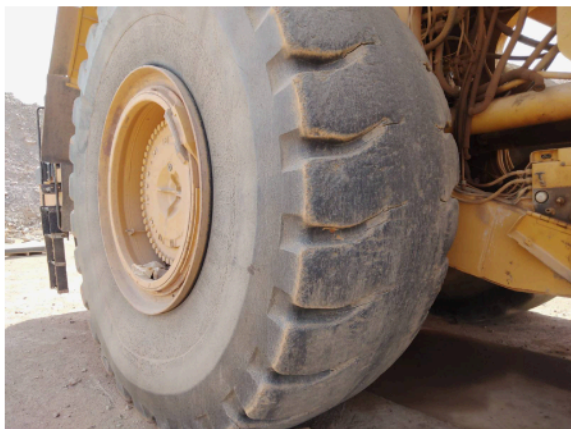
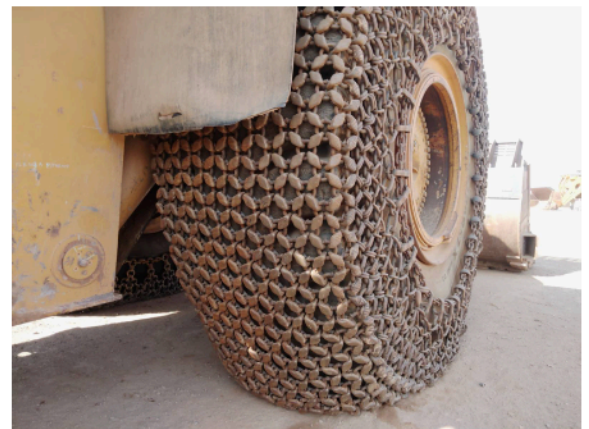
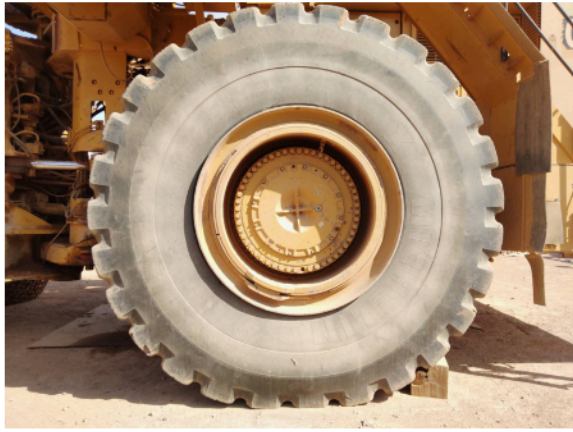
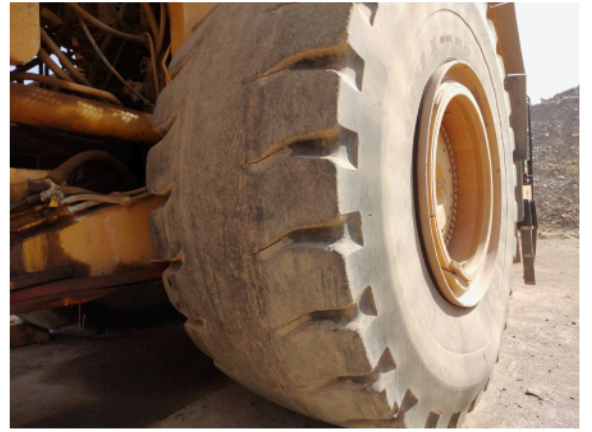
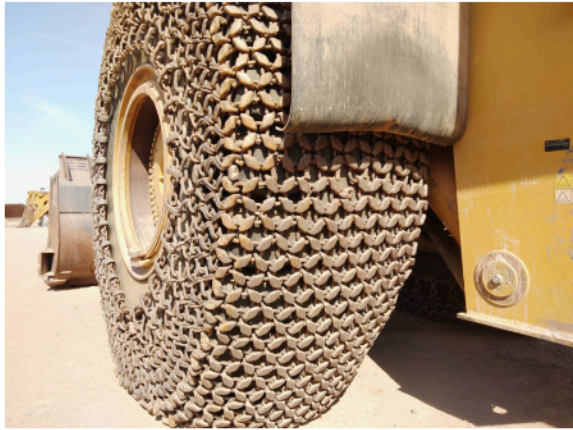
Notes - TIRES

Both front tires have chains, left rear one lug nut missing, sections on rim lock been torched out
