2022 CAT 259D3 COMPACT TRACK LOADER

INSPECTION DETAILS

Inspection Type	Trade
Inspection Form	Standard
Inspection #	10256168
Inspection Status	Completed
Created	12/08/25 14:57:06
Updated	12/11/25 09:32:09
Created By	Preskitt, Billy
Inspector	Preskitt, Billy
Reviewers	Preskitt, Billy
Salesperson	Schultis, Derrick R.
Stock #	E196732
Serial #	CW920348
SMU / Hours	1,184
Location	Eloy, AZ 85131, United States

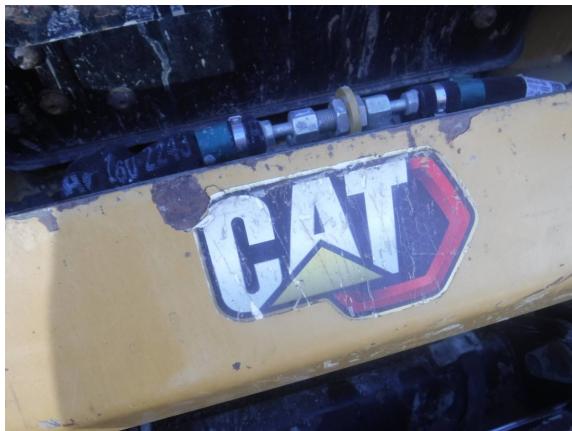
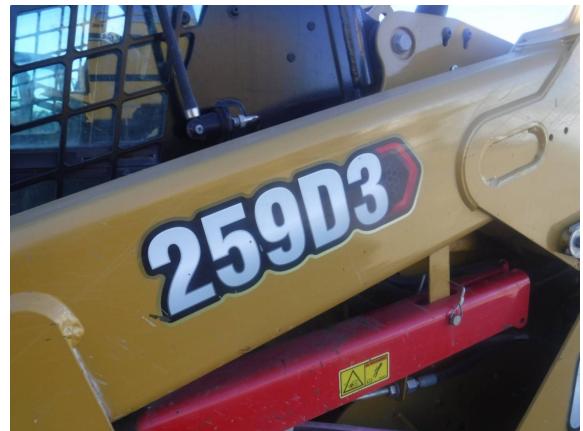
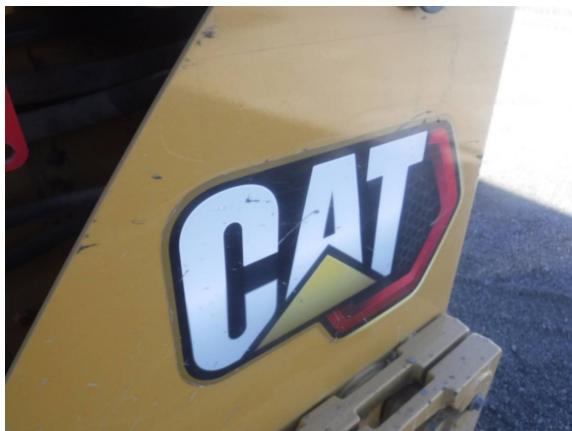
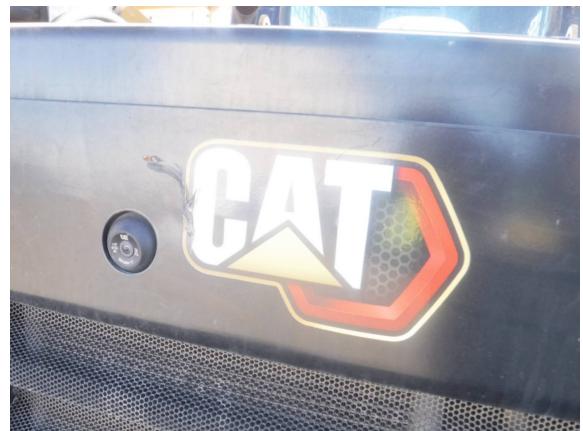
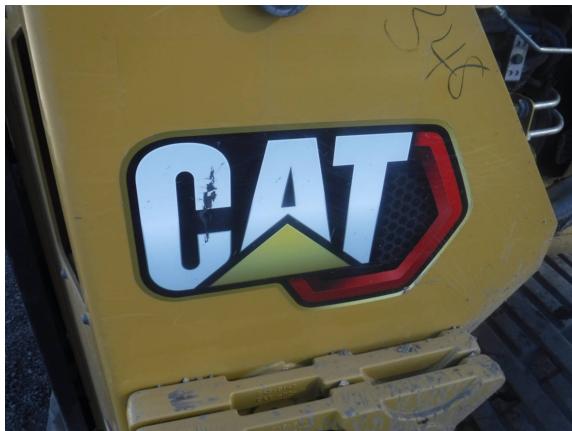
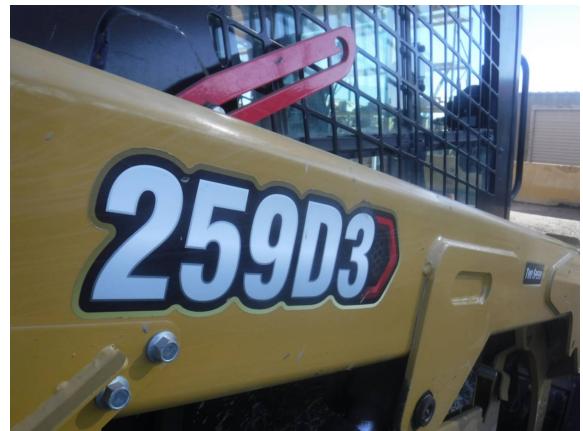
Decals are scratched and peeling

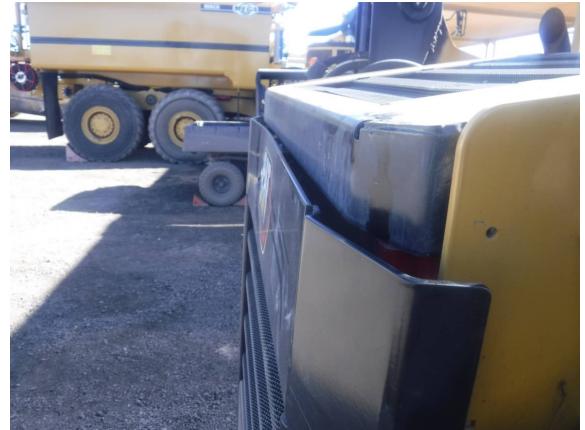
Eng. Enclose Hood / Stack

Engine compartment door is bent (opens and closes as it should)

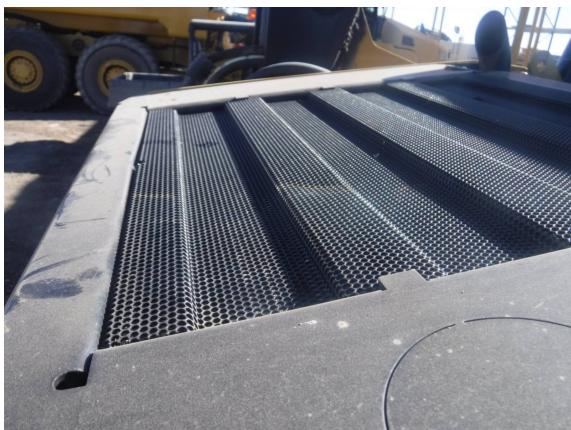
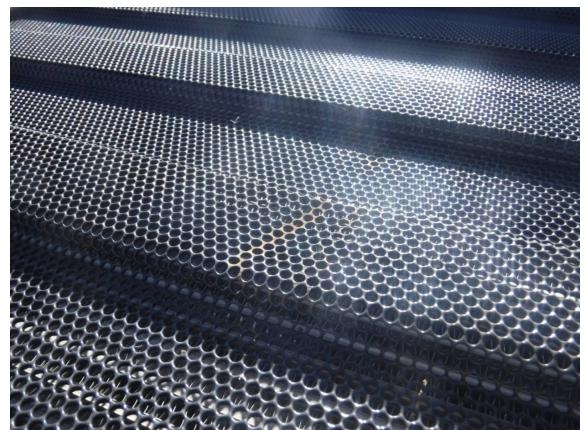
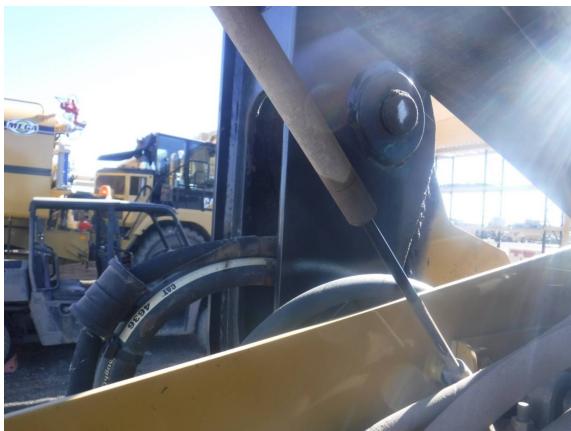
Radiator Grill & Shroud

strut is leaking. screen has small dent

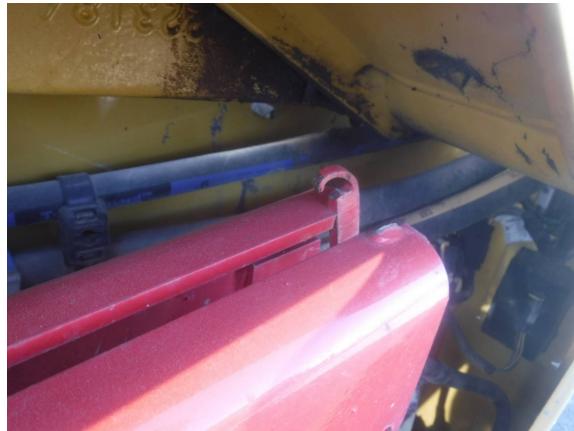
Safety Locks / Pins

Lift arm safety lock is broken

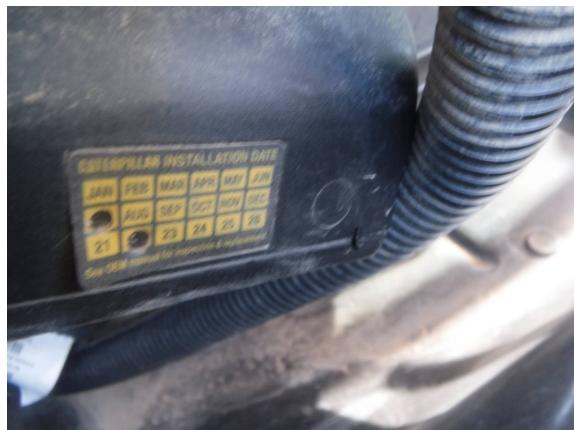
Seat Belt / Date

1
●
seat belt is expired 07-2022

seat belt is expired 07-2022

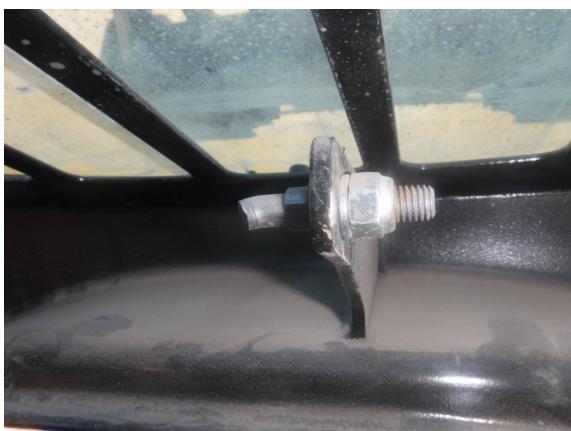
Mirrors

Missing mirror

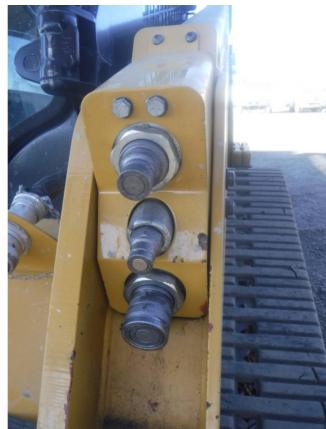
Hoses / Lines

auxiliary ports are missing dust caps

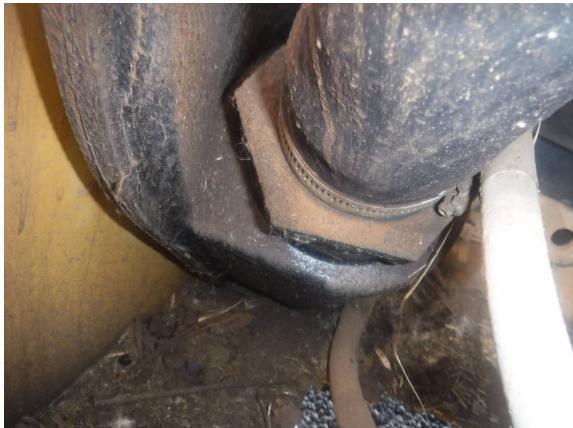
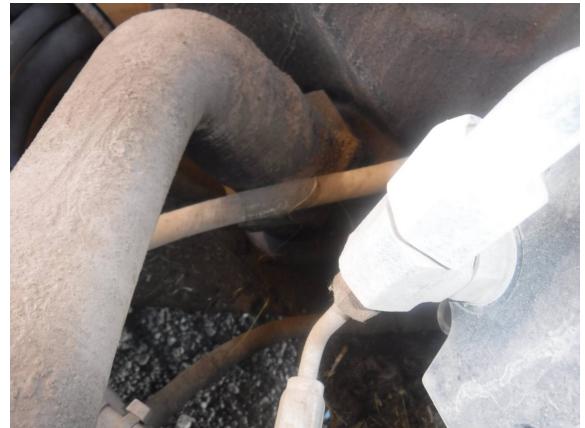
Tank

Quoted under tank

hydraulic tank strainer is leaking

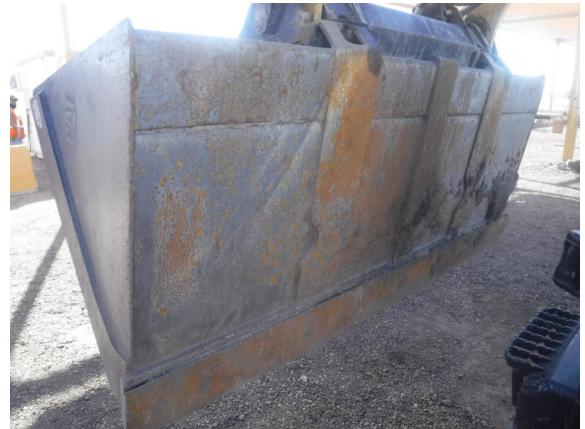
Bucket Bottom

Has dents

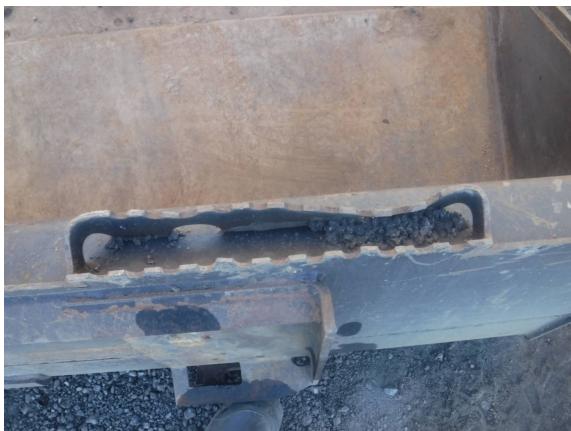
Bucket step

step is bent on bucket (can be straightened weld repair)

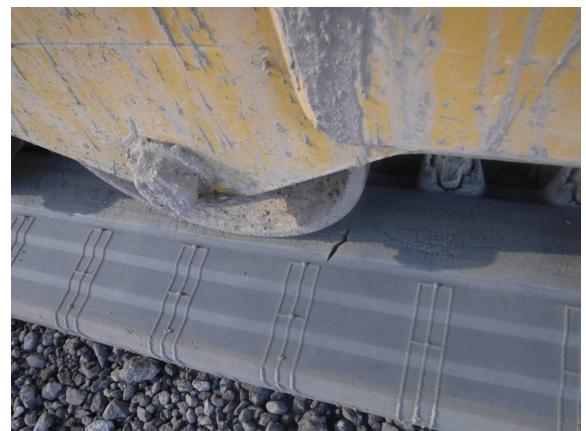
Track / Belt Condition

both Tracks have cuts
