2018 CAT 12M3AWD MOTOR GRADERS

INSPECTION DETAILS

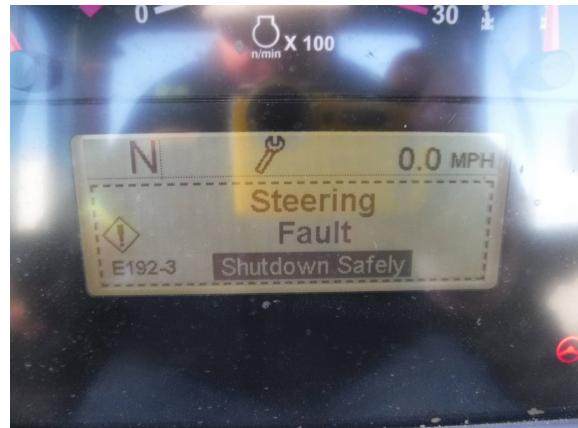
Logged / Active Codes

JOY STICK ISSUE. STEERING
AND BLADE CUSHION
CONTROL FAULT

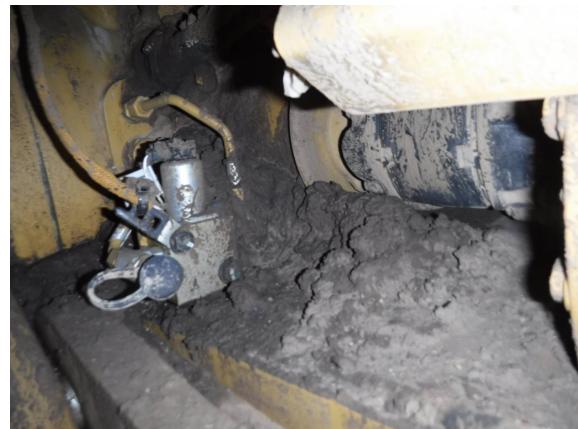
Transmission Guard

Full of dirt. Part of wash

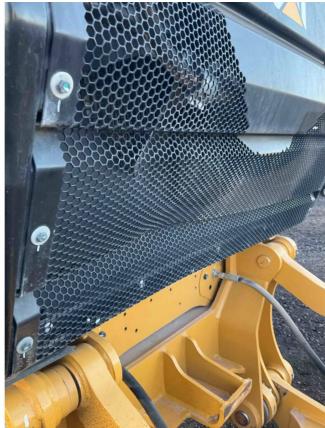
Radiator Grill

Dented can be repaired.

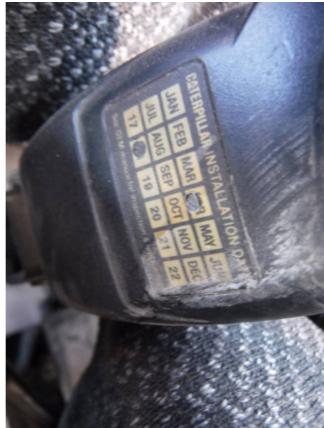
Seat Belt / Date

OUTDATED APRIL 2018

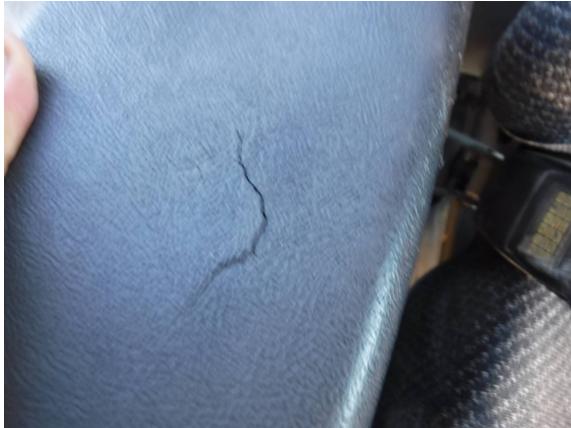
Armrests

Right side is cracked

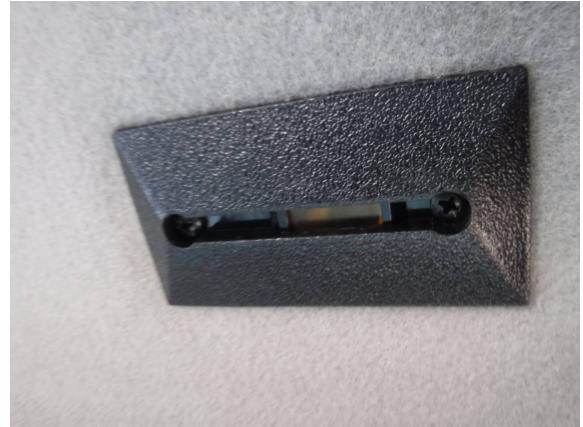
Interior Lights

Small operator lights are inop

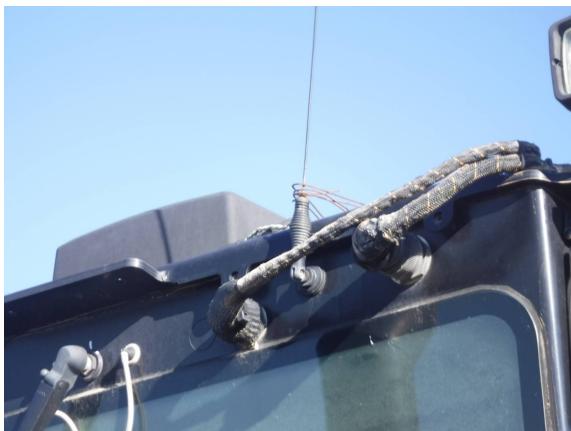
Radio

ANTENNA DAMAGE, HAS WIRE
WRAPPED AROUND BASE

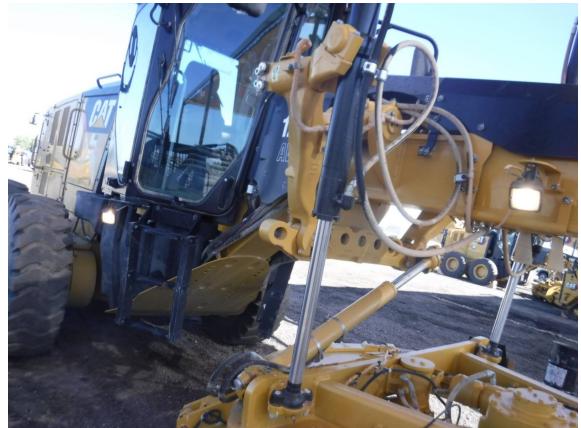
Work Lights

LEFT FRONT HEAD LIGHT IS
INOP

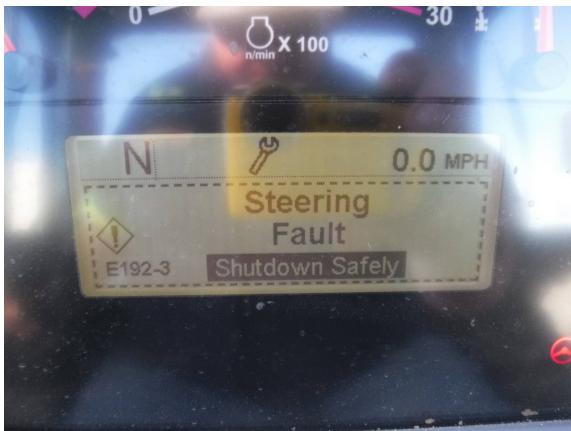
Active Codes

Has steering malfunction. Does not fully turn right.

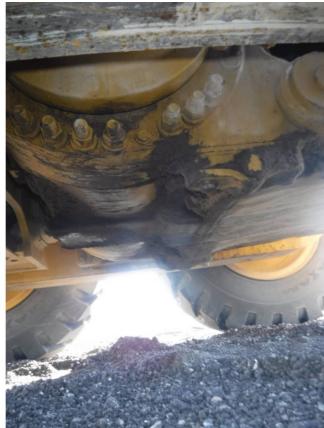
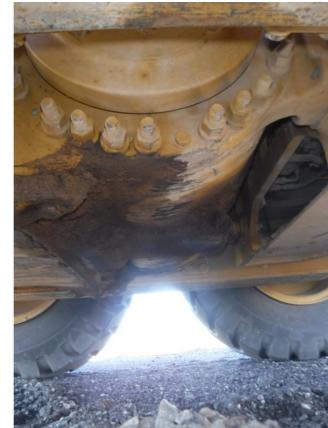
Drivetrain / Tandem Leaks

Has oil residue present on lower diff. Not leaking at time of inspection

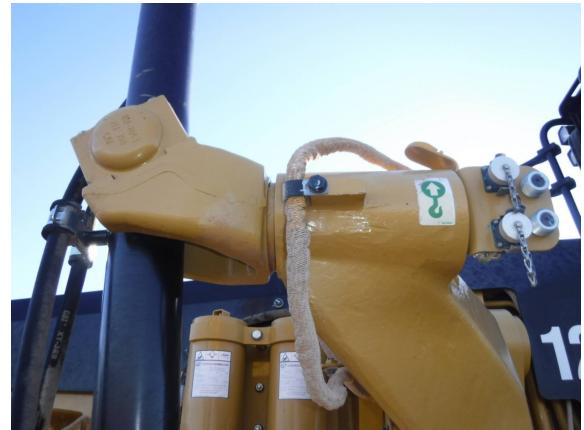
Cylinder Mounts / Pins

Has movement at yoke pins and fiber bushings

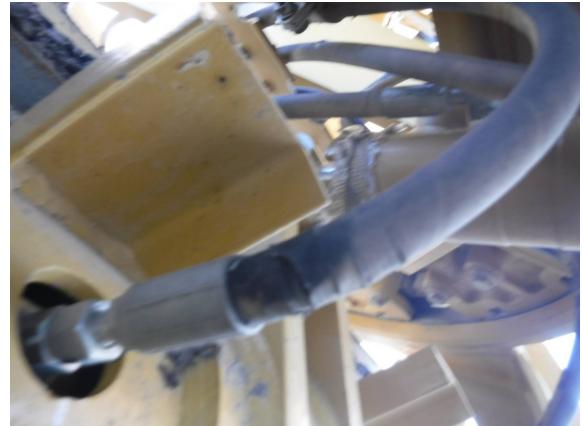
Hydraulic Lines / Fittings

Has slight peeling on side shift cylinder lines. Not down to metal. Outer cover only.

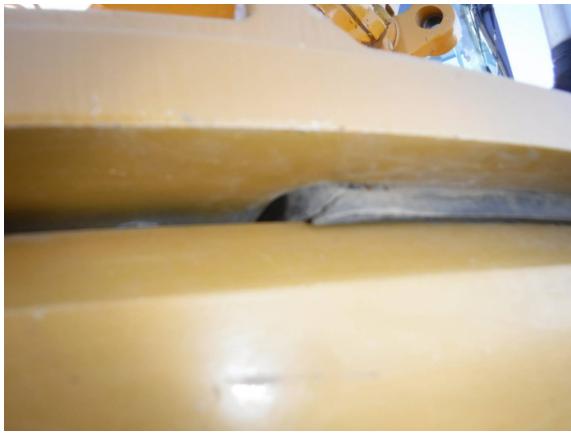
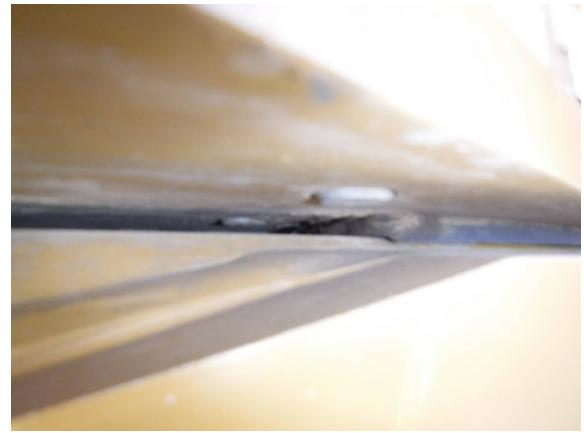
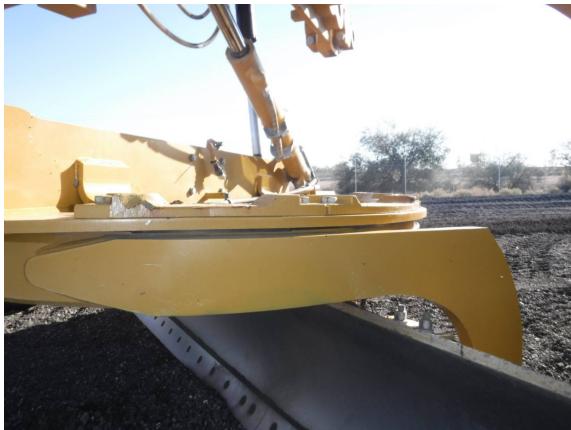
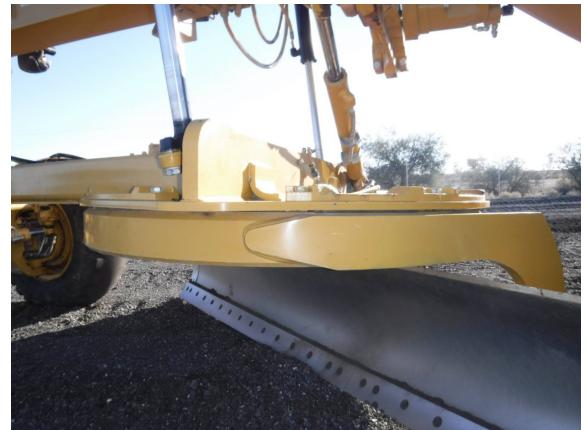
Circle Frame

Has movement and cracked
wear strips on left side. Needs
adjusted and new wear strips.

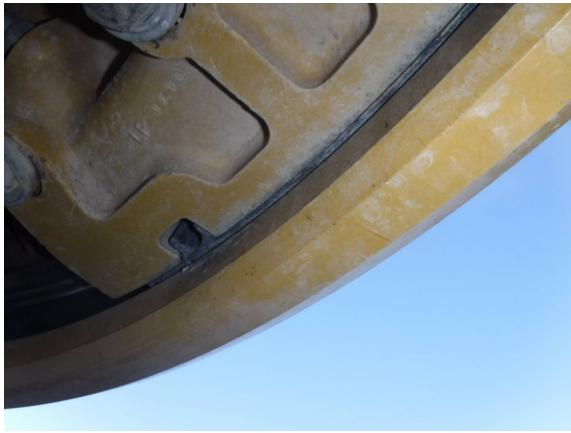
Circle Shoes / Inserts

Needs adjusted

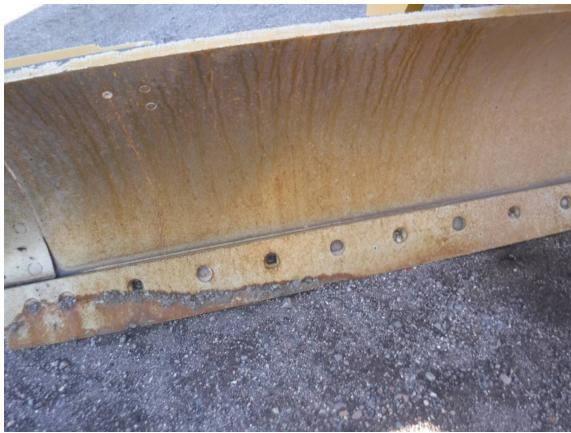
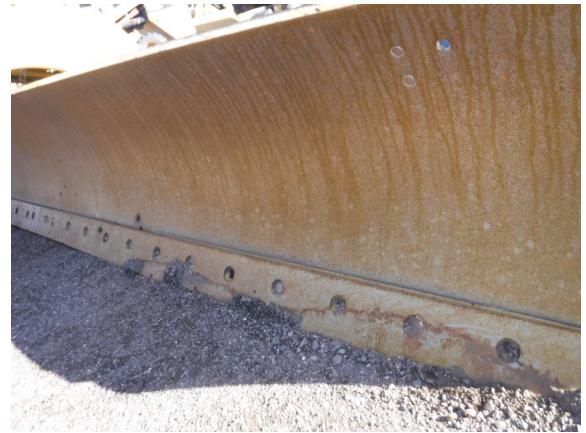
Cutting Edge

Worn uneven and missing
multiple bolts

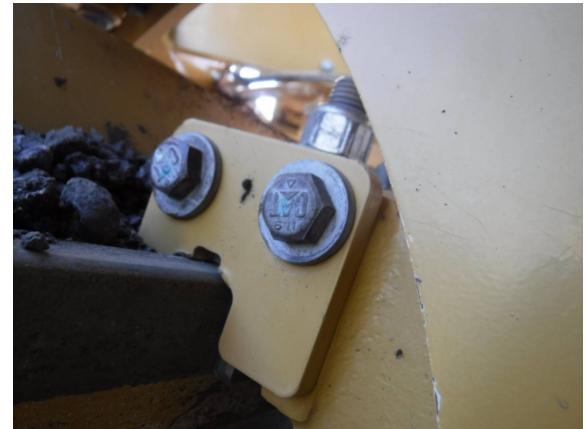
Moldboard Tip Brackets /

Needs adjusted

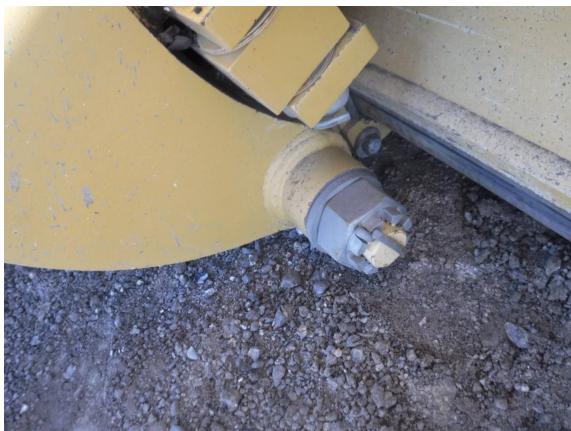
Tip Bracket Pivots / Bearings

Has movement at pins and
bearings

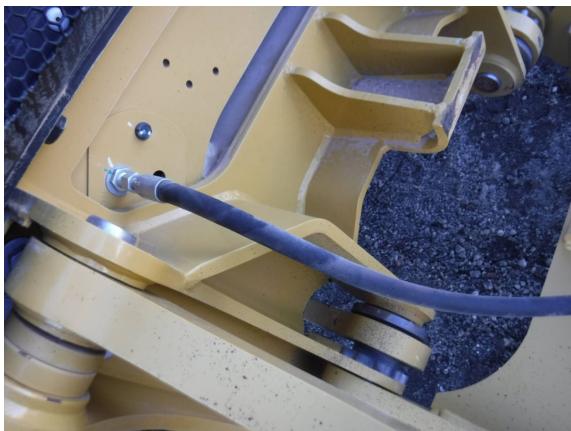
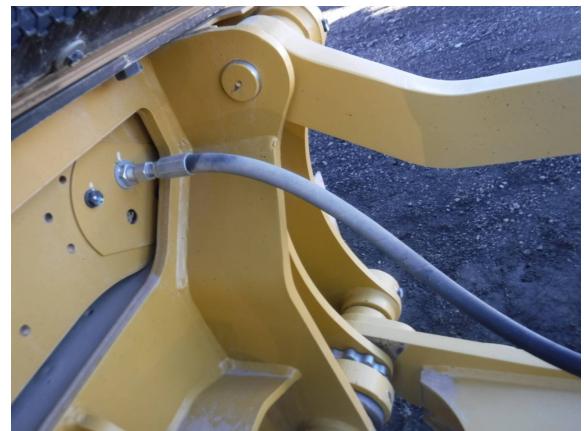
Cylinders

Has slight movement at ripper cylinder mount trunnions

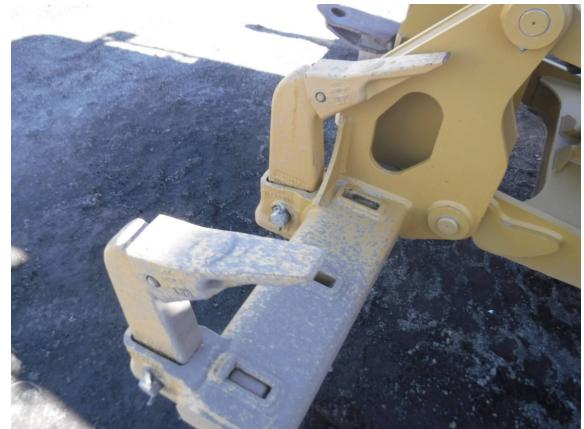
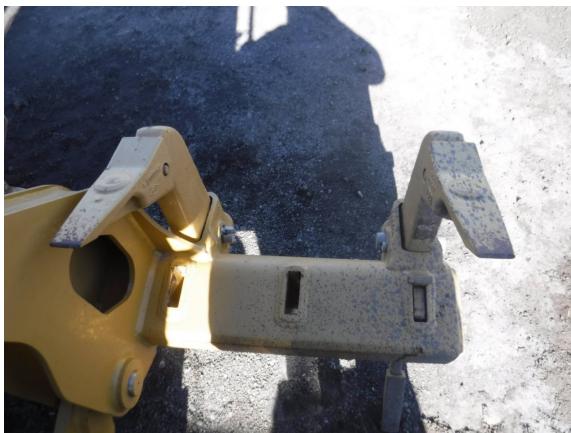
Shanks / Ripper (GET)

Center has home made hitch in shank pocket

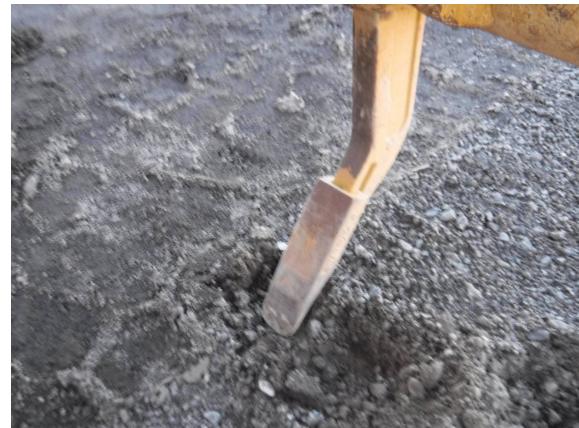
Shanks / Scarifier (GET)

3 SHANKS ONLY
