2017 JOHN DEERE 300GLC EXCAVATOR

INSPECTION DETAILS

Inspection Type	Trade
Inspection Form	Standard
Inspection #	10258416
Inspection Status	Completed
Created	12/16/25 14:24:06
Updated	12/30/25 11:18:30
Created By	Preskitt, Billy
Inspector	Preskitt, Billy
Reviewers	Preskitt, Billy
Salesperson	Schultis, Derrick R.
Stock #	E212183
Serial #	1FF300GXLHF730567
SMU / Hours	4,259
Location	Eloy, AZ 85131, United States

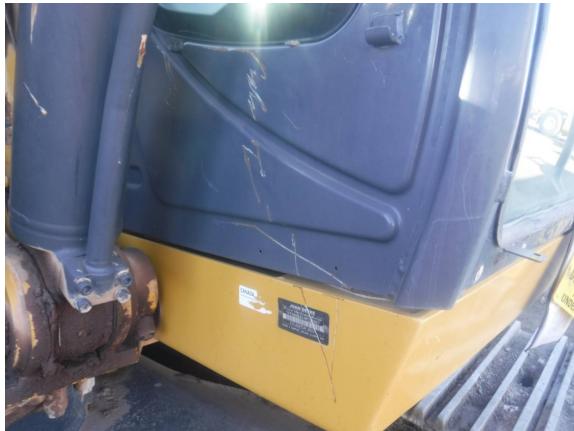
General

cab has deep scratches on right side by serial decal

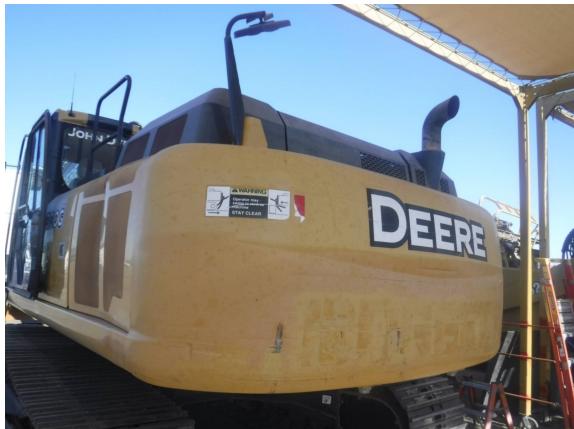
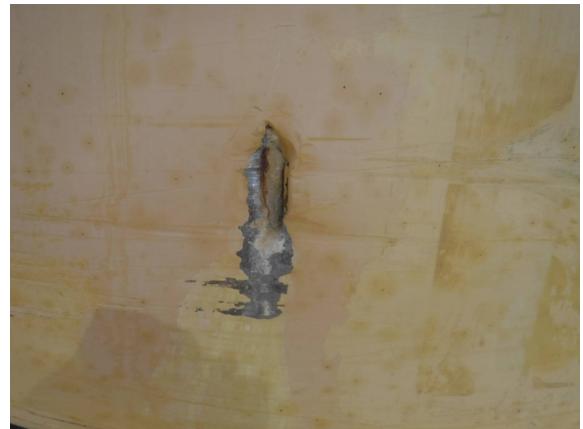
Counterweight

Has deep gouges in counter weight

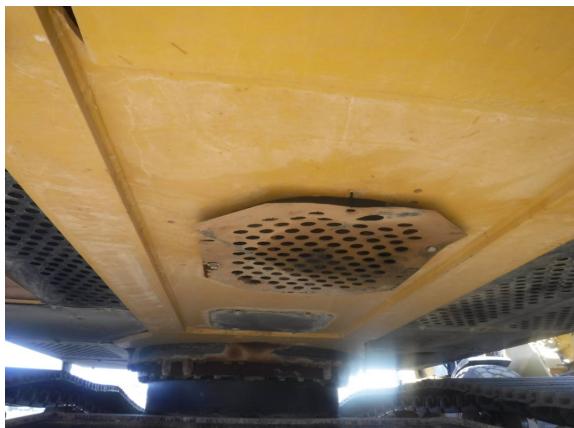
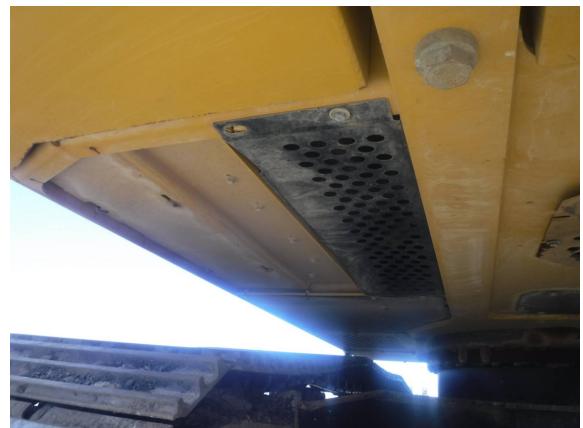
Crankcase Guard / Battery Box

Crank case guards are bent and missing hardware

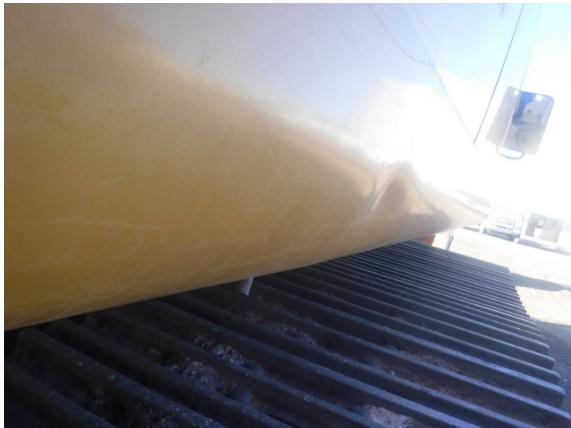
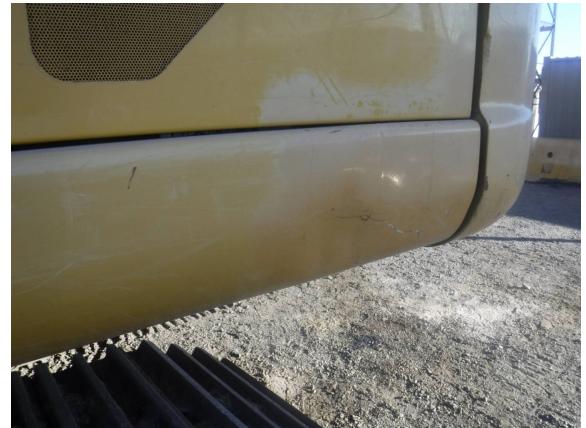
Fenders

Left and right side fenders have dents

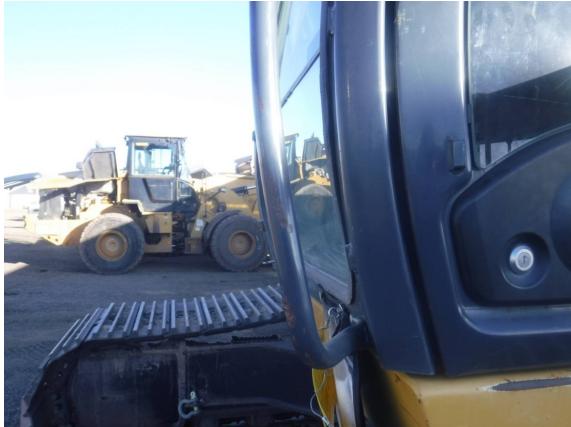
Grab Irons

Grab handle on cab is bent

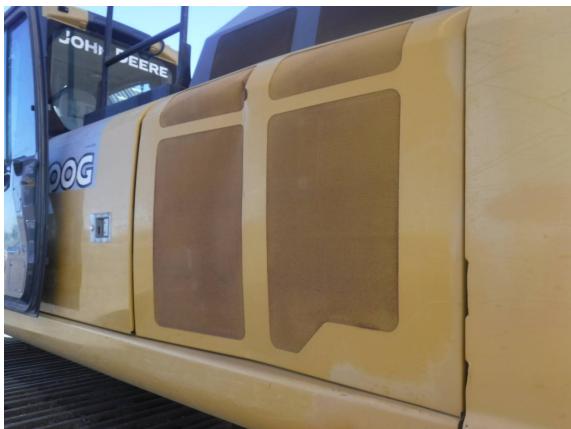
Radiator Grill & Shroud

Radiator compartment door is bent

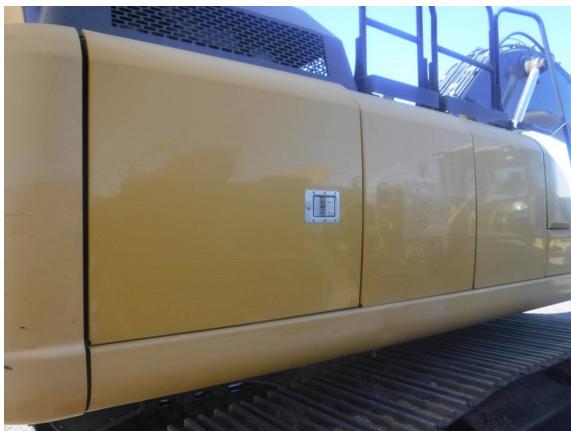
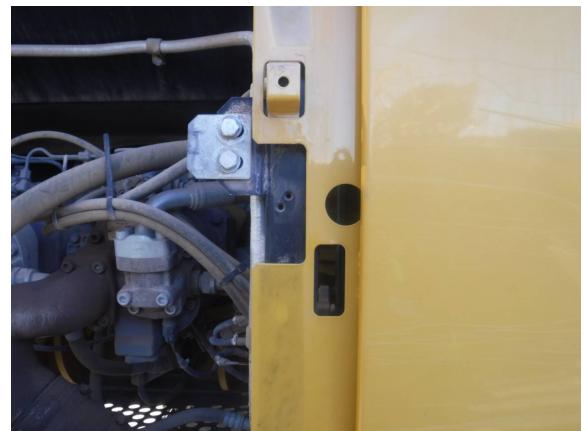
Sheet Metal

Hydraulic compartment doors
are bent and missing latch

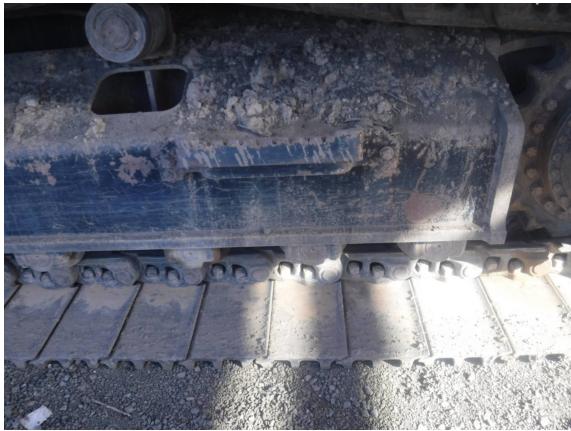
Steps / Ladder

Left rear step is bent

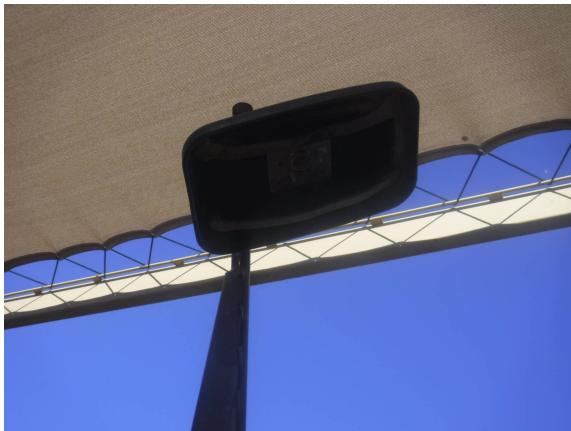
Glass / Mirrors

Left rear mirror is broken

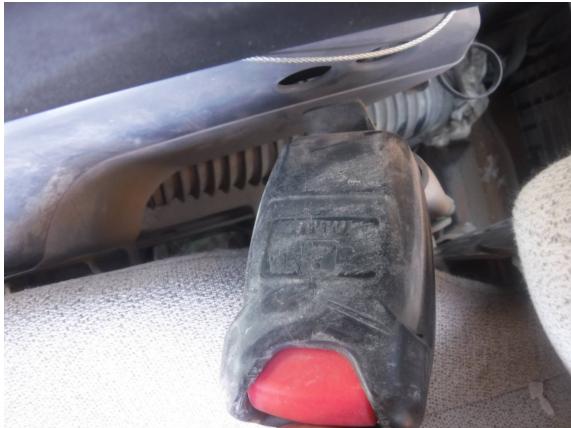
Seat Belt - SAFETY ITEMS

No date tag on seat belt

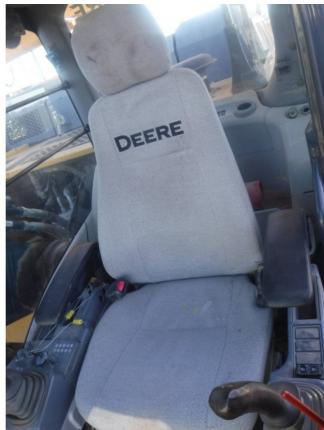
Seat Cushion / Arm Rest

Seat cushions have stains

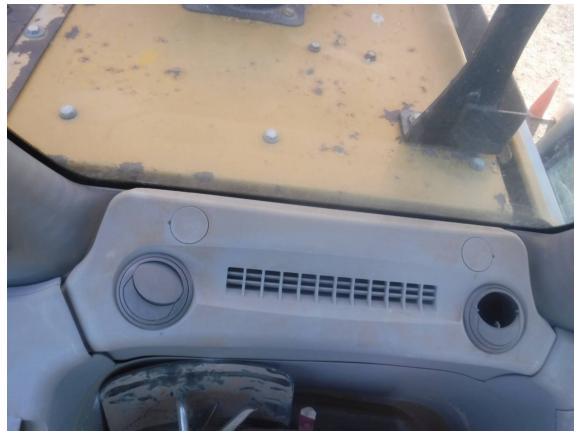
Vent/louver

left rear vent louver is broke

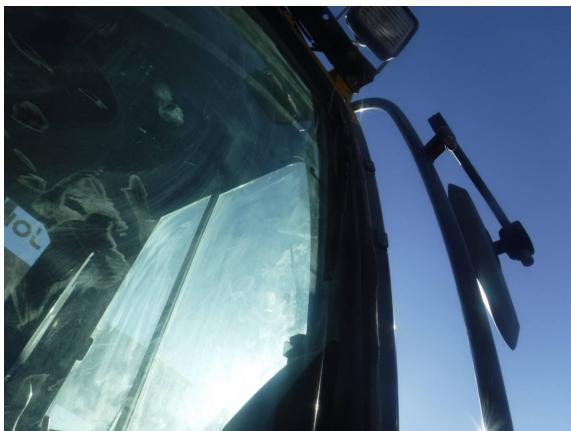
Windshield Wipers

Wiper blade is torn
washer fluid tank does not hold water

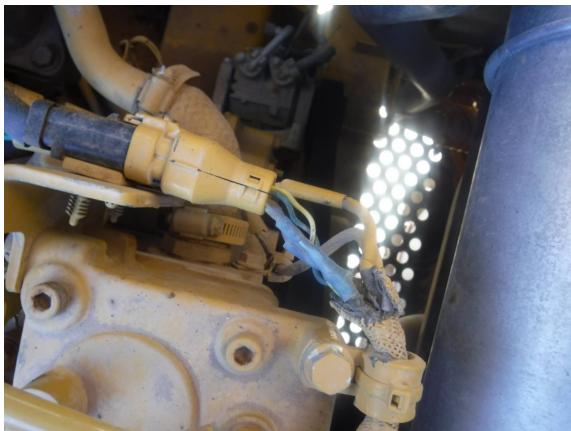
Apparent Other Engine Damage

Engine wiring, harness has been spliced

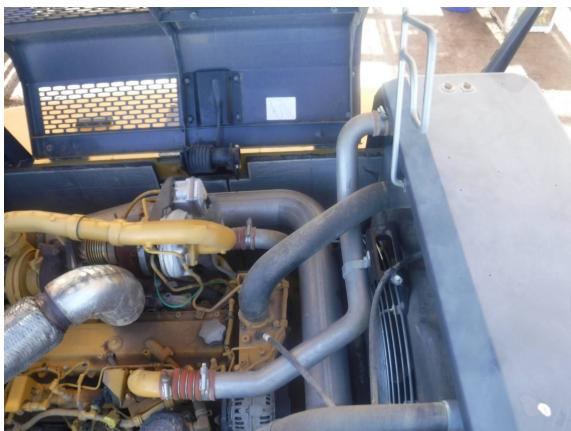
Oil Leaks

Valve cover has oil residue on top

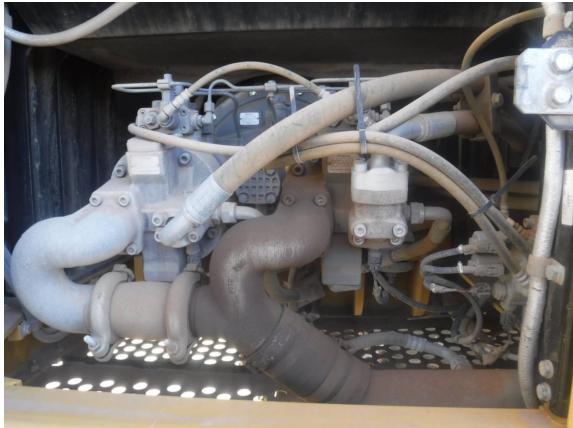
Pump Drive

hydraulic pump is wet

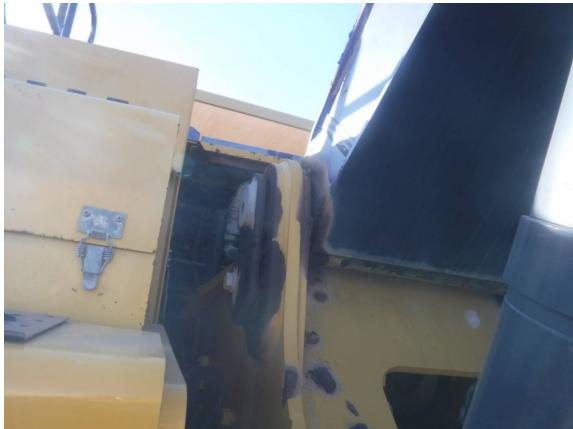
Pins & Bushings - BOOM

pins and bushings have movement

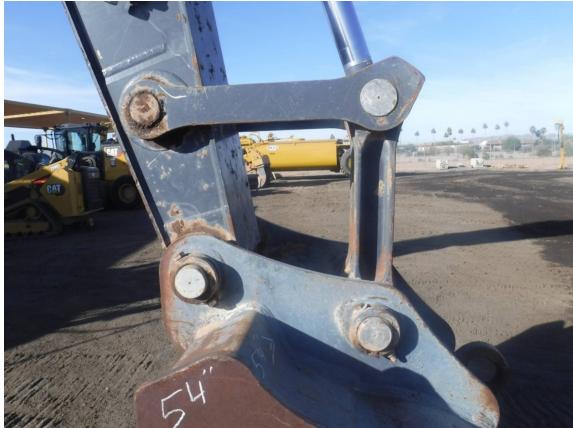
Pins & Bushings - STICK

stick pins and bushings have movement

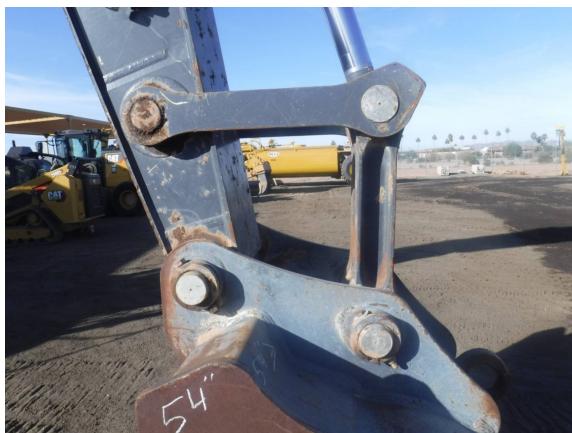
Bucket Linkage

bucket linkage has movement

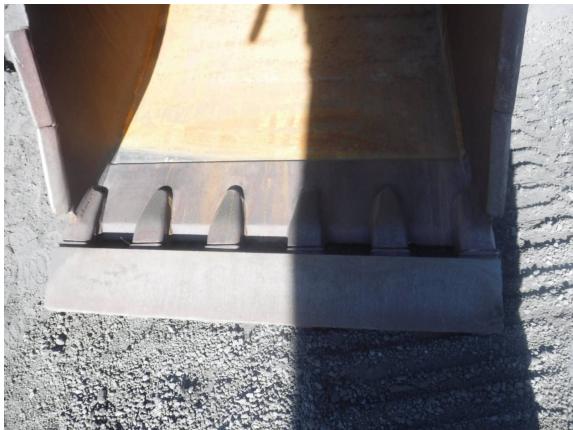
Teeth / Adapters

Plate welded to G.E.T

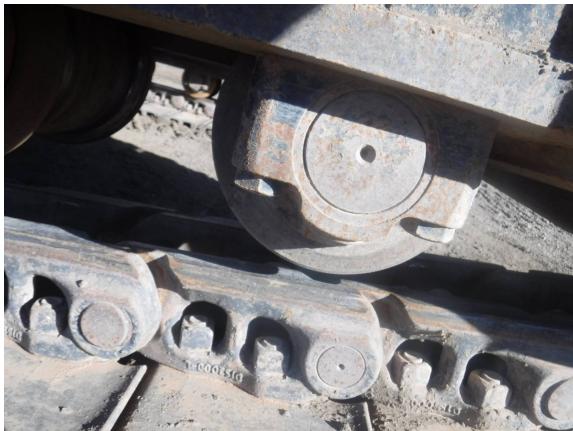
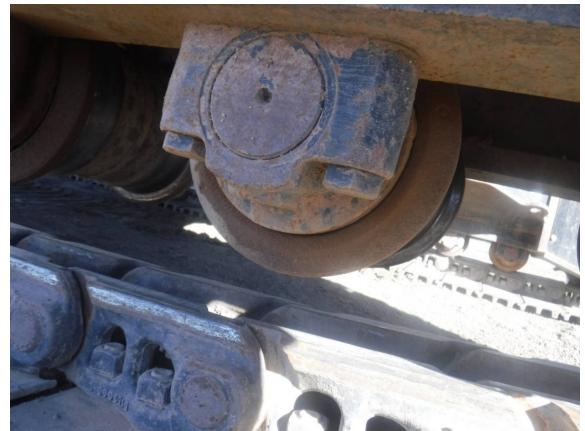
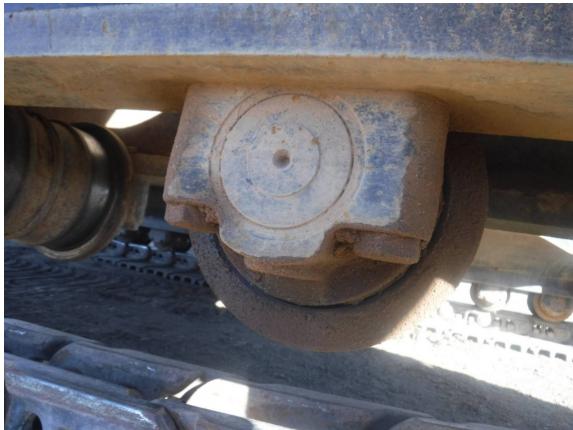
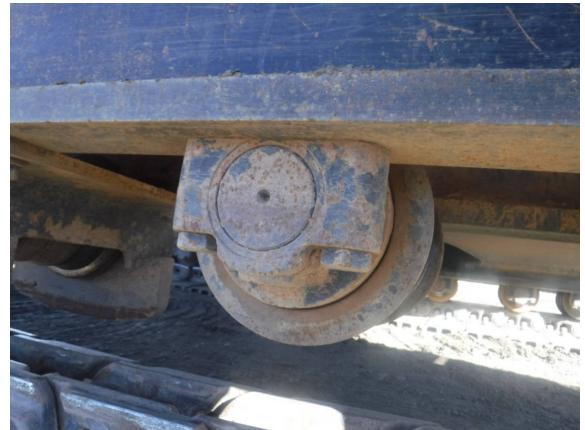
Notes - UNDERCARRIAGE 2

All track rollers are showing signs of leaking
