2016 CAT
336FL
TRACK EXCAVATORS

INSPECTION DETAILS

Inspection Type	Marketing
Inspection Form	Standard
Inspection #	10147652
Inspection Status	Completed
Created	09/09/24 16:08:34
Updated	09/20/24 16:37:06
Created By	Willis, Joseph
Inspector	Willis, Joseph
Reviewers	Willis, Joseph
Salesperson	Schultis, Derrick R.
Stock #	E189496
Serial #	RKB01933
SMU / Hours	5,245
Location	Eloy, AZ 85131, United States

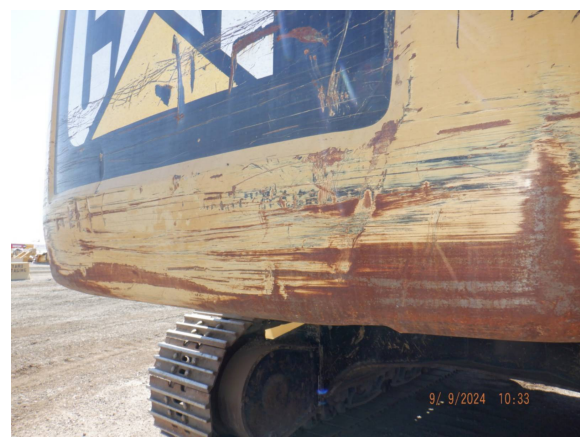
Counterweight

Has dents and scratches

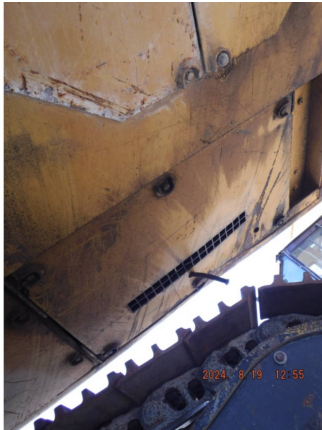
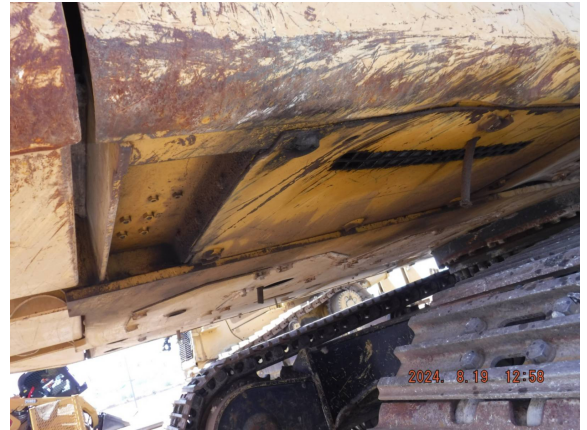
Crankcase Guard / Battery Box

engine guards are bent can be
straightened weld repair

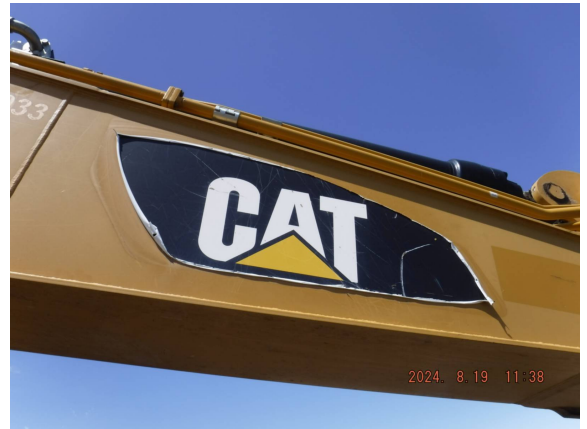
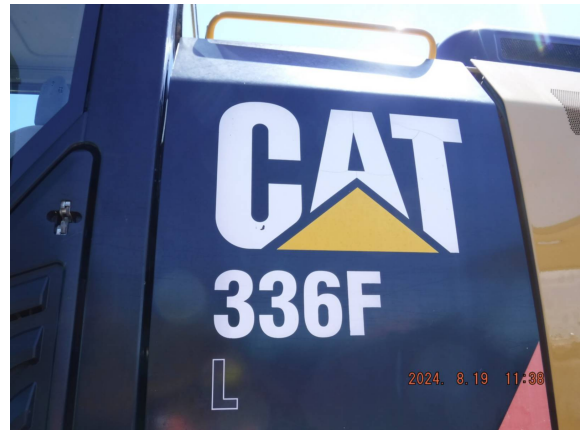
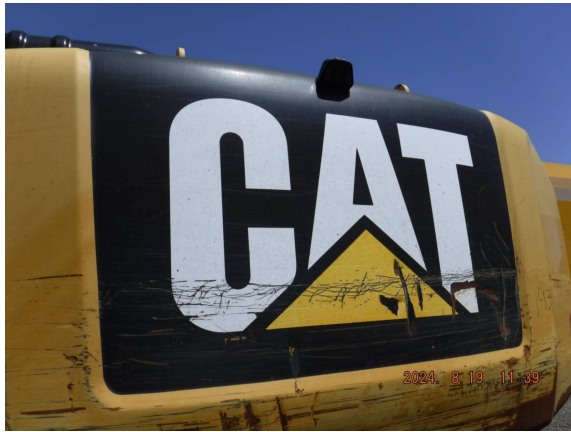
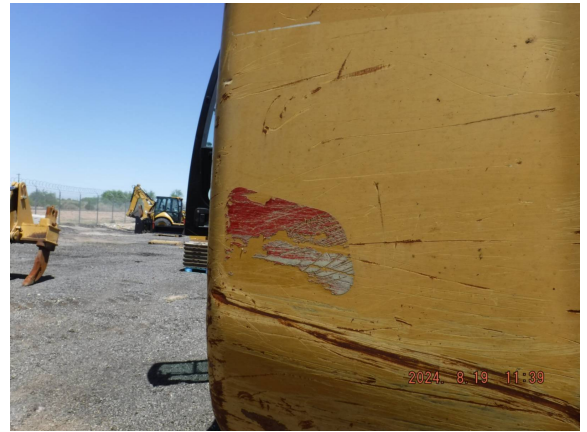
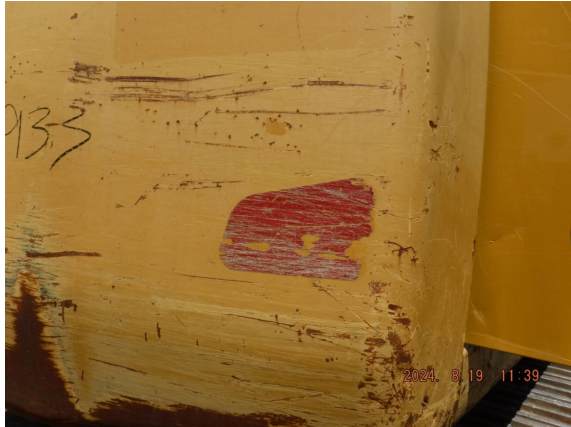
Decals are peeling

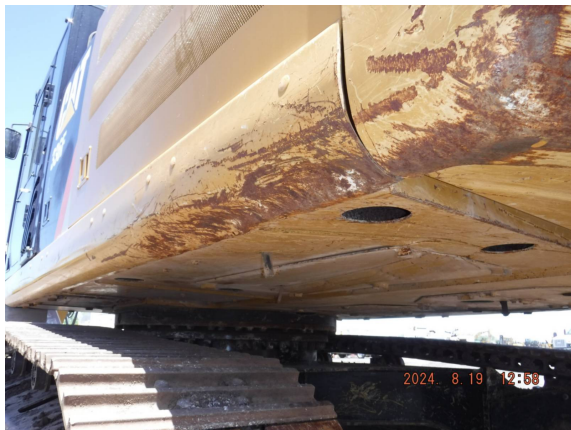
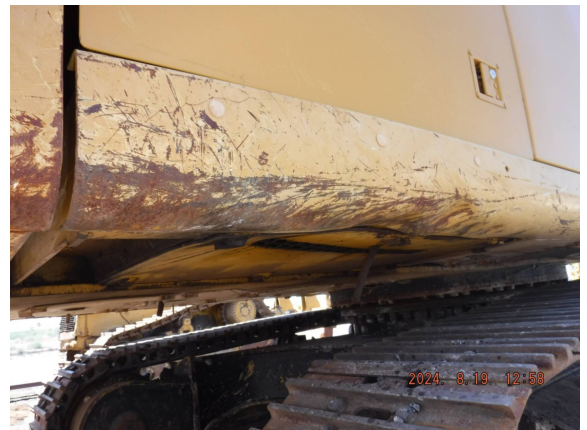
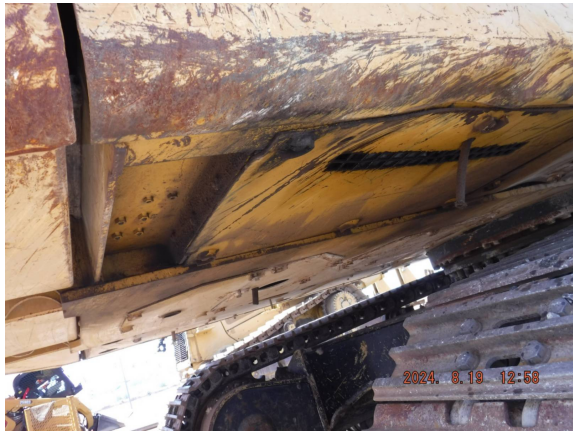
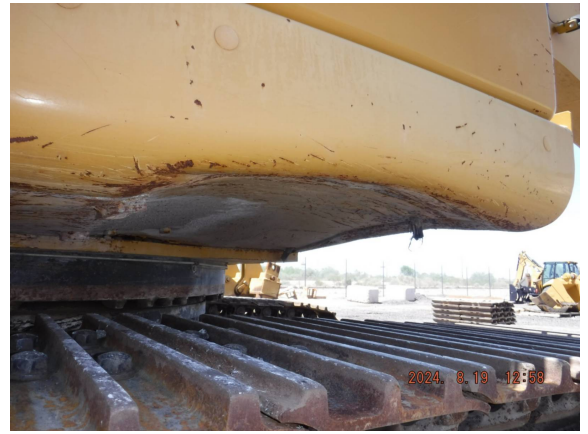
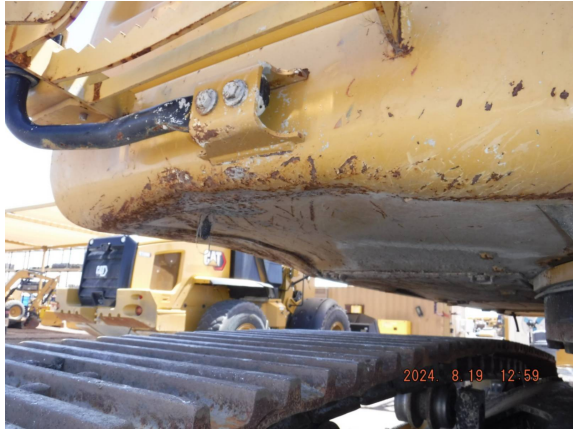
● Fenders are bent on both sides of machine can be repaired (weld repair)

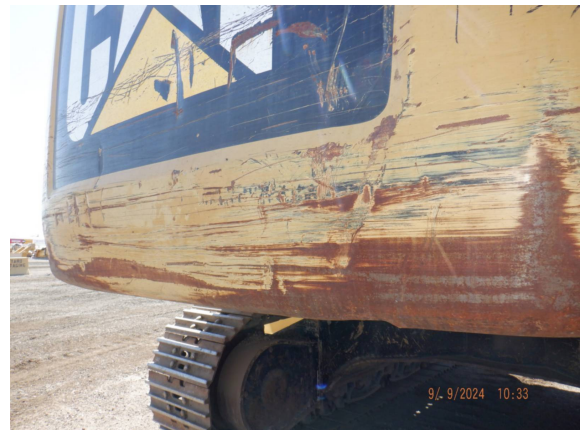
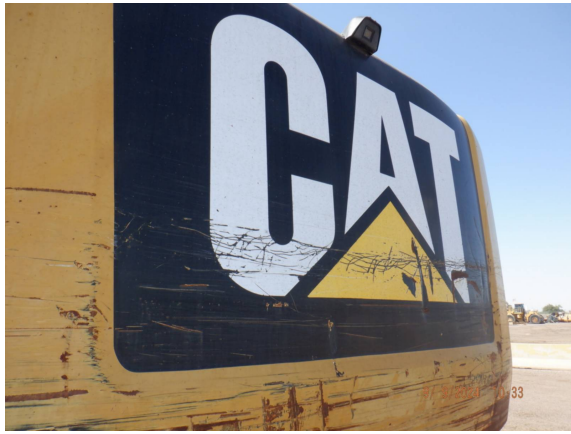
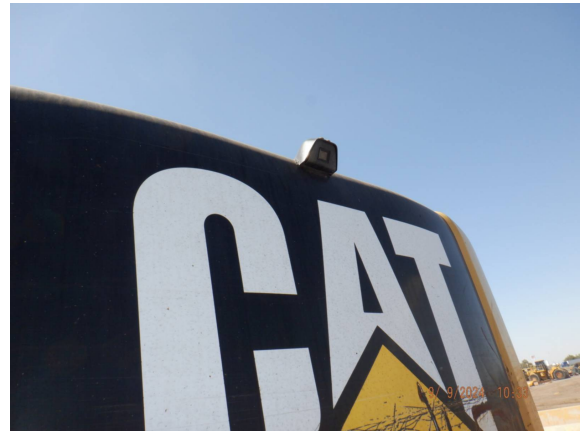
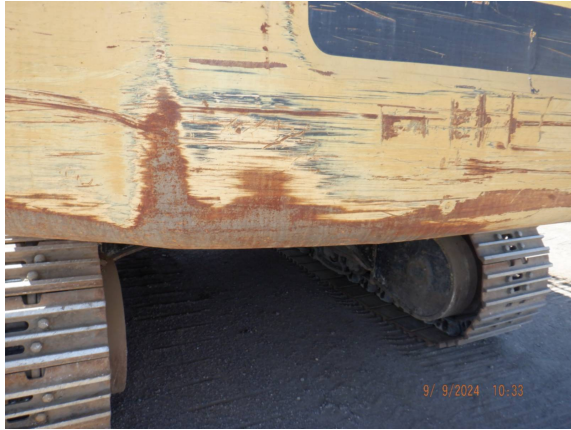
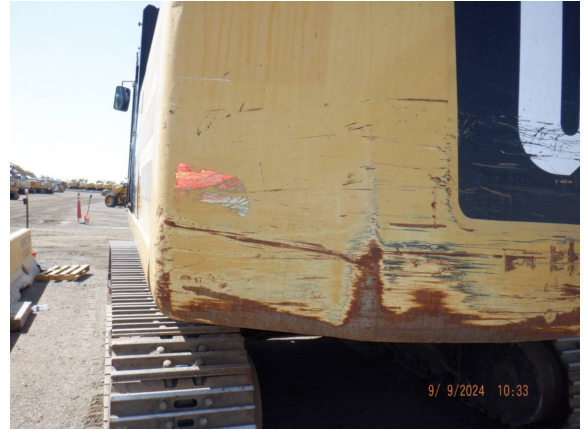
Paint

Has scratches

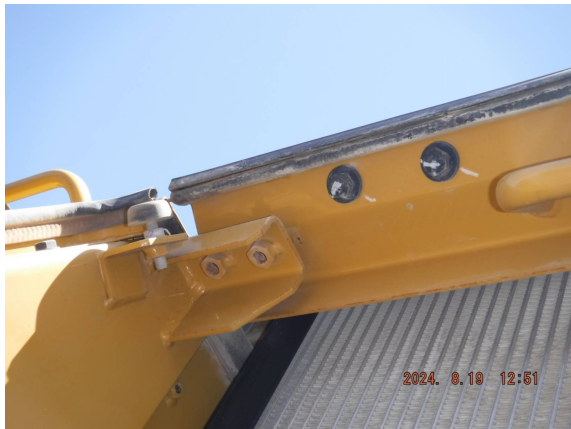
Radiator Grill & Shroud

●●
Top radiator cover bracket is missing bolts

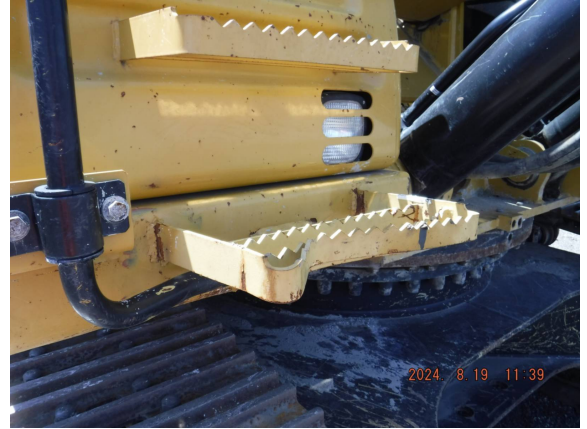
Steps / Ladder

Right front lower step is bent.

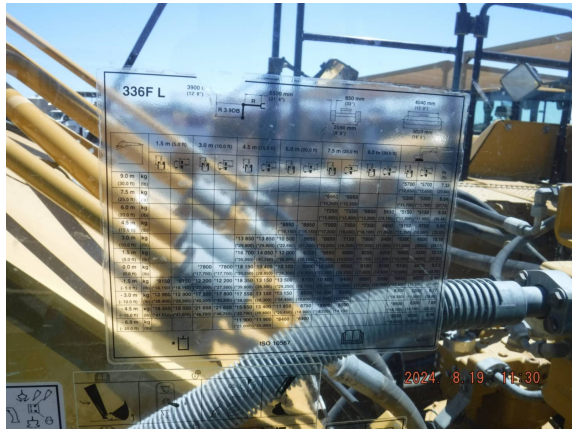
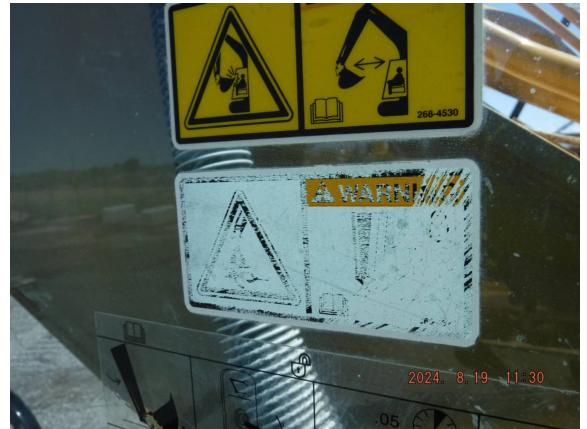
Safety Decals Legible

safety decals in cab are not legible

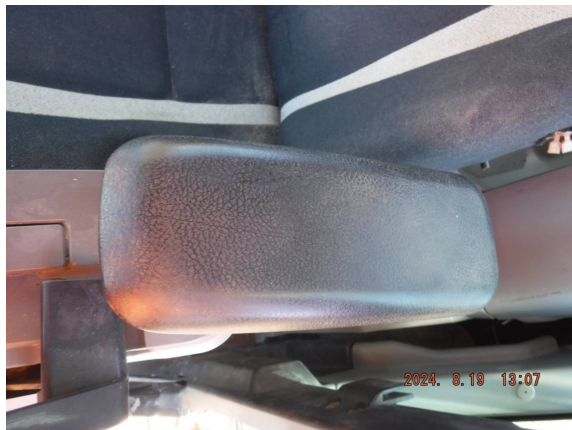
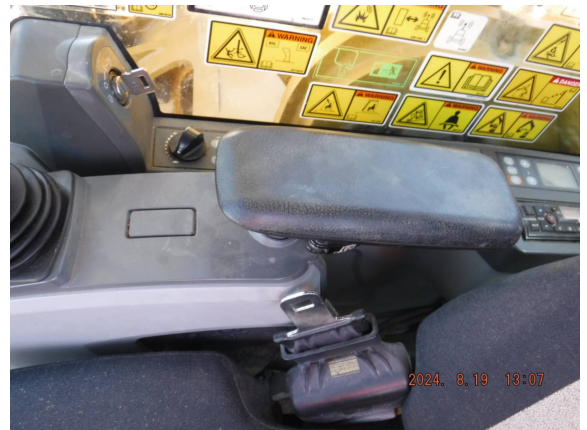
Armrests

Arm rest are worn

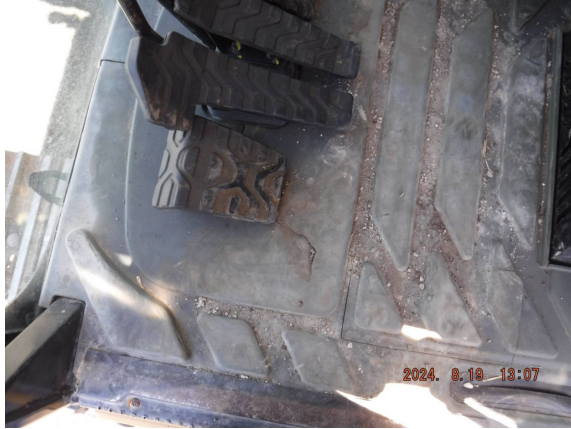
Floor Boards / Mats

Floor mat is torn

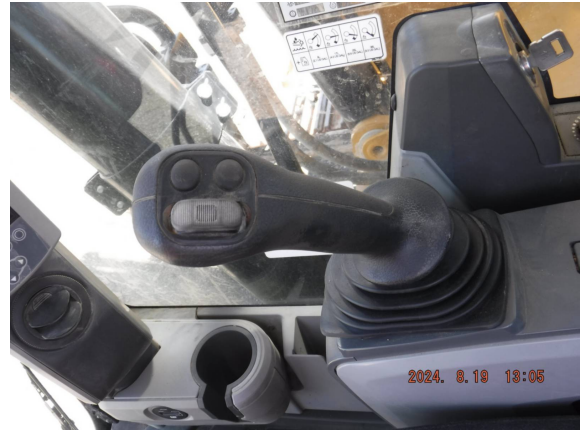
Hydraulic Controls

buttons on joysticks are not legible

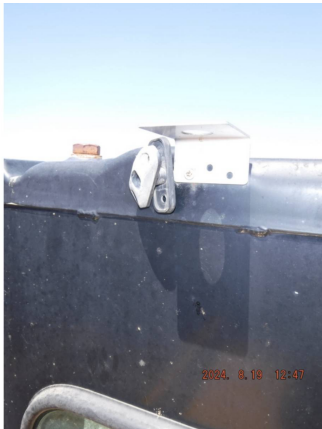
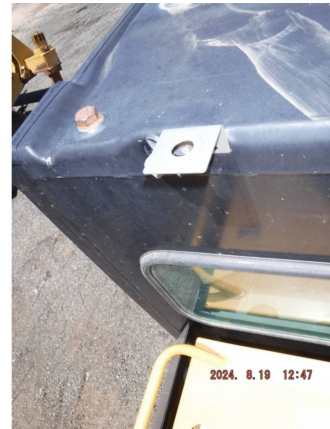
Radio antenna is missing

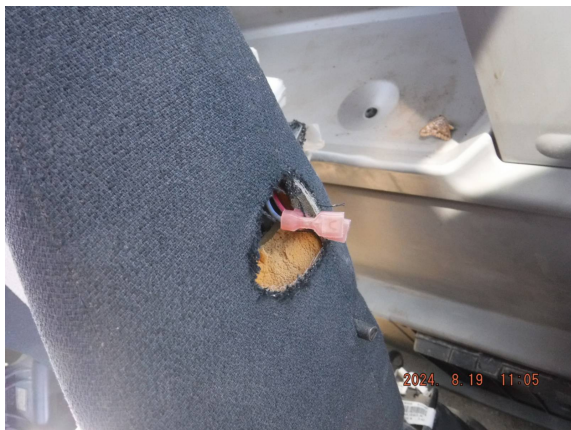
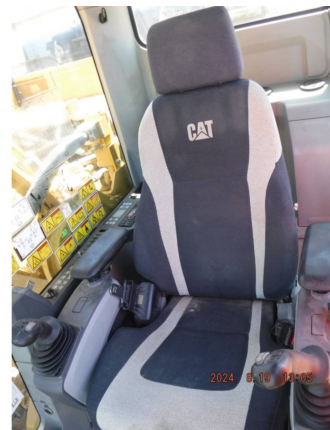
Seat Cushions / Suspension / Type

seat has hole in left side of seat

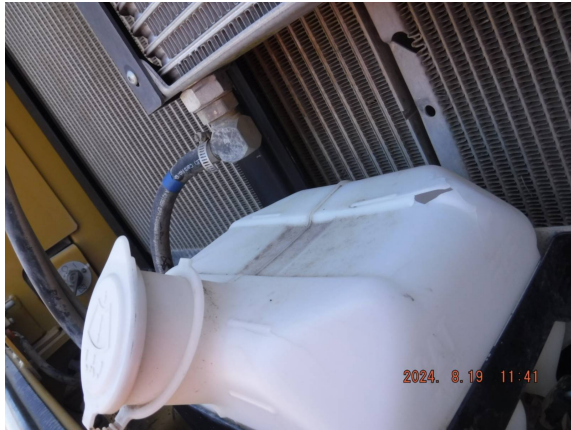
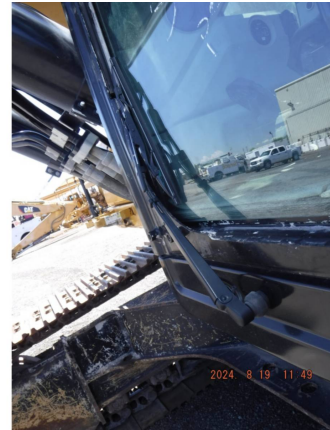
Windshield Wipers

●
Washer fluid tank is cracked. lower wiper motor does not work. both wiper blades are torn

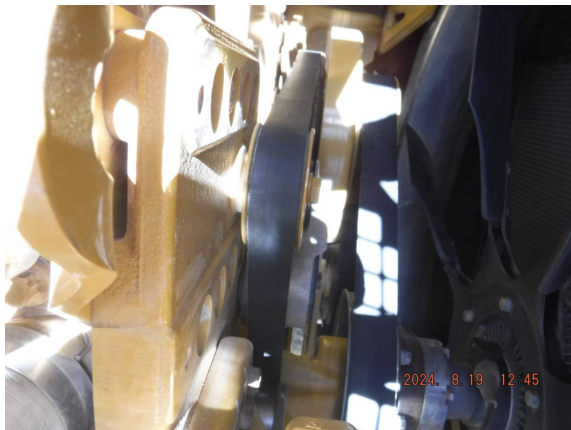
Belts / Pulleys - ENGINE

●●
Belts have cracks

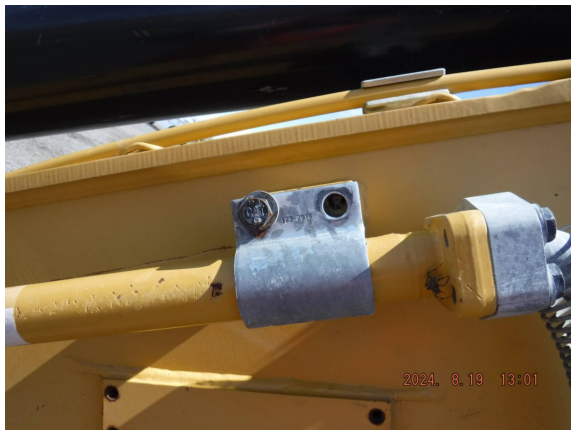
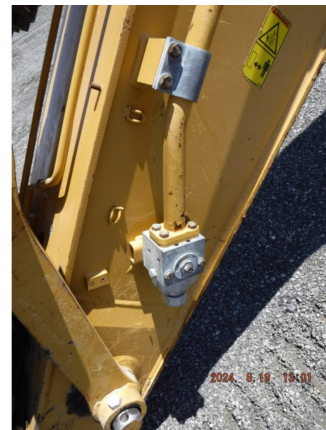
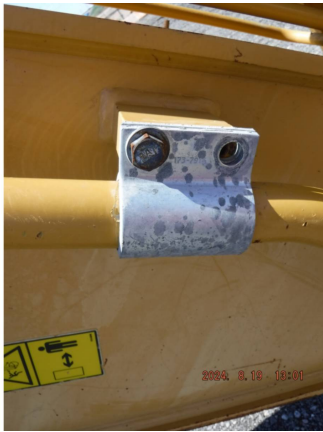
Hose Lines

Line on right side of stick is
bent both aux lines are missing
bolts on mounts (bolts are
broke off in hole)

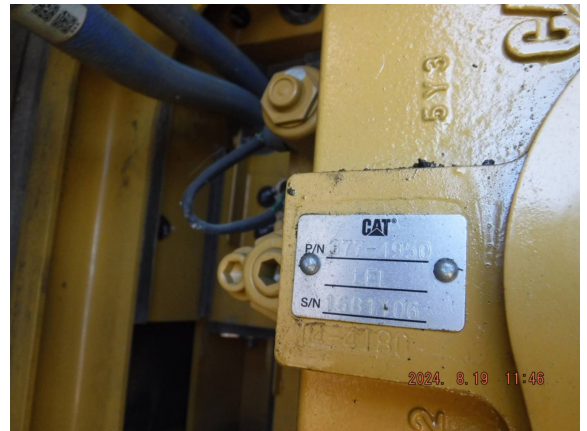
Pumps & Valves

●●
Hydraulic pump is wet

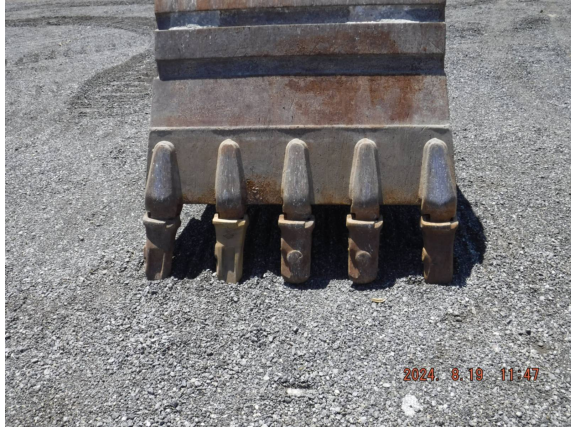
Teeth / Adapters

bucket teeth are worn
