Water Wagon Inspection Report

Inspection Date: 4/30/2025

MACHINE DETAILS					
Manufacturer: AA		Model: 613C WW		S/N: 08LJ01391	
Year: 1996		Eng S/N: 98Z16181		Trans S/N: 9KE01129	
SMU/Hrs: 24461		Hours Date: 4/30/2025			
Last Schedule:		Last CTS:		Last PM:	
Date Oil Sample Sent to Lab: 5/2/2025		Oil Sample: ENG TRANS			
Recommendations:					
CONFIGURATION					
ECM Download:		ROPS:	Enclosed	Product Link:	Inquire for options on
Air Conditioning:	Yes	Retarder:	Yes	Cushion Hitch:	No
Transmission Guard:	Yes	Product Link:	No	Engine Tier Rating:	
Tire Size:	23.5-25	Tank Capacity:	5000 GAL.	Front Spray System:	No
Rear Spray System:	Yes	Side Spray System:	Yes	Hose Reel:	Yes
Water Cannon:	Yes	Comment:		Comment:	
GENERAL APPEARANCE					
	CODE	REMARKS			
Radiator Grill	Good				
Shroud	Good				
Engine Enclosure	Good				
Hood / Stack	Good				
Fenders	Fair	FENDERS HAVE DENTS, NO REPAIRS.			
Fuel Tank	Good				
Crankcase Guard	Fair	BELLY PAN HAS BEEN HIT AND DISFIGURED, MISSING HARDWARE.

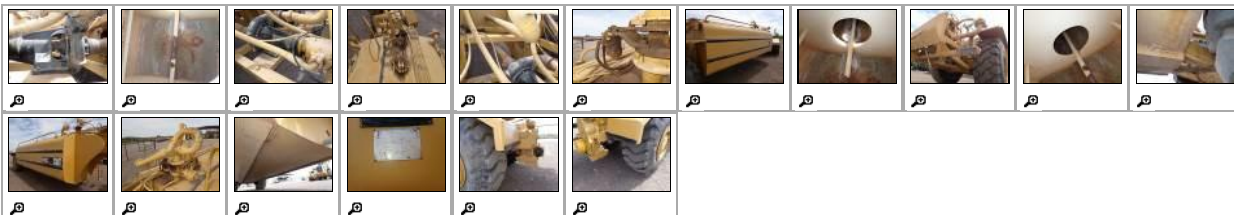
CODE	REMARKS
Ends	Good	
Sides	Good	
Top	Good	
Baffles	Good	
Bottom	Good	
Spray Heads	Fair	RIGHT SPRAY BAR TAPED, ASSESS FOR REPAIRS.
Spray System	NI	
Water Cannon	Poor	INOPERABLE WITH LEAK FROM DRIVE MOTOR AND WIRING SPLICED AND NOT CONNECTED.
Hose Reel	Good	
Mud Flaps	Poor	FRONT MUD FLAPS BROKE OFF.
Steps / Ladders	Good	
Grab Irons	Good	
Fenders	Good	
Clearance Lights	Good	
Water Pump	Fair	WATER PUMP SHAFT SEAL SEEPING.
Pump Drive	Good	
Mounts	Good	
Pipes / Hoses / Tubes	Fair	TUBES IN TANK ARE RUSTED.
Notes
