2016 CAT 279D COMPACT TRACK LOADER

INSPECTION DETAILS

Inspection Type	Purchase
Inspection Form	Standard
Inspection #	10260852
Inspection Status	Inspected
Created	12/31/25 11:38:51
Updated	01/14/26 16:12:40
Created By	Fuller, Scott U.
Inspector	Fuller, Scott U.
Reviewers	Fuller, Scott U.
Salesperson	Heath, Jason
Last Preventative Maintenance	Oct 24, 2025
Stock #	E212869
Serial #	GTL02844
SMU / Hours	3,899
Location	Henderson, NV, United States

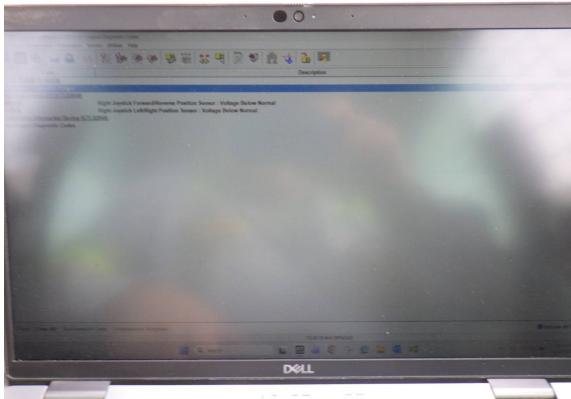
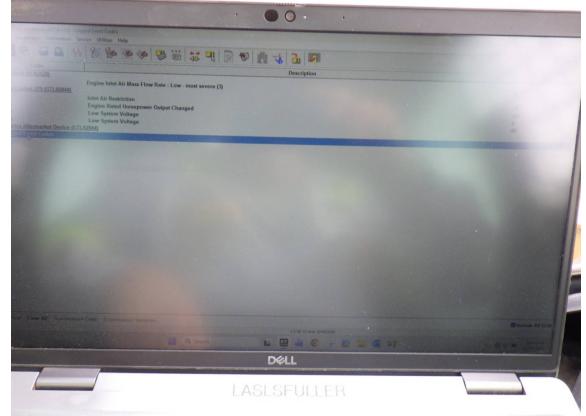
Logged / Active Codes

Has a few logged fault codes in machines ECM's

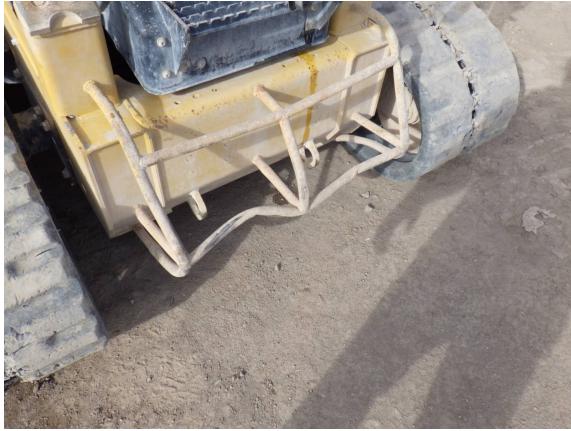
Bumper

Client has welded guarding on the
front of machine, which is damaged.

Client has welded guarding on the front of machine, which is damaged.

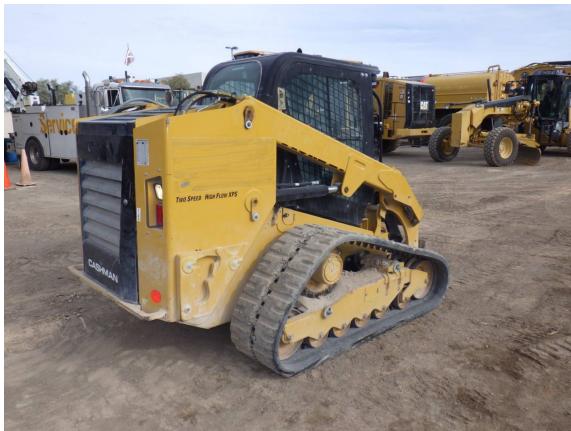
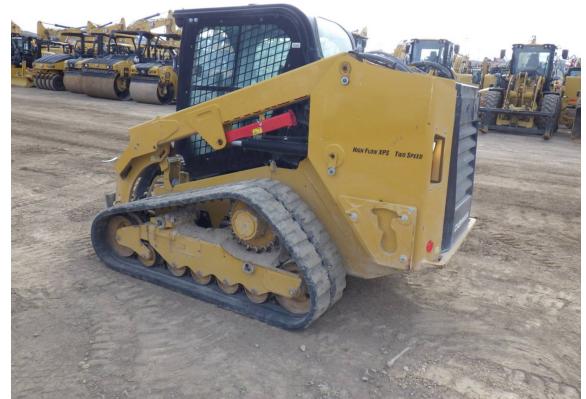
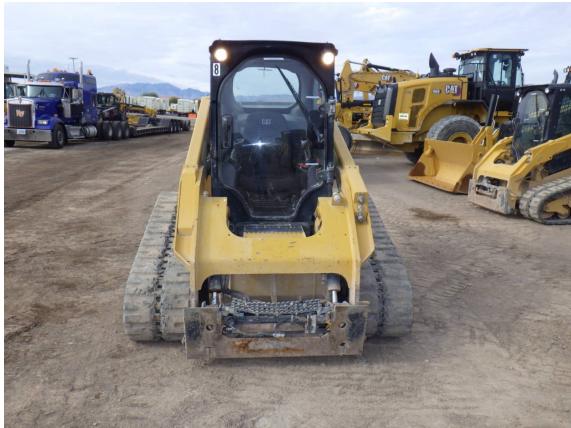
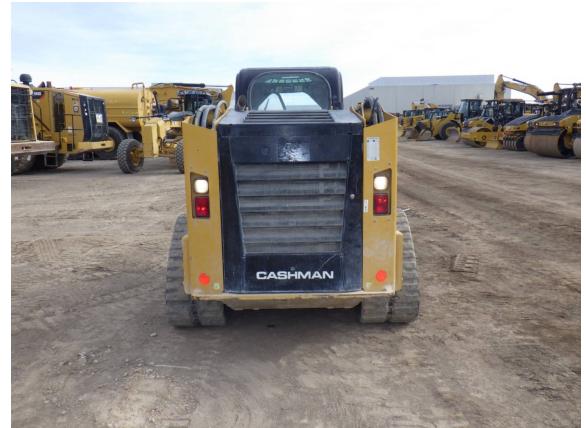
Decals

Missing all make and model decals.

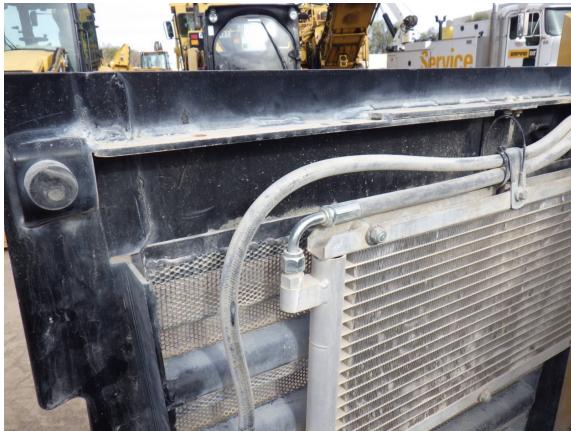
Eng. Enclose Hood / Stack

Missing engine door prop pin.

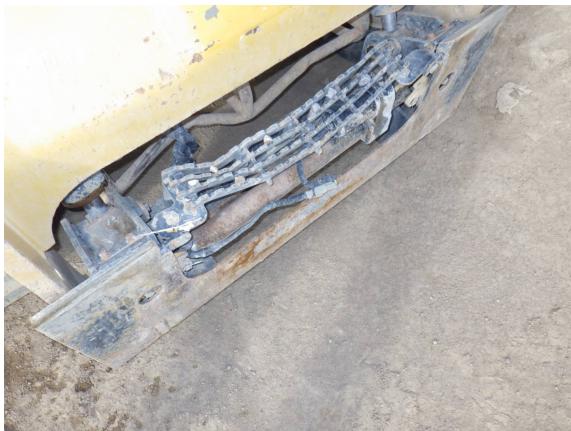
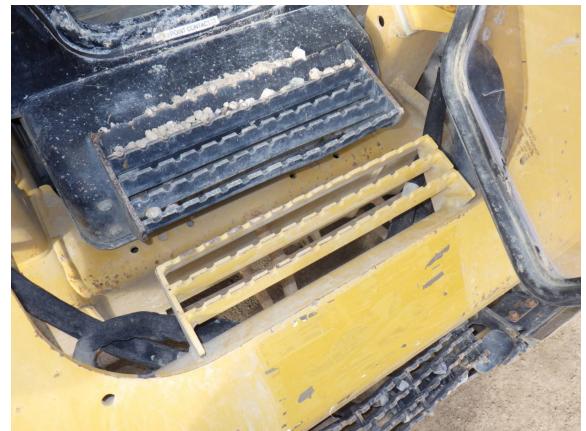
Steps / Ladder

Q/C step is bent/damaged.

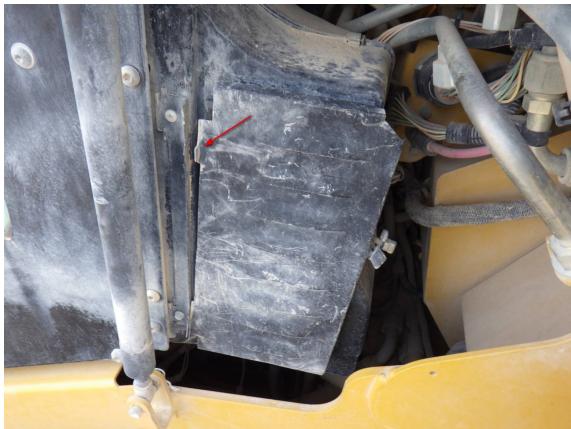
Cab Filter / Heat Vent Louvres

Outside cab air filter cover is broken.

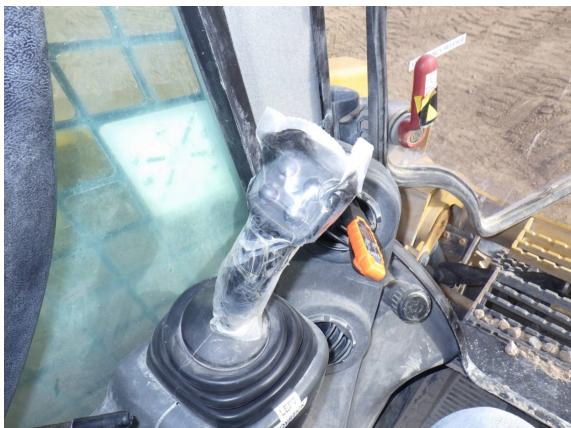
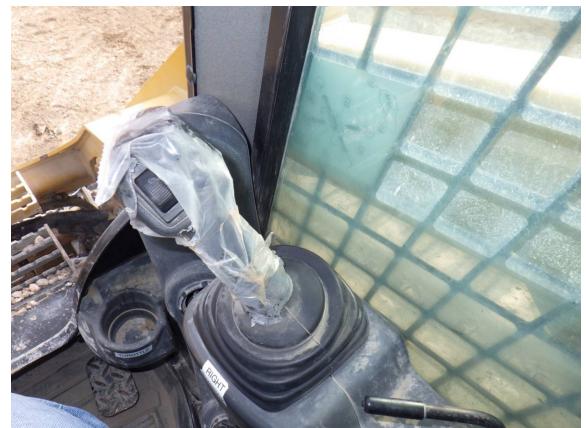
Hydraulic Controls

Joystick handles are covered with plastic. Needs removed and cleaned.

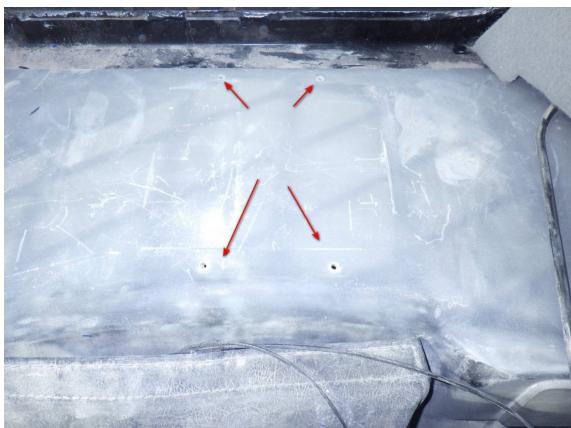
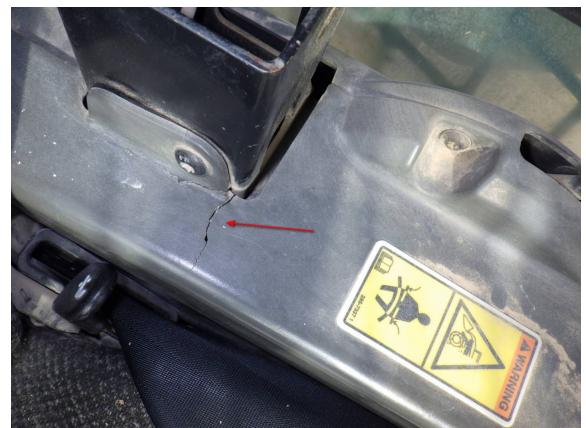
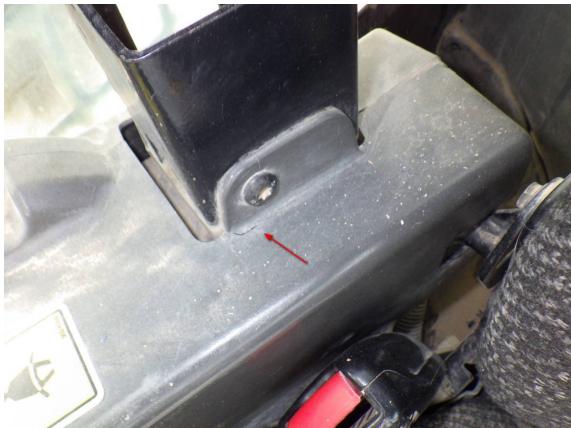
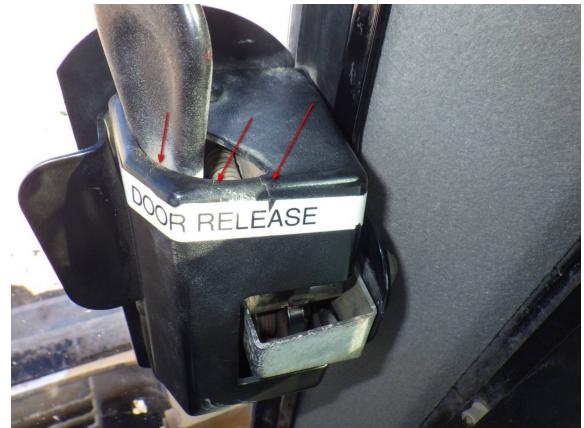
Interior Plastic / Fabric

Door latch trim cover is cracked.
Joystick consoles are cracked. A few
holes drilled through rear cab panel.

Door latch trim cover is cracked. Joystick consoles are cracked. A few holes drilled through rear cab panel.

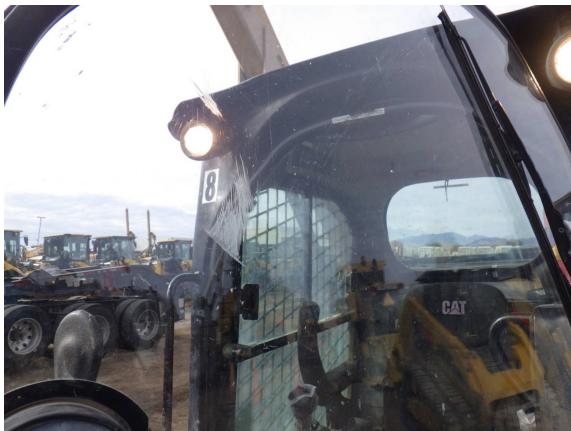
Windows

Front door polycarbonate window has
some gouges.

Front door polycarbonate window has some gouges.

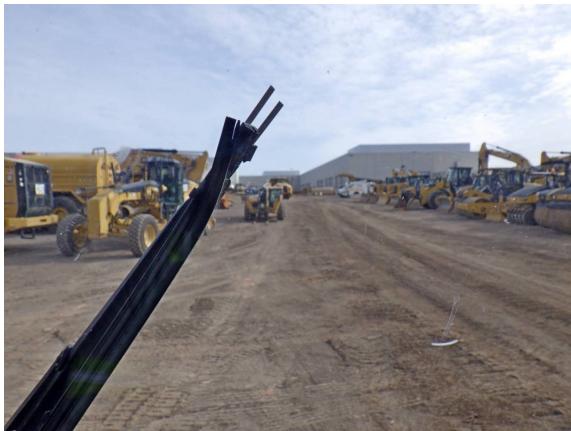
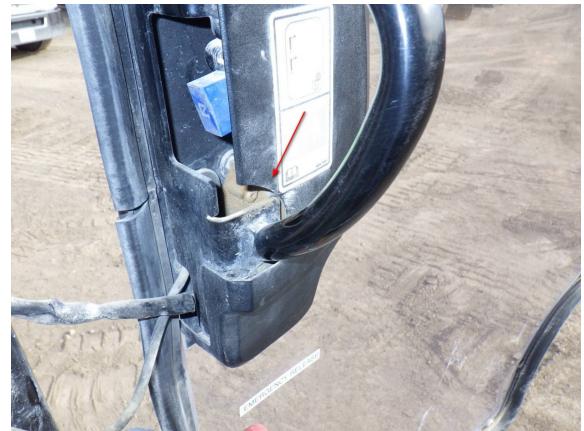
Windshield Wipers

Wiper motor trim cover is broken at
corner. Wiper blade needs replaced.

Wiper motor trim cover is broken at corner. Wiper blade needs replaced.

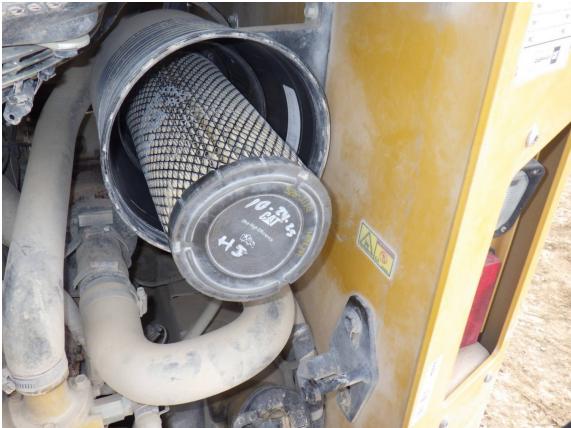
Intake / Air Filters

Wrong primary filter installed.

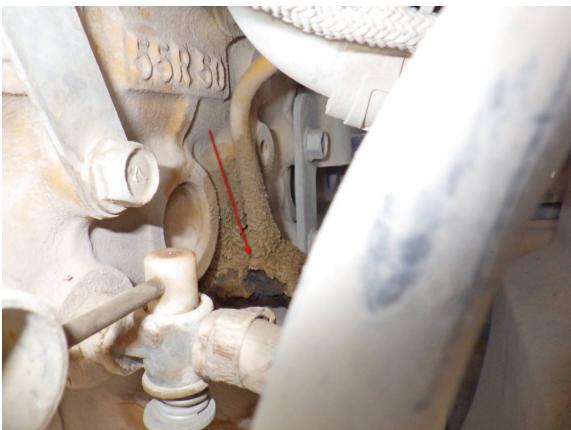
Oil Leaks

No significant leaks found, but has excess oil residue at turbo oil line.

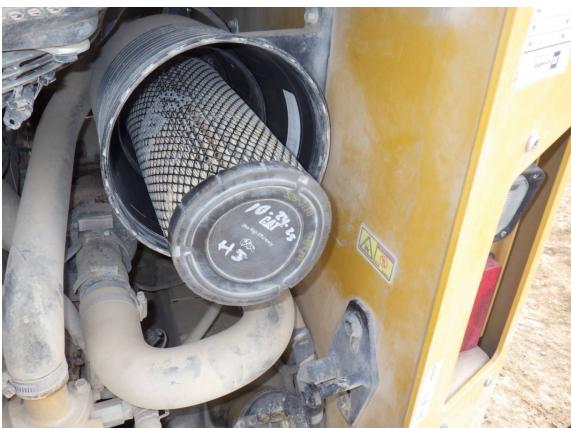
Service Needed

Most recent pm service performed. 10/24/2025 at unknown hours.

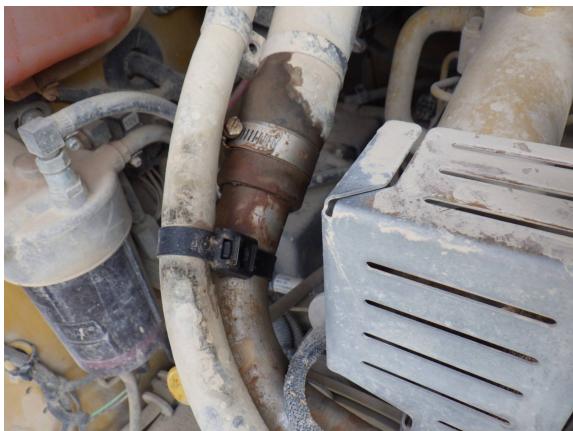
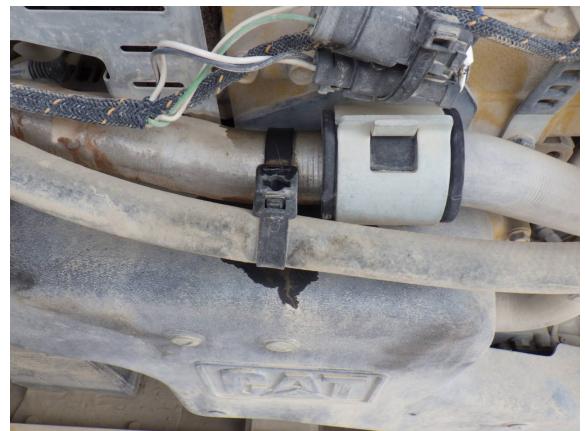
Hoses / Tubes

Seepages at coolant at tube connections/clamps.

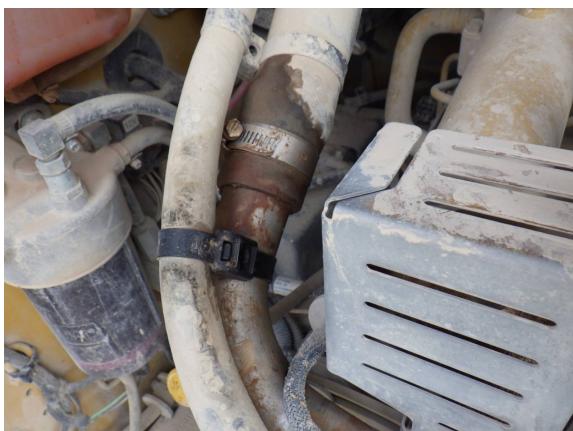
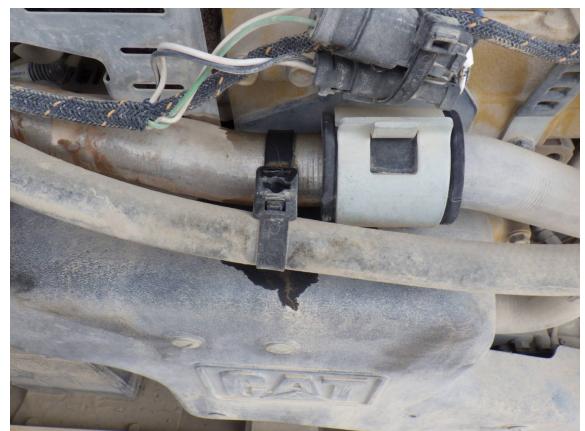
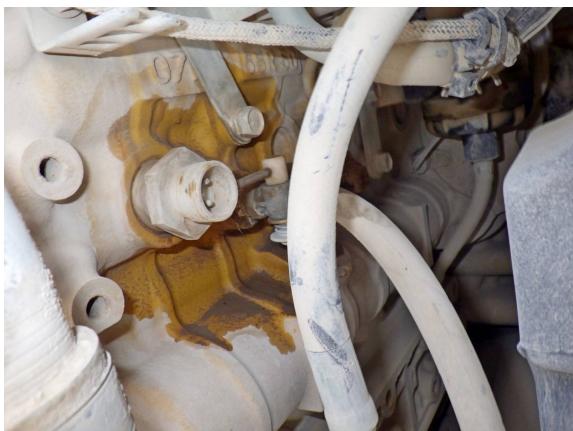
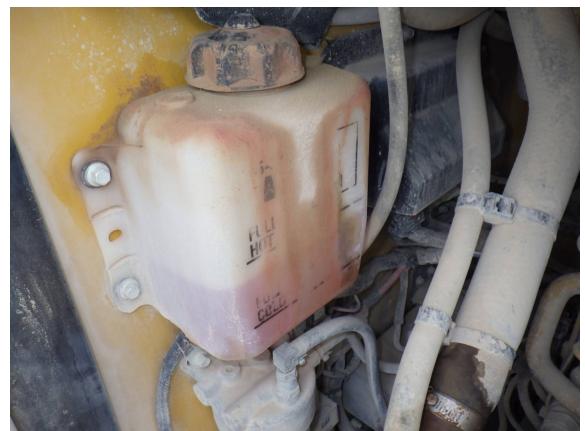
4 Coolant Leaks
YES
Coolant leaks at tube connections/clamps, expansion tank fill cap and at block drain valve.

Coolant leaks at tube connections/clamps, expansion tank fill cap and at block drain valve.

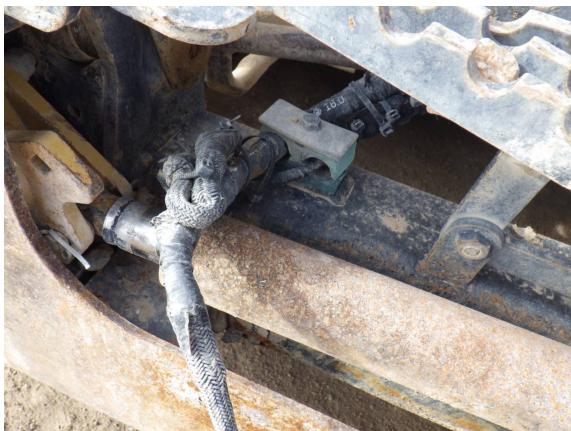
Wiring to q/c has damage and poorly
secured/routed.

Wiring to q/c has damage and poorly secured/routed.

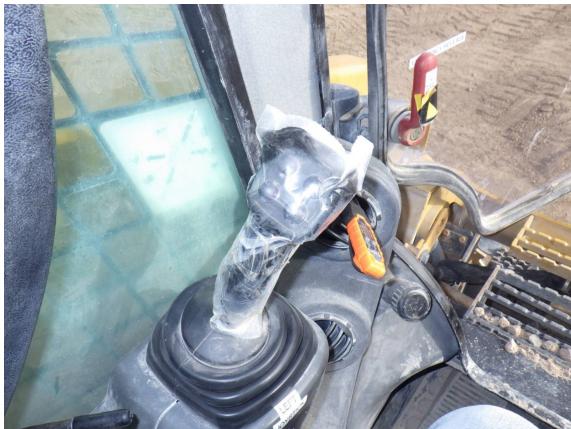
Travel Controls

Joystick covered with plastic- Needs
removed and cleaned

Joystick covered with plastic-
Needs removed and cleaned

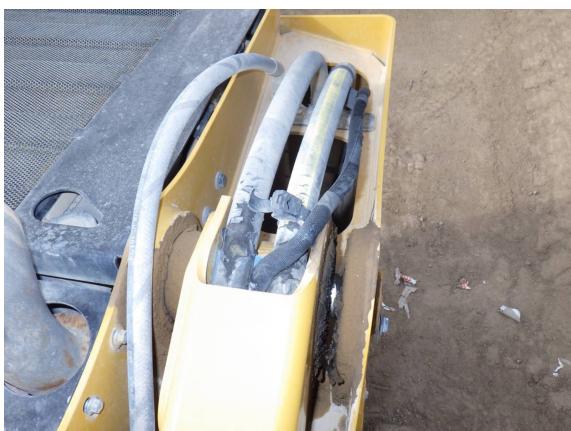
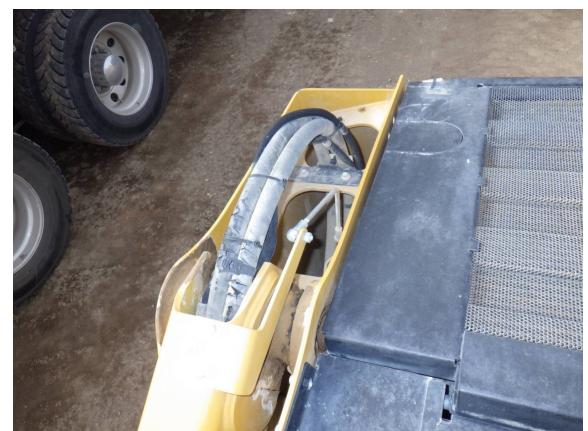
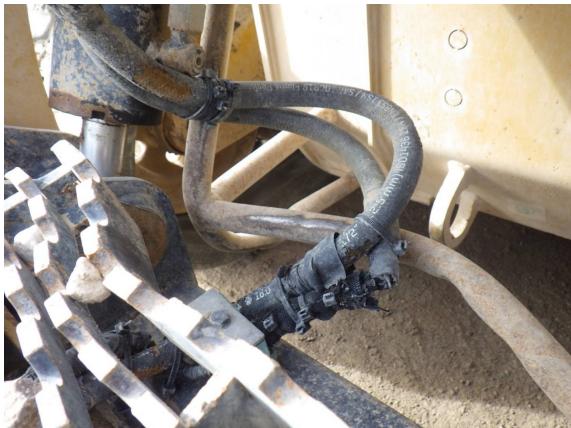
Hoses / Lines

Lines to q/c have damage and poorly secured/routed. Various lines weathered, some with braid showing.

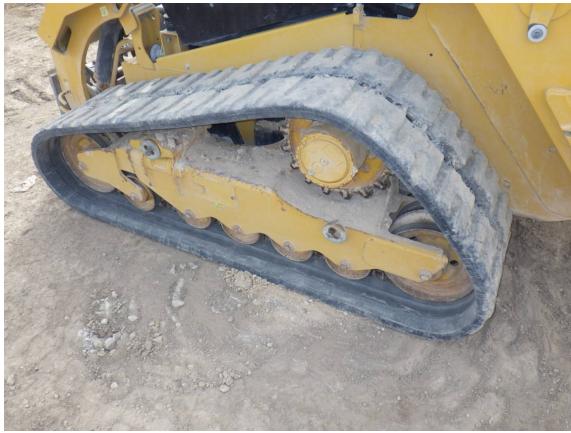
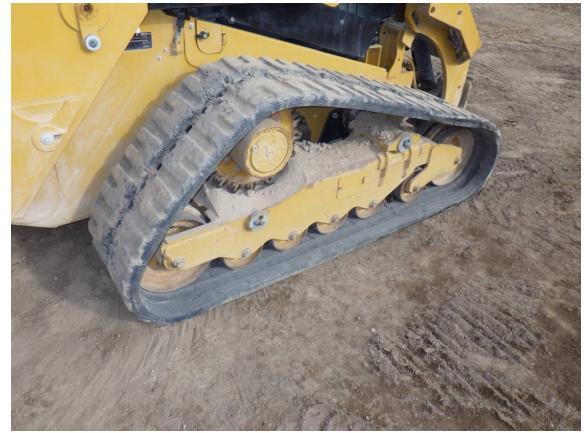
Track / Belt Condition

Various cuts in belts.

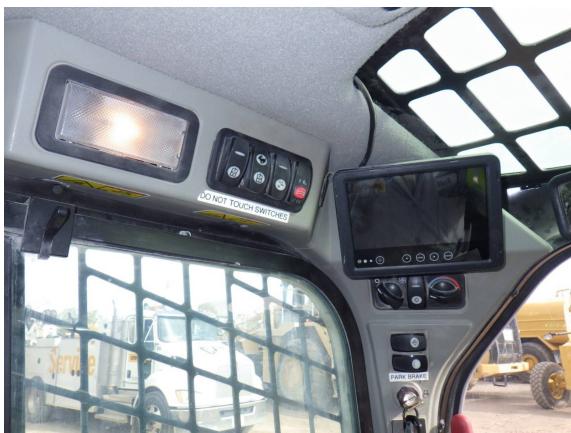
Notes - GAUGES, OPERATOR STATION, CONSOLE

Camera monitor in cab is
inop/disconnected. Client
removed the remainder of the
camera system that was
installed.

Camera monitor in cab is inop/disconnected. Client removed the remainder of the camera system that was installed.
