# 2015 CAT 279D COMPACT TRACK LOADER

## INSPECTION DETAILS

Inspection Type	Purchase
Inspection Form	Standard
Inspection #	10260836
Inspection Status	Inspected
Created	12/31/25 10:31:49
Updated	01/13/26 15:51:18
Created By	Fuller, Scott U.
Inspector	Fuller, Scott U.
Reviewers	Fuller, Scott U.
Salesperson	Heath, Jason
Last Preventative Maintenance	Sep 26, 2025
Stock #	E212870
Serial #	GTL01976
SMU / Hours	3,898
Location	Henderson, NV, United States

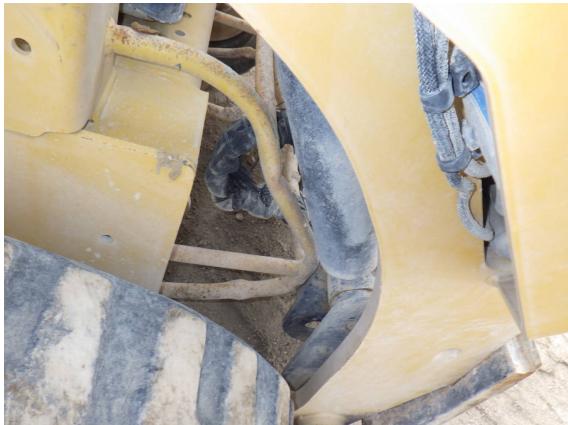
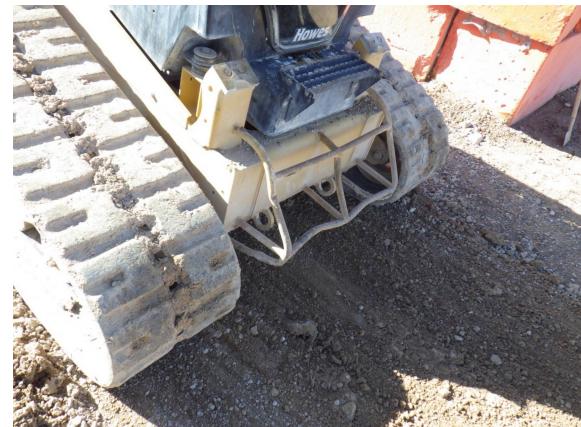
## Bumper

Client has welded guarding on the front of machine, which is damaged.

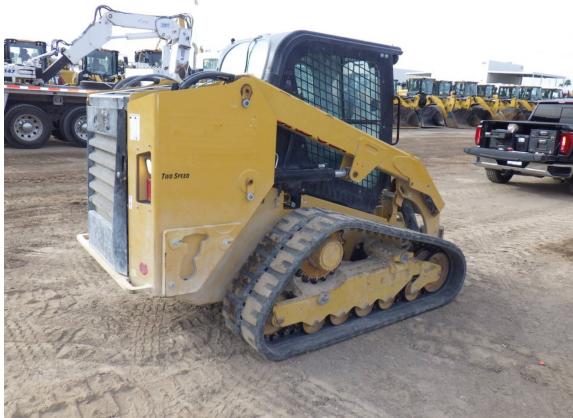
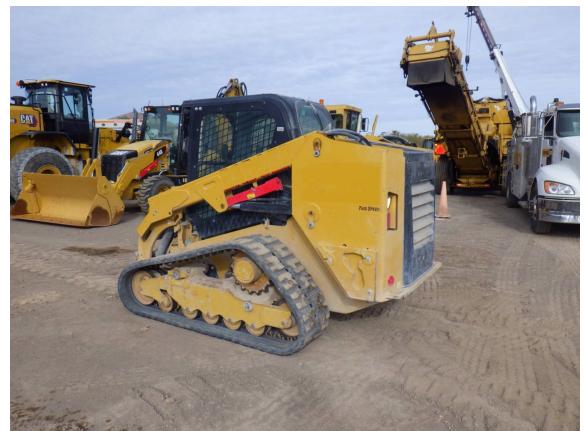
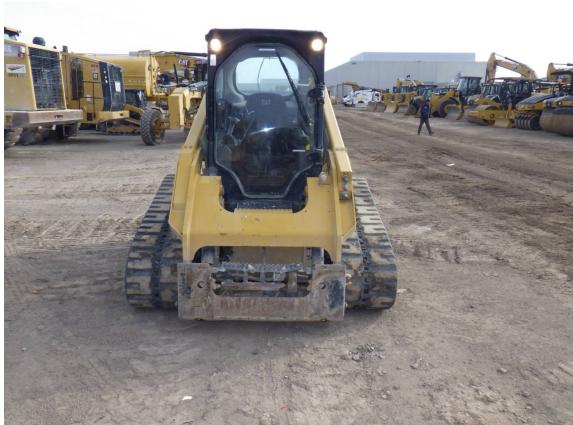
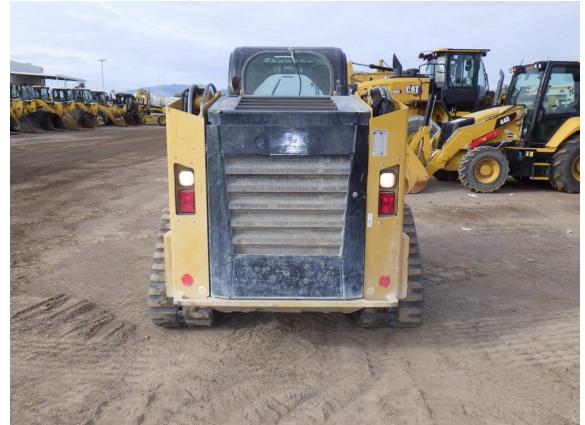
## Decals

Missing all make and model  
decals.

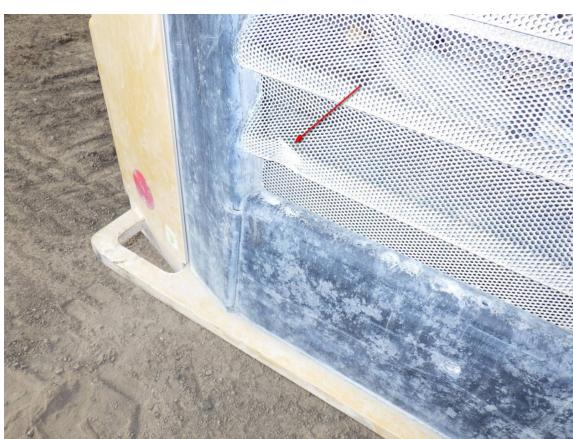
## Eng. Enclose Hood / Stack

🟡🟡  
Dent in engine door grill.

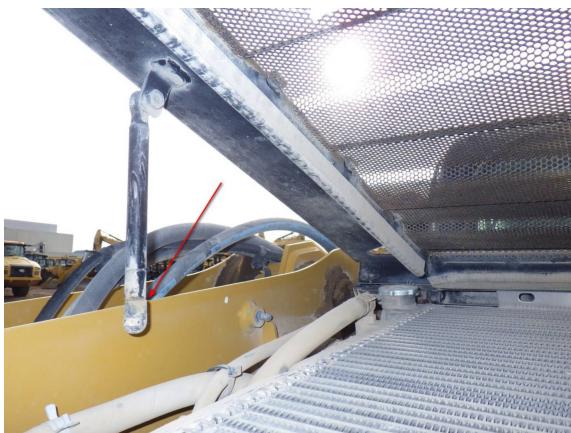
## Radiator Grill & Shroud

Grill support strut is disconnected, missing clip.

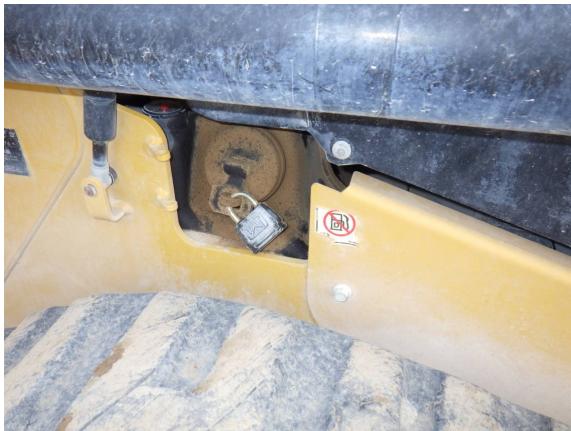
## Sheet Metal

Missing access door and latch to hyd. fill cap.

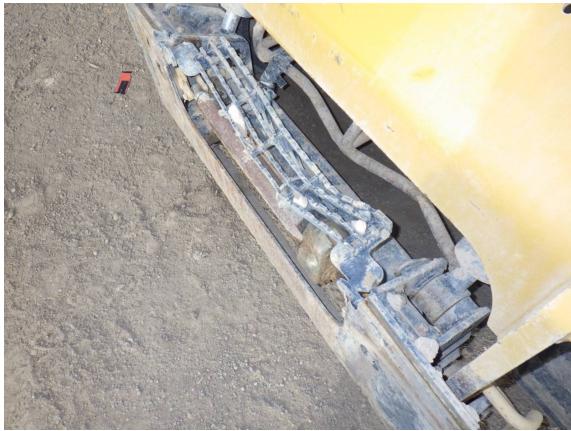
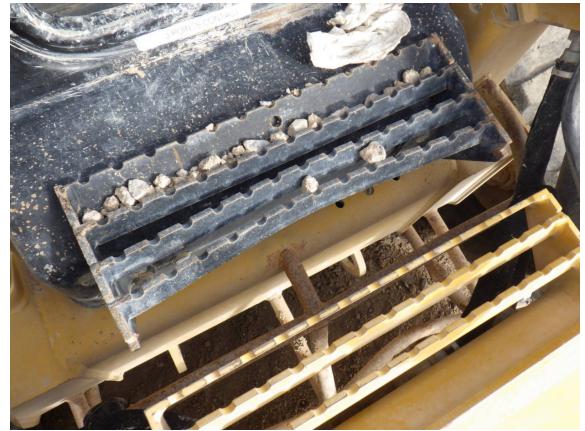
## Steps / Ladder

Q/C step is bent/damaged. Step at cab entrance is slightly bent.

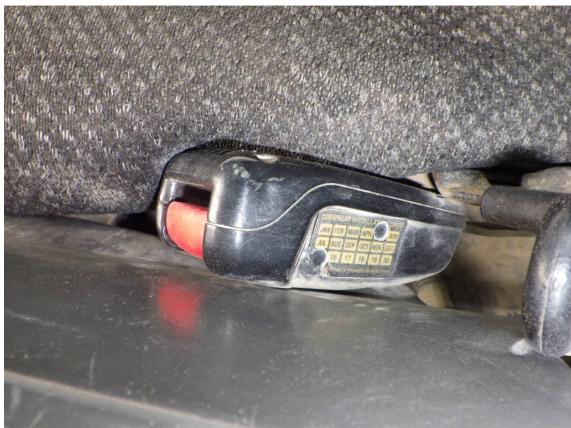
### Seat Belt / Date

●  
Expired

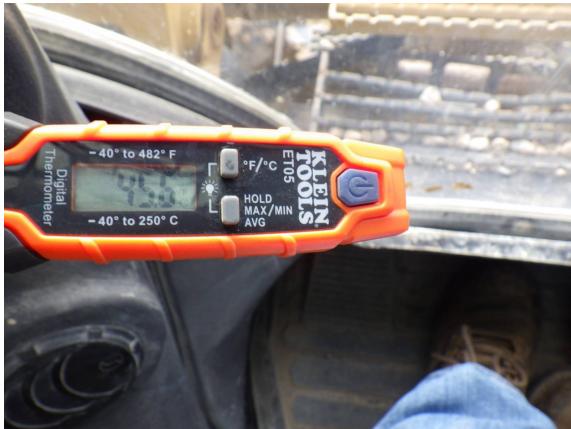
### Air Conditioner

Cooled to 45 degrees at 53  
ambient temp.

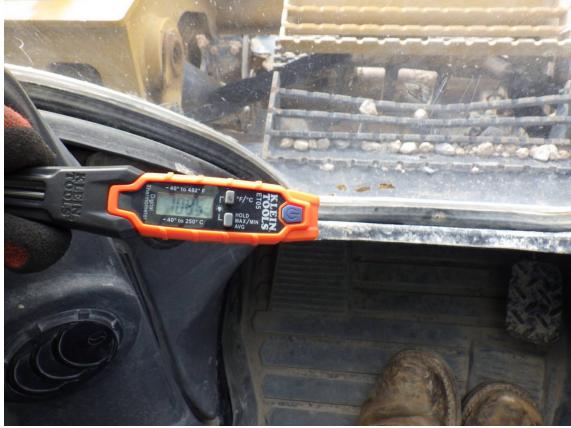
### Heater / Defroster

Warmed to 108 at 53 ambient  
temp

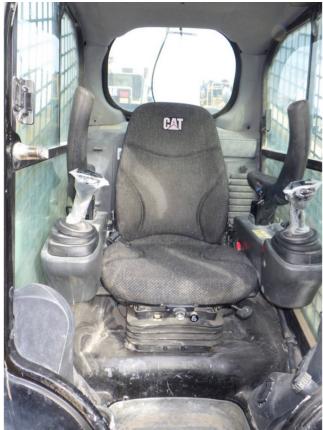
## Hydraulic Controls

Joystick handles are covered with plastic. Needs removed and cleaned.

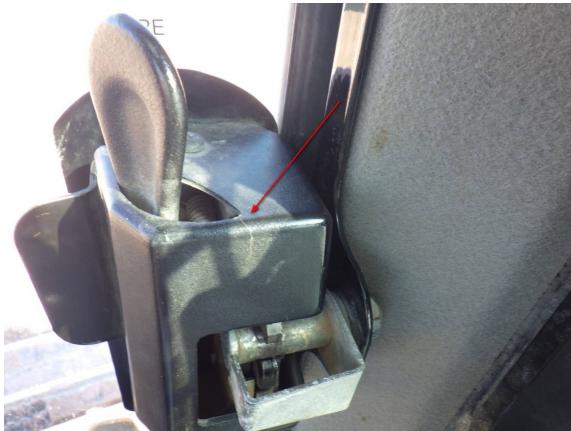
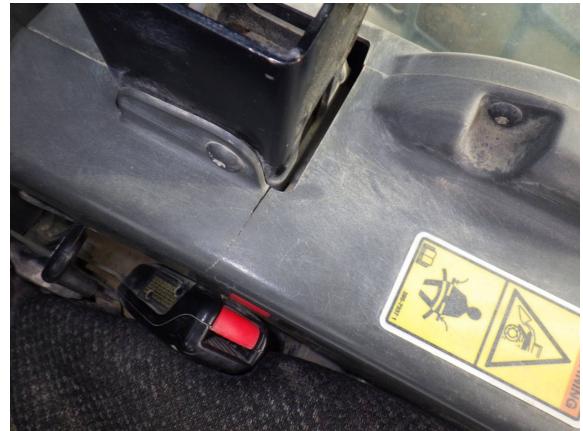
## Interior Plastic / Fabric

Door latch trim cover is cracked. Brack in left joystick console trim

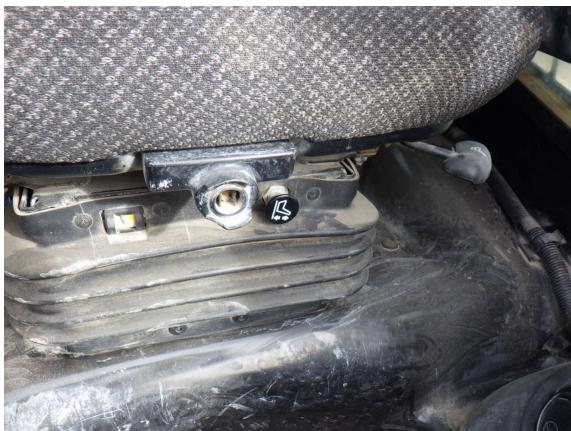
## Seat Cushions / Suspension /

Heater switch is broken. Right joystick console will not slide.

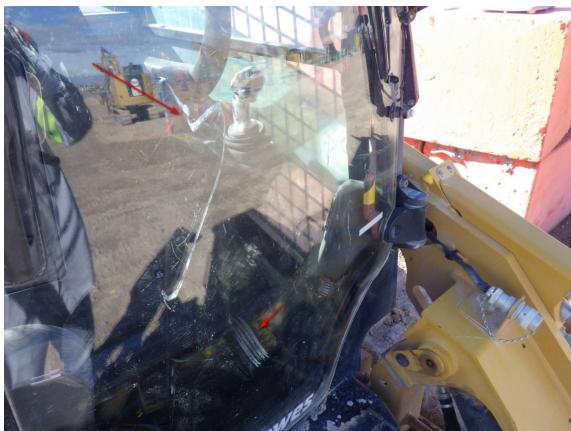
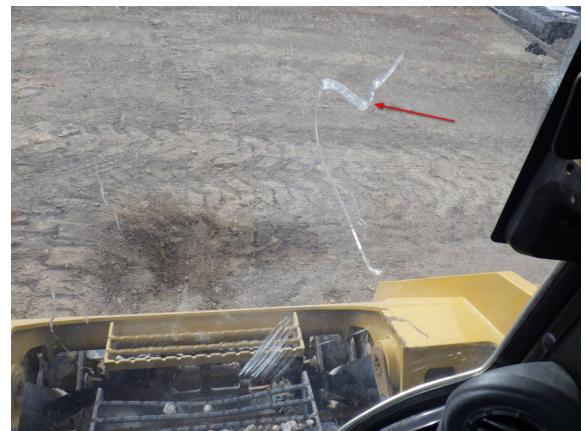
## Windows

Front door polycarbonate window has some deep gouges.

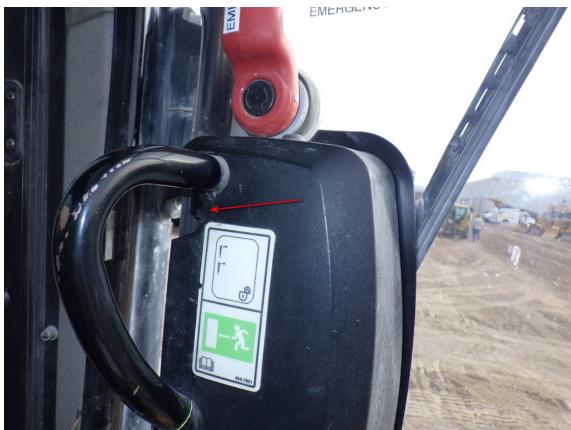
## Windshield Wipers

Wiper motor inop. Washers spray in to cab. Wiper motor trim cover is broken at corner.

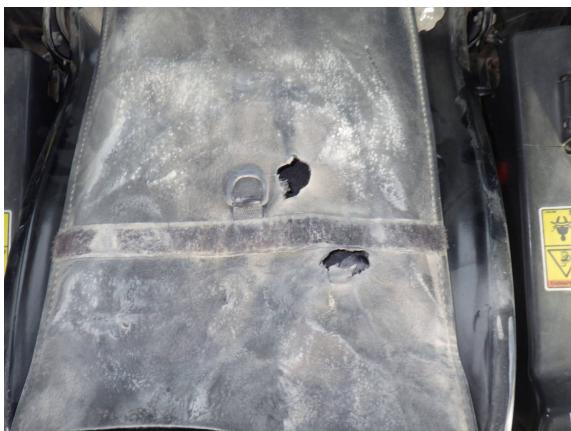
## Current O&MM

OMM pouch has holes worn through. Missing OMM

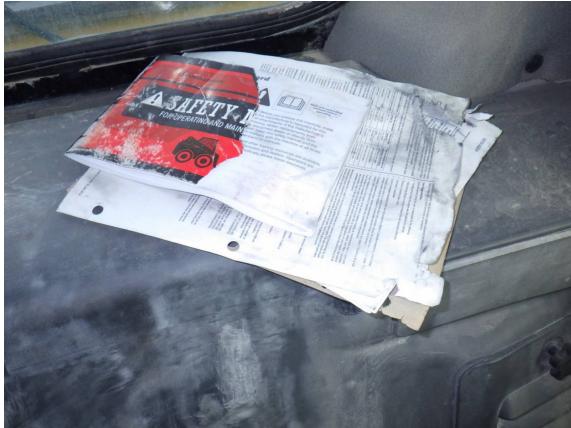
## Current Safety Manual

Torn

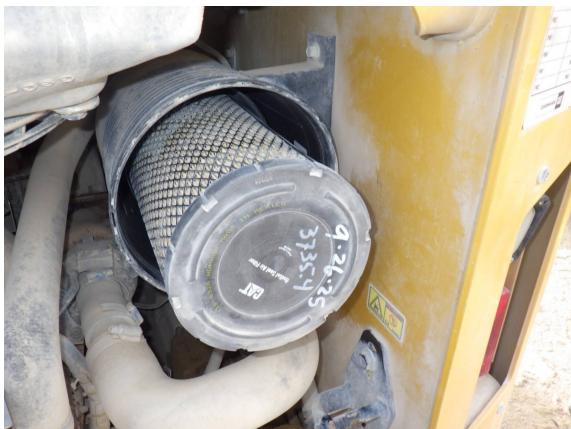
## Service Needed

Most recent pm service performed. 9/26/25 at 3735 hours.

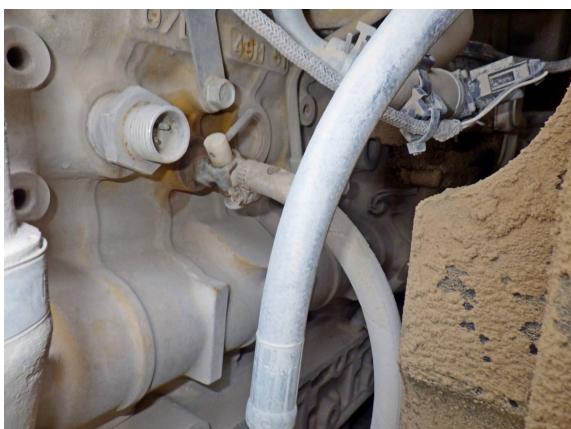
## Coolant Leaks

But has some residue at block drain valve. Should clean and recheck.

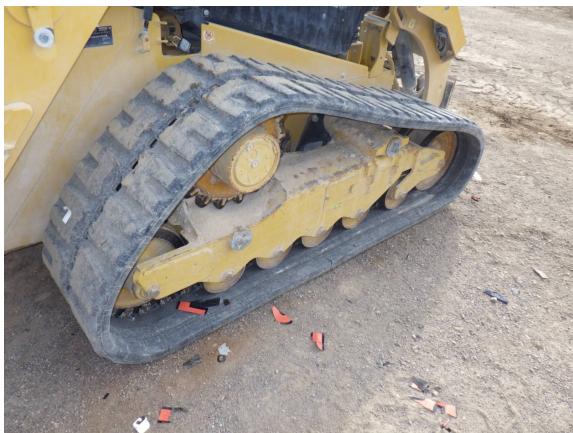
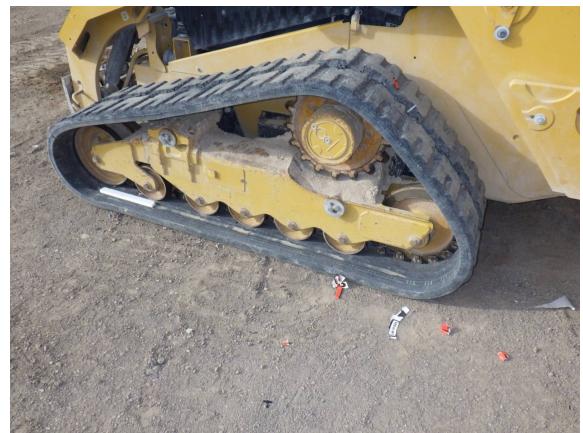
## Track / Belt Condition

Various cuts in belts. Tracks are slightly loose.
