2016 CAT

950M

WHEEL LOADER

INSPECTION DETAILS

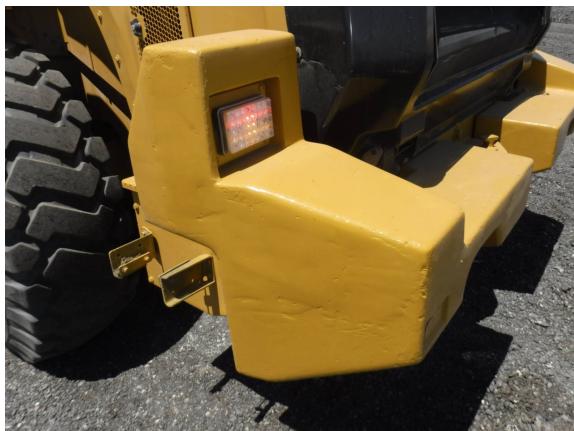
Counterweight

Has been repaired.

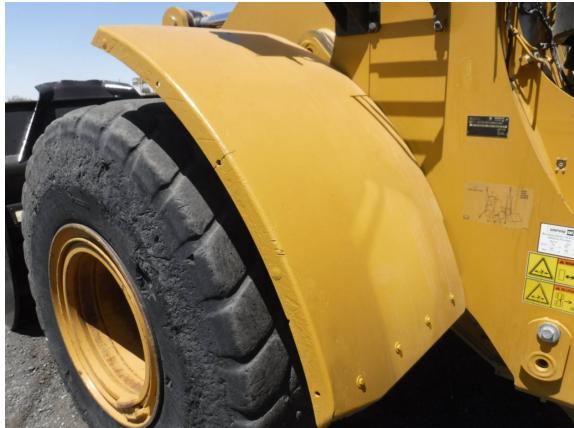
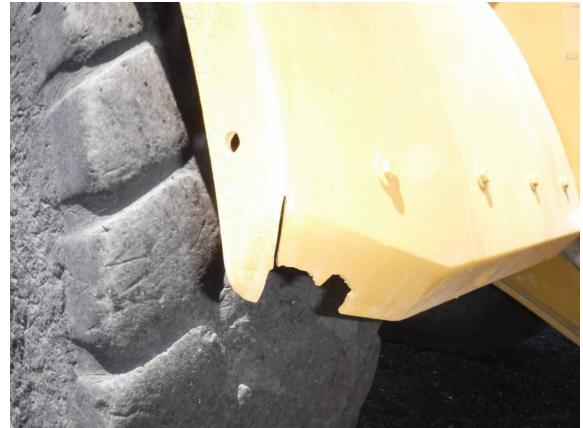
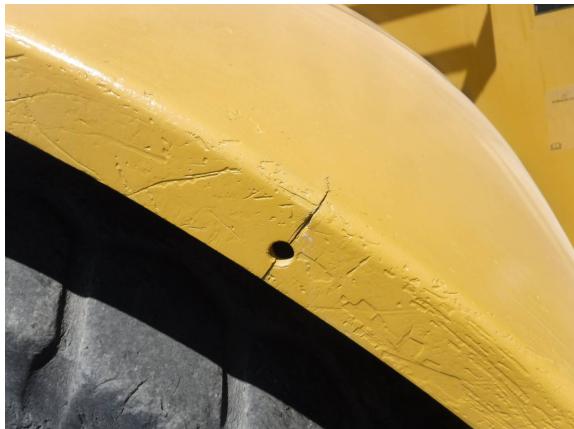
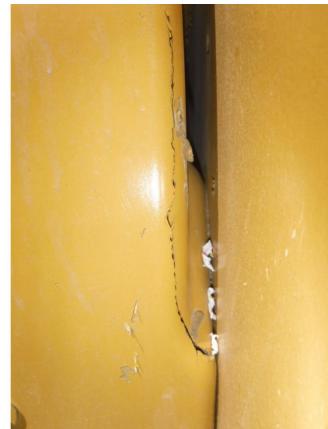
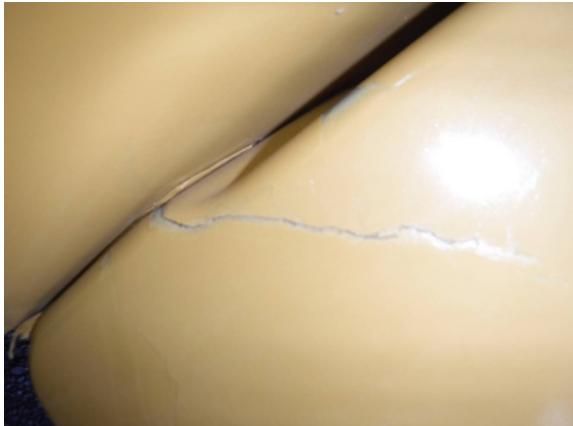
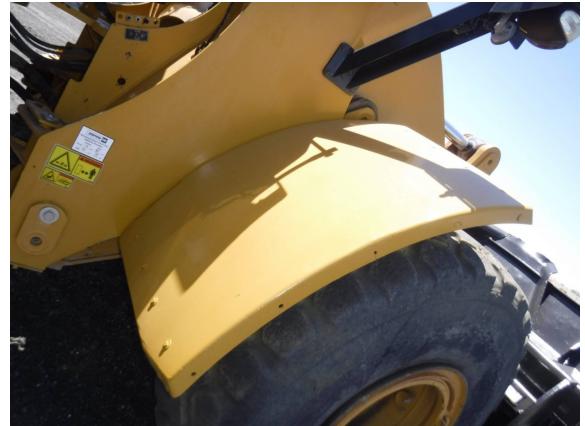
Fenders

Front fenders are cracked

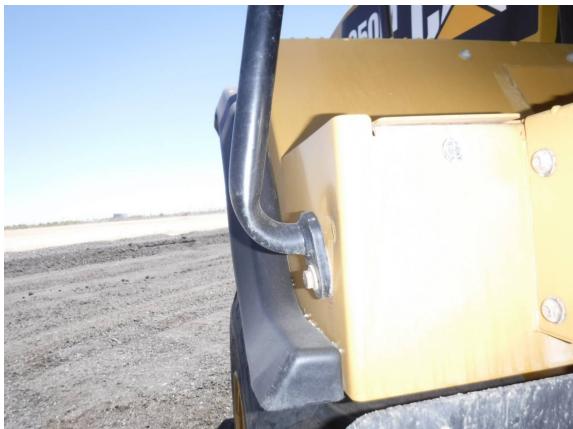
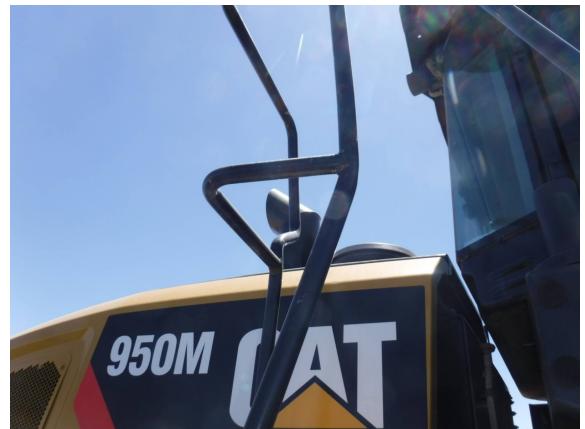
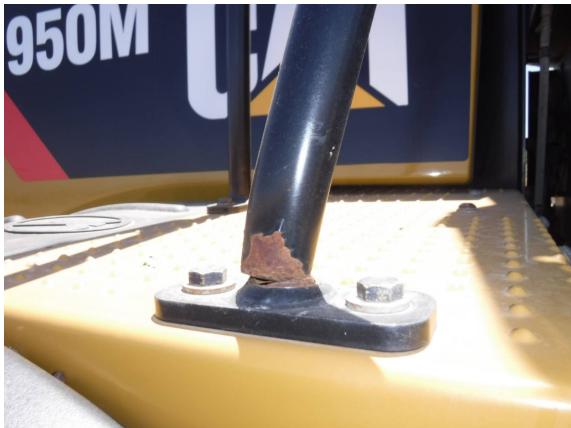
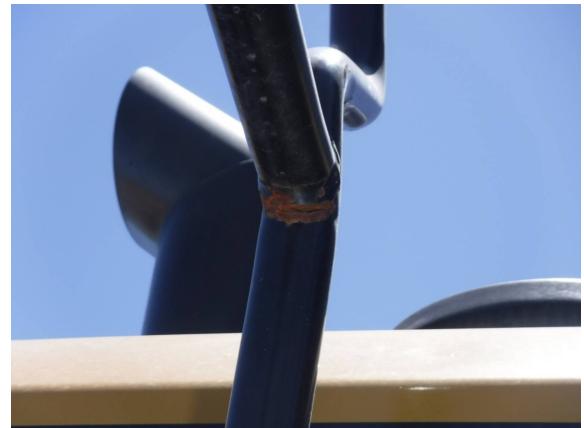
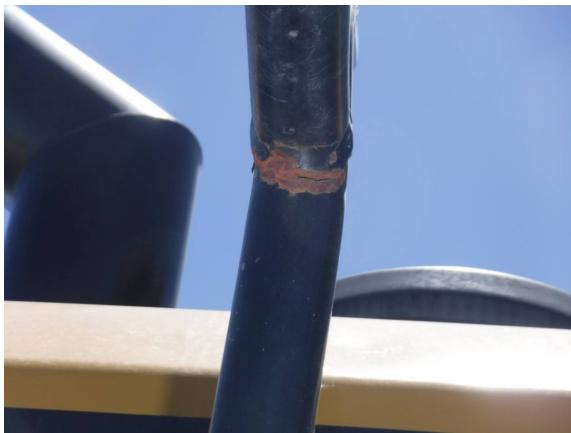
Grab Irons

Right rear hand holds are cracked and bent

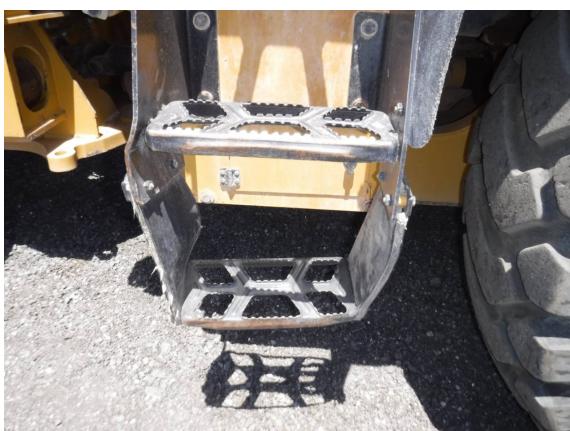
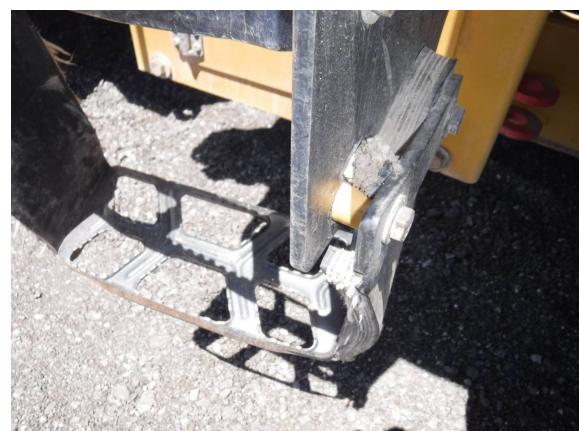
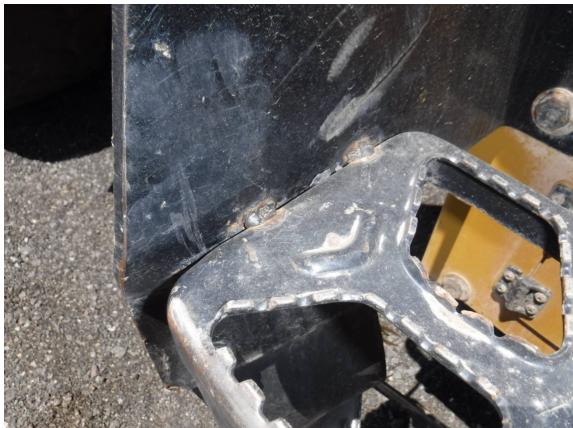
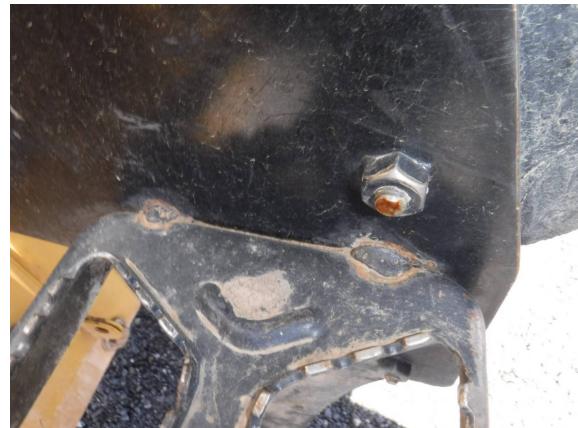
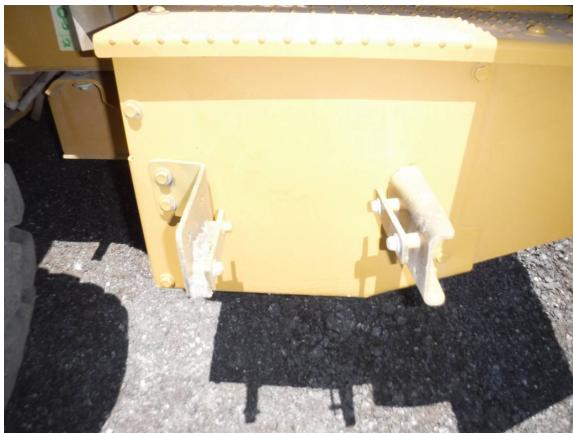
Steps / Ladder

Left side rear is missing belts and steps. Has bent brackets.

Left side cab entry belts damaged and has step welded in place

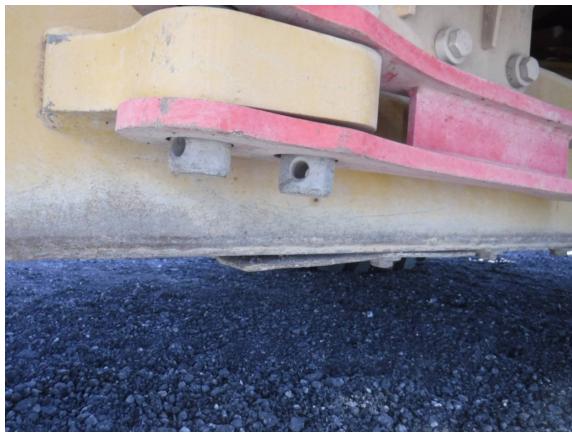
Safety Locks / Pins

Missing pin keepers on frame lock

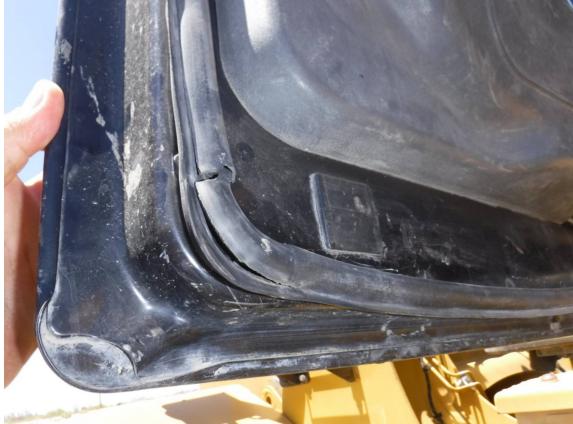
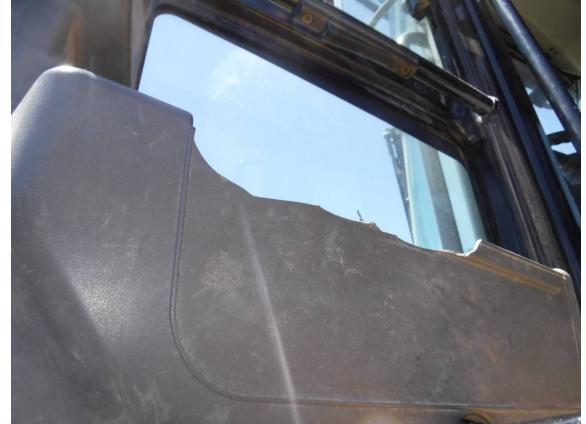
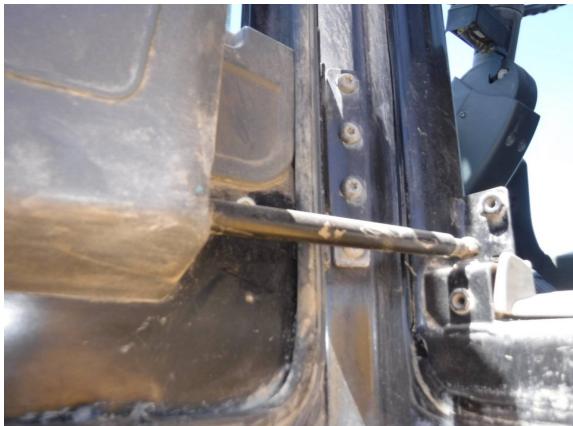
Door Latches / Hinges / Seals

Door strut is blown and seal is torn. Door pocket is cracked.(Door does not lock shut right) almost have to slam it to get it close

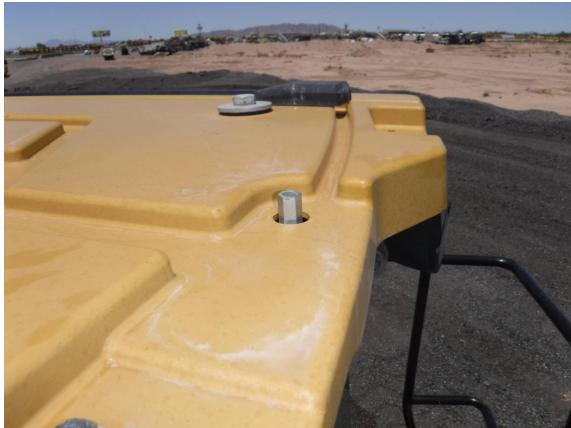
Radio

Missing antenna

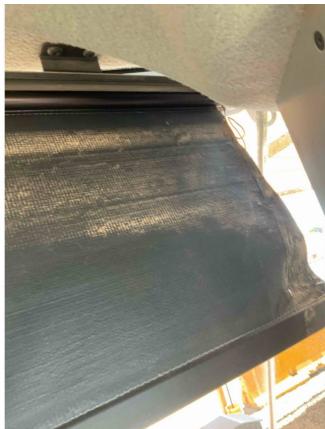
Visor / Sunshade

Damaged. Will not hold

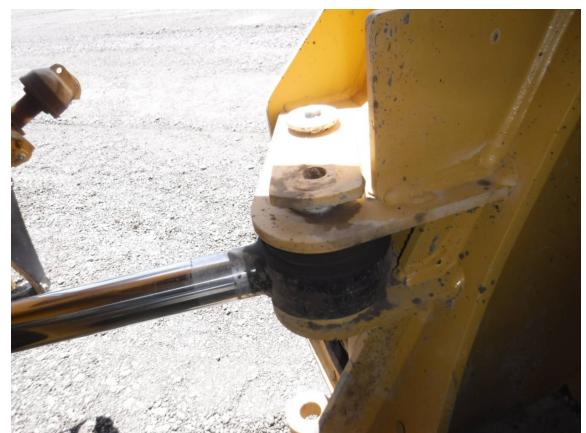
Steering Cylinder

Has movement at pins and bushings both cylinders rod and barrel ends

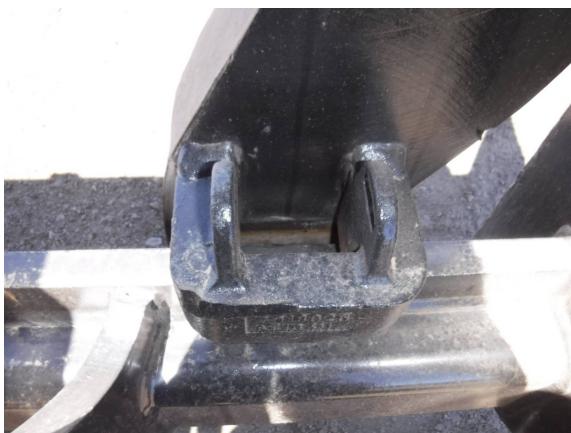
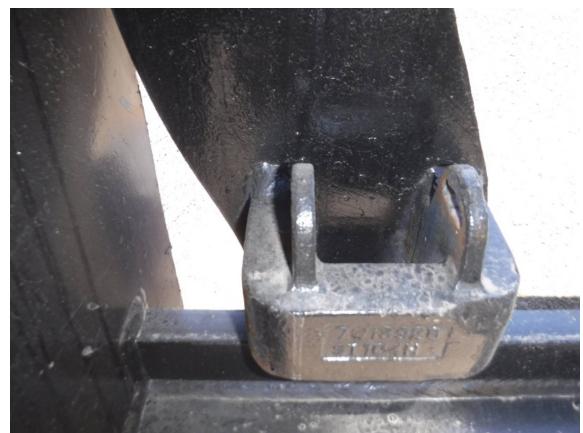
Operating Condition -
ATTACHMENTS / WORK TOOLS
●●
MISSING LOCKS

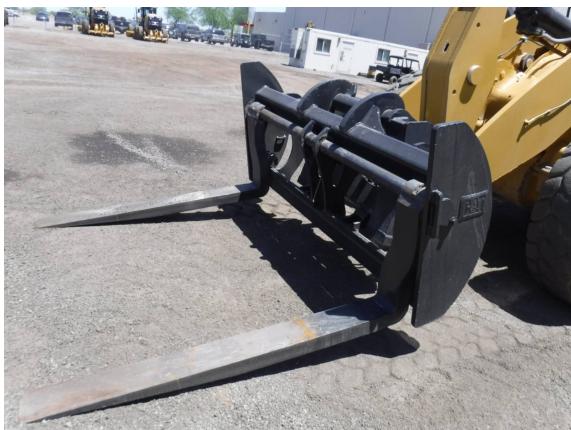
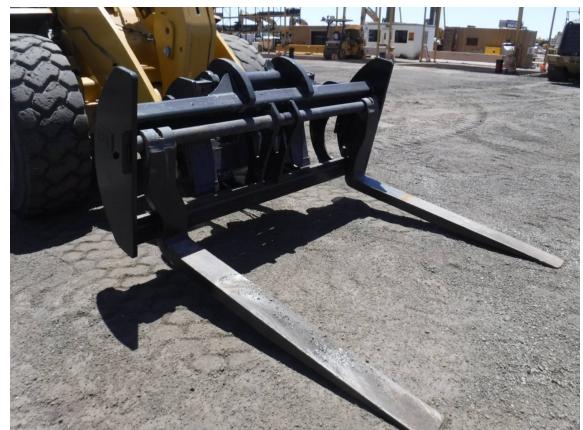
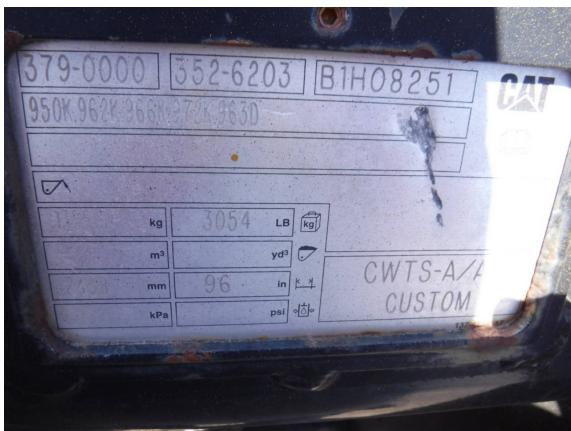
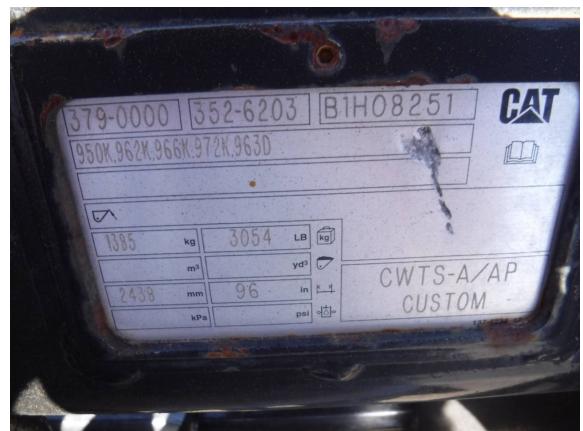
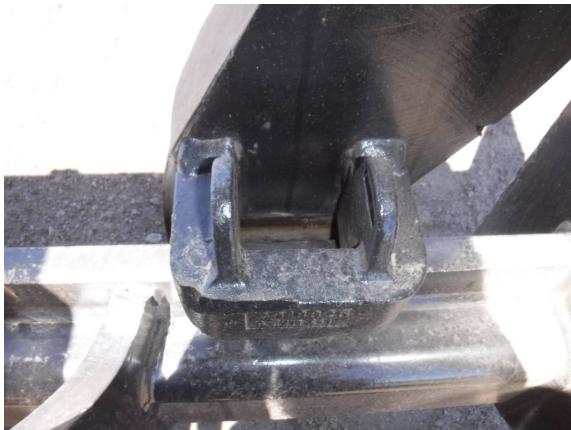
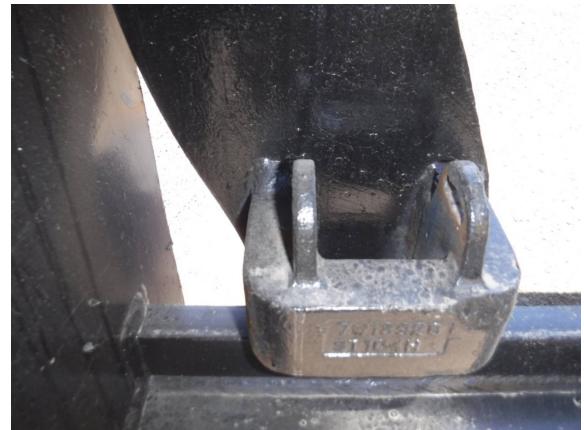
Forks

MISSING FORK LOCKS AND
HARDWARE

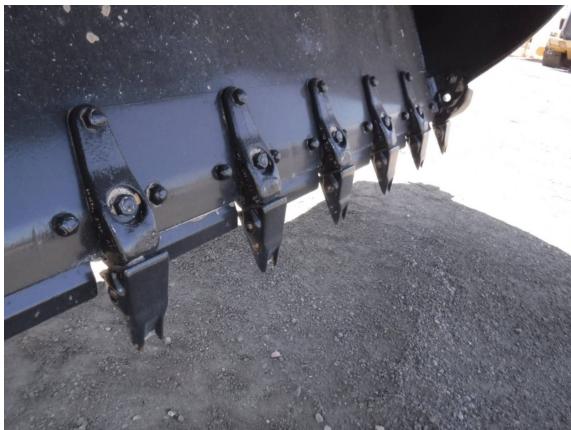
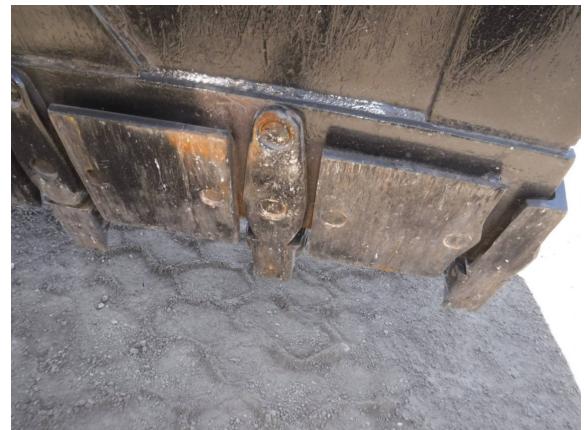
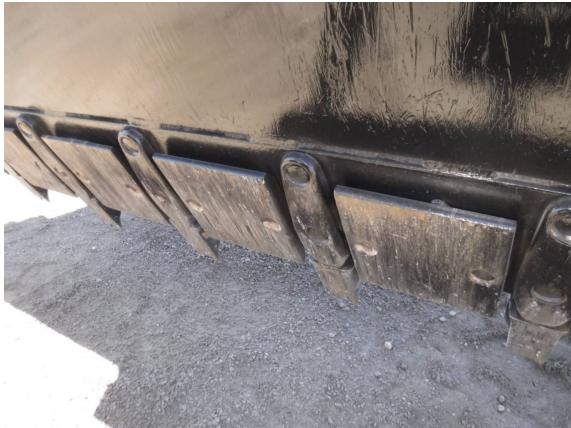
Segments
●●●
Worn

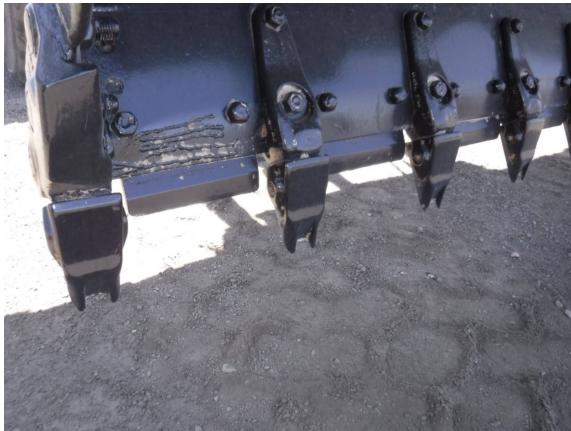
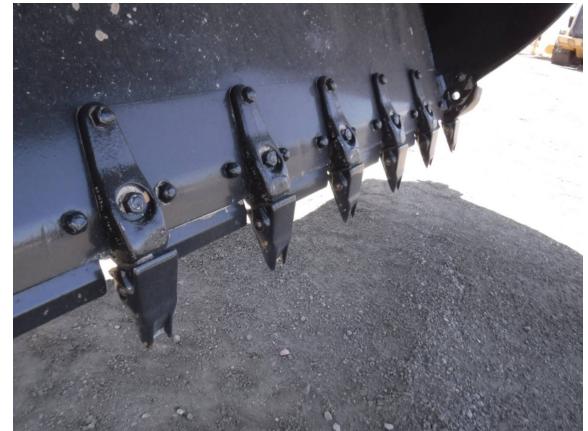
Teeth / Adapters

Worn
