2022 CAT 74504 ARTICULATED TRUCKS

INSPECTION DETAILS

Inspection Type	Trade
Inspection Form	Standard
Inspection #	10266466
Inspection Status	Completed
Created	01/27/26 13:46:02
Updated	02/03/26 09:03:32
Created By	Willis, Joseph
Inspector	Willis, Joseph
Reviewers	Willis, Joseph
Salesperson	Schultis, Derrick R.
Stock #	E196889
Serial #	3T603174
SMU / Hours	4,294
Location	Eloy, AZ, United States

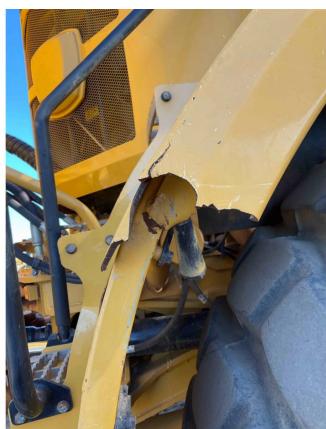
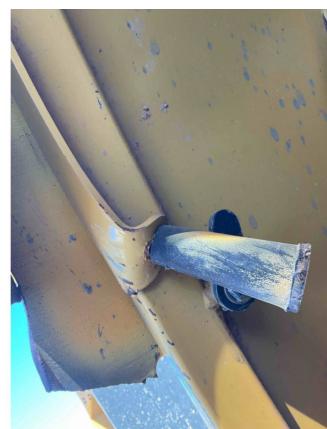
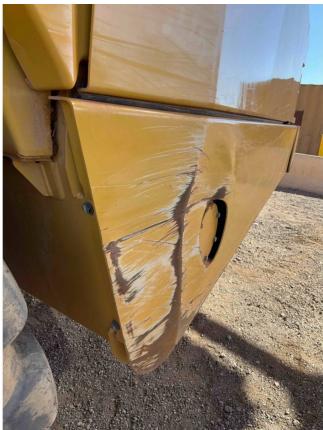
Fenders

Right front extension is cracked. Inner section has bent tab.

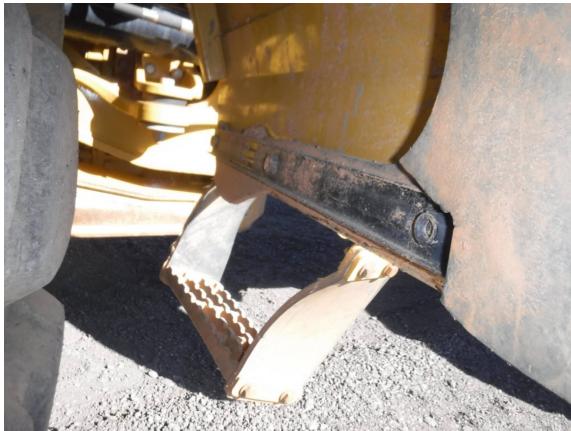
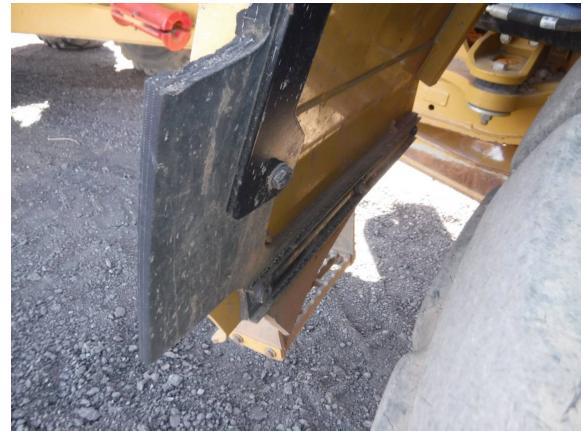
FRONT MUD FLAPS

●
Has been ripped off.

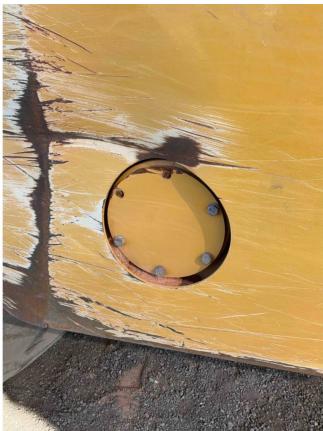
Fuel Tank

●●
Quick fuel adapter cover gas
broken bolts

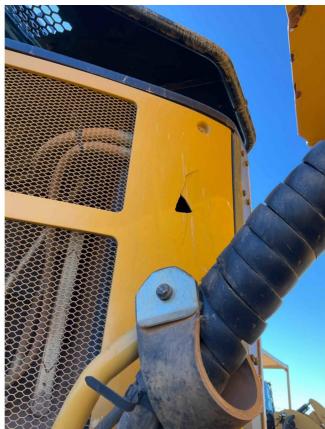
Radiator Grill

Left side is cracked

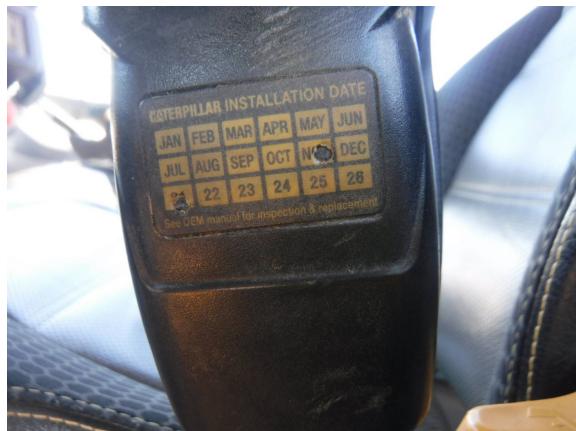
Seat Belt / Date Driver

NOVEMBER 2021 OUTDATED

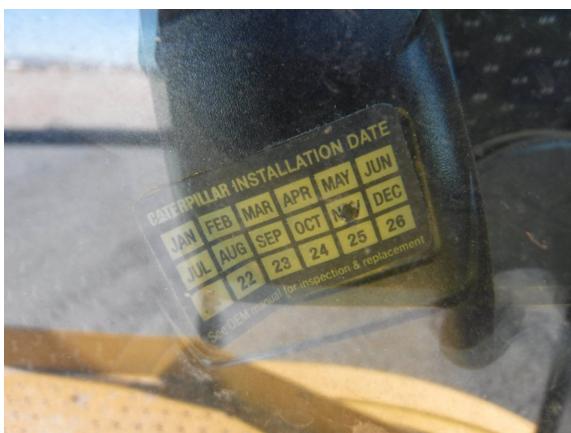
Seat Belt / Date Passenger

NOVEMBER 2021 OUTDATED

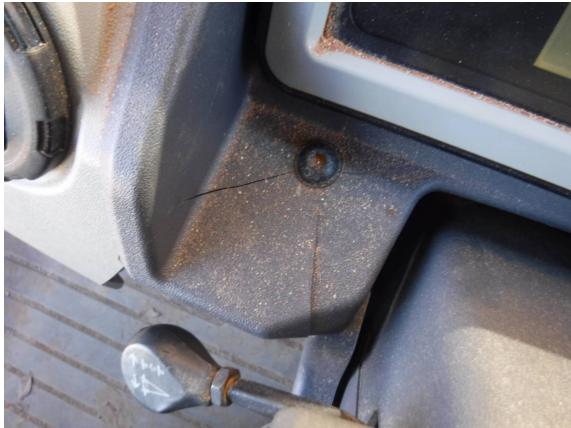
Dash Console

Cracked bezel at display

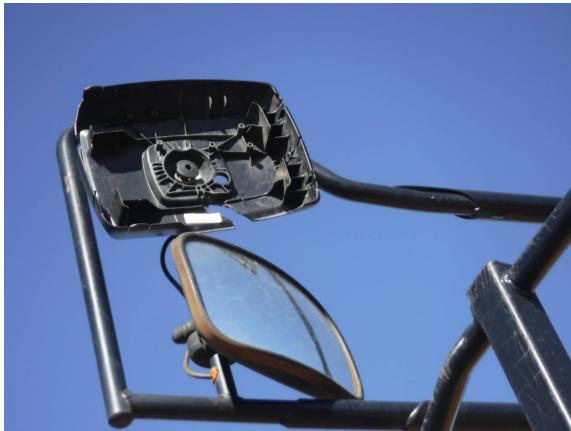
Mirrors

Left side has cracked mirror
missing hardware

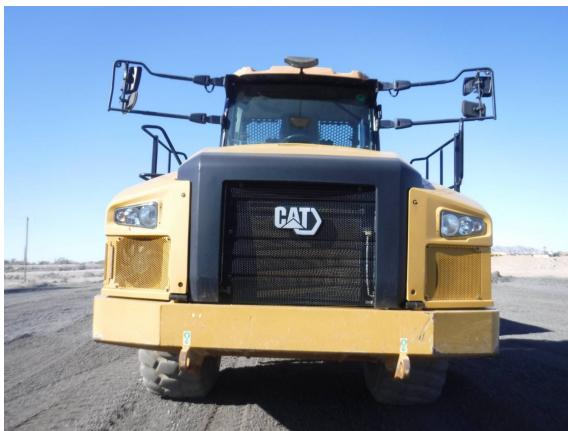
Windshield Wipers

Clogged. Pumps work will not spray. NEEDS HOSES.

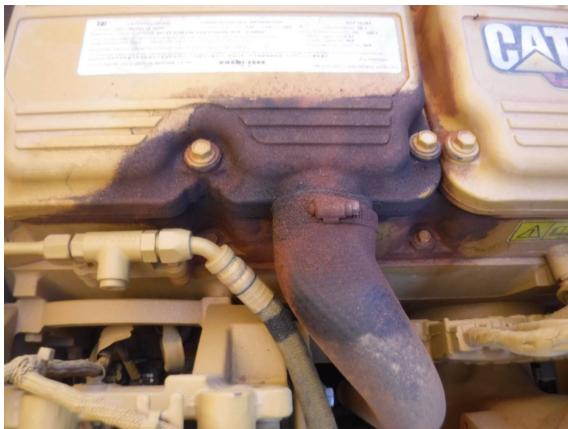
Notes - ENGINE

Has oil around breather hose.
Clamp is tight.

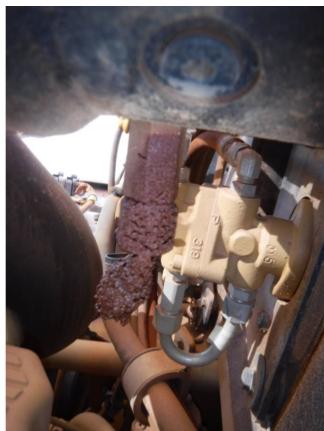
Hand Metering Unit

PILOT LINE TO HMU LEAKING.

Leaks at lower hose. Line is tight

QUOTED WITH HMU.

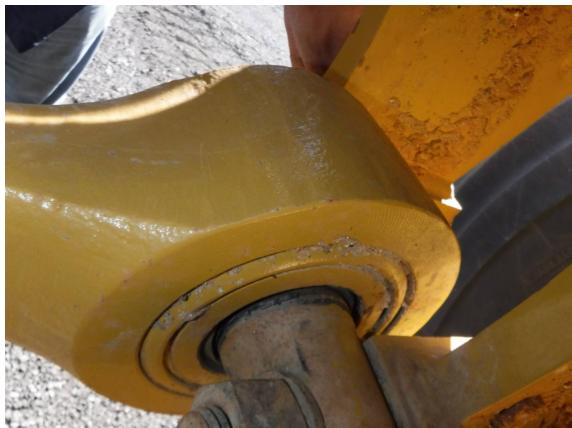
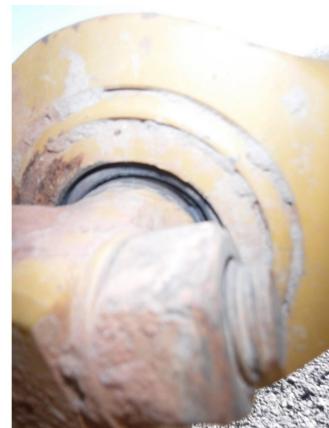
Center Torsion Bars

Both bushings are damaged and cracking on pan hard bar

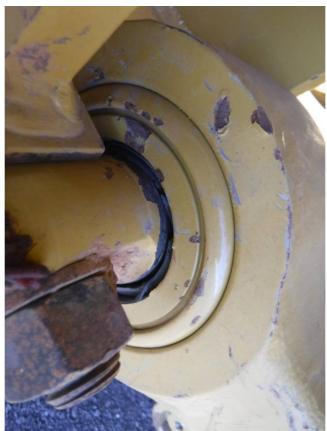
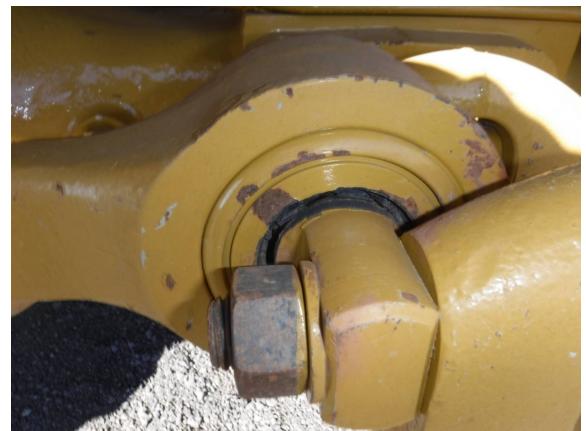
Front Torsion Bars

Both bushings are worn and cracking in pan hard bar

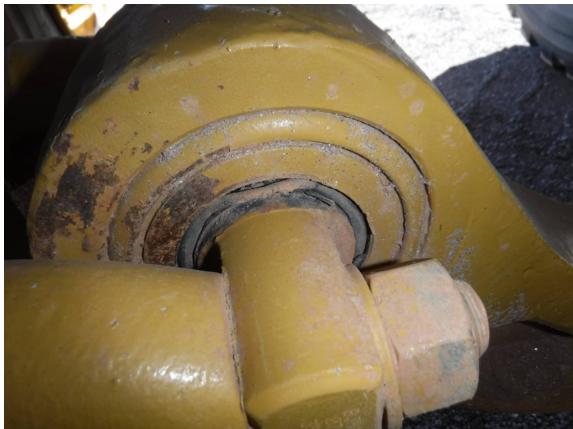
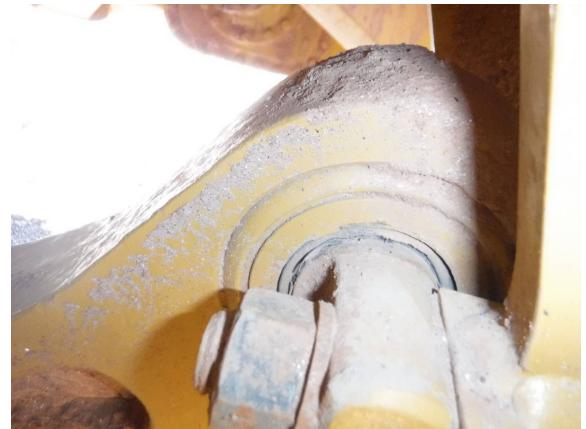
Rear Torsion Bars

Both bushings are dry and cracking on pan hard bar

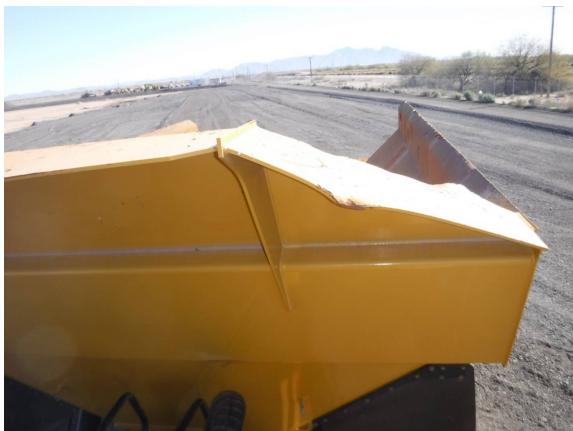
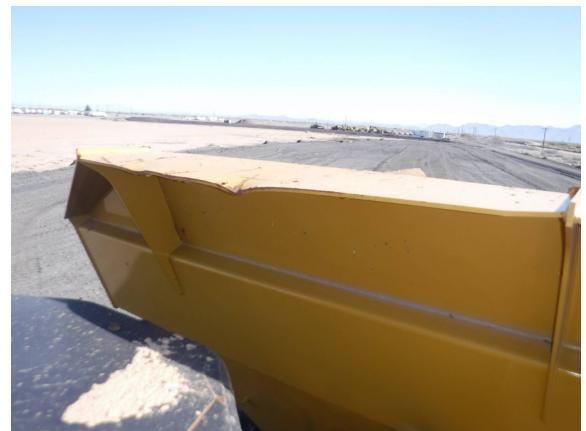
Spill Guard

Spill guard dented no tailgate

Dented center and left front

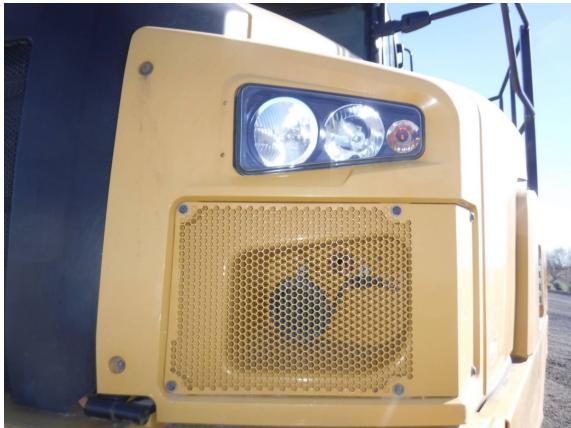
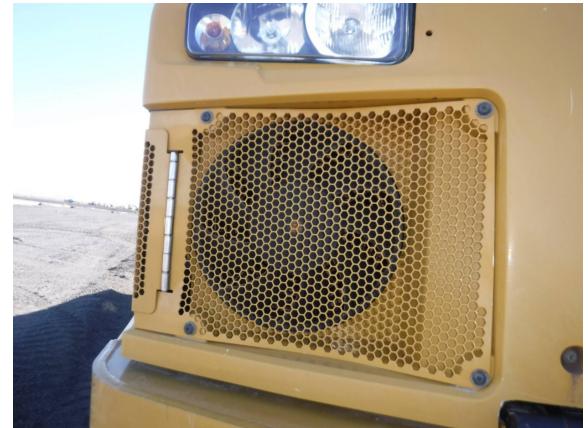
Notes - ELECTRICAL, STARTING AND CHARGING SYSTEM

Head light guards are dented.
Can be straightened
