CAT / Hensley Tooth Comparison

The following images show a study comparing the performance and wear of CAT J-400 PenTip with ARM vs. Hensley J-400 HD PenTip with TC Impregnation in a Quarry Aggregate Application. The tips were installed on the same machine and put to work. Images were taken along the way to document and compare pocket and profile wear. By 265 hours, the Hensley teeth showed significant wear, needing to be replaced. The CAT tips maintained the pocket and a sharper profile for the duration of the study to 590 hours.

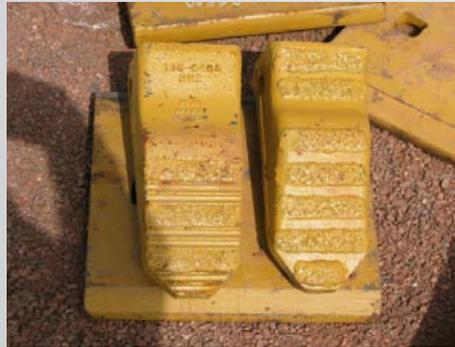
NEW

New tips were installed on a CAT 980 Wheel Loader.

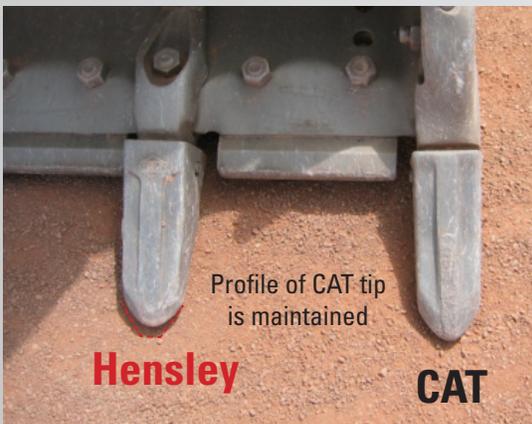
**CAT** **Hensley****50 HRS**

Profile of CAT tip is maintained

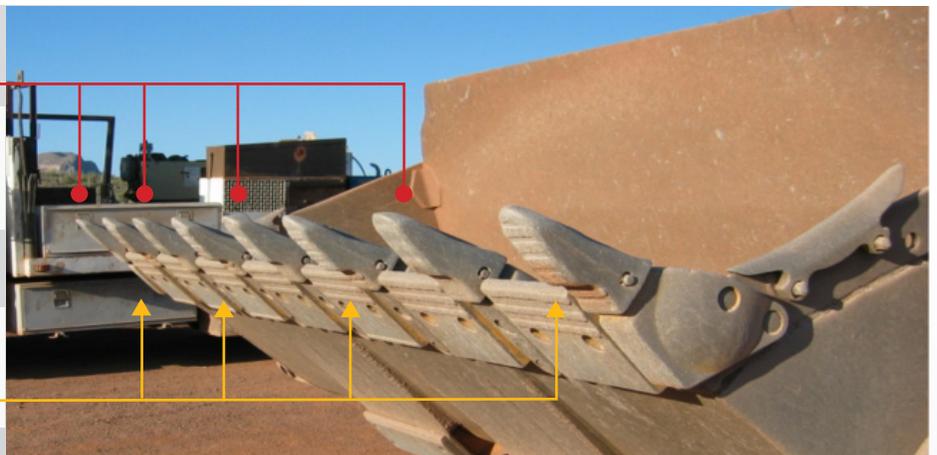
**112 HRS****Hensley**

Loss of penetration profile, TC Impregnation washed out, and pocket profile is visibly wearing

Pocket and penetration profile are maintained as well as longer ARM life

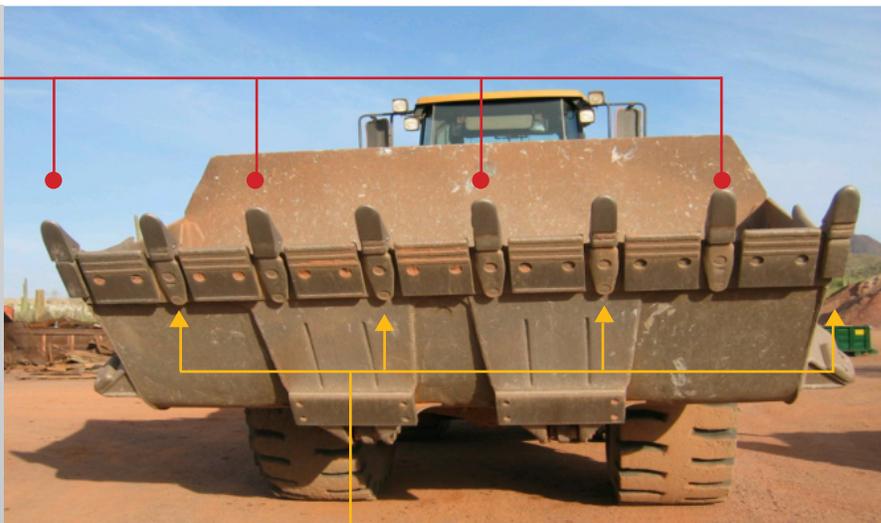
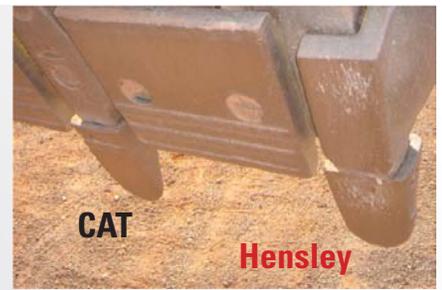
265 HRS

Hensley need to be replaced due to pocket wear.

CAT usable life remaining due to ARM protection on the Pocket and longer wear life with DH-3 steel.

Hensley Tip doesn't have enough pocket material to keep running – needs to be replaced

CAT Tip pocket is maintained and thick enough to keep running

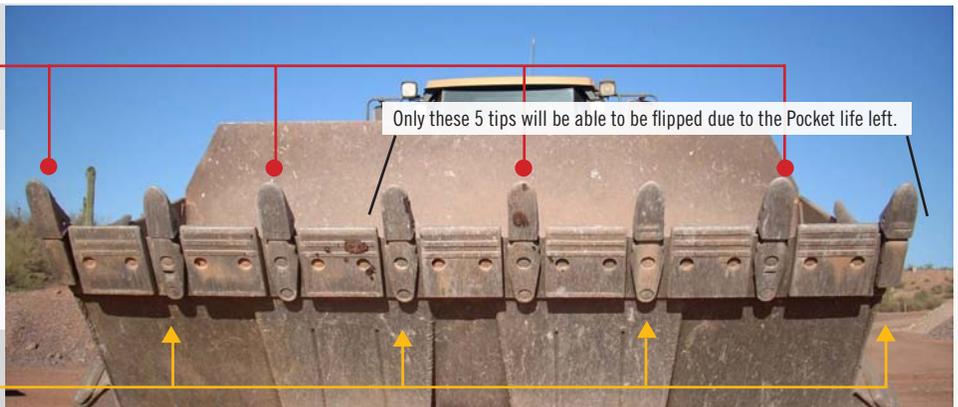
501 HRS

All Bucket tips Wearing from Left to Right but the Hensley end tip has been replaced. The CAT tip next to it is on its first Life

Only these 5 tips will be able to be flipped due to the Pocket life left.

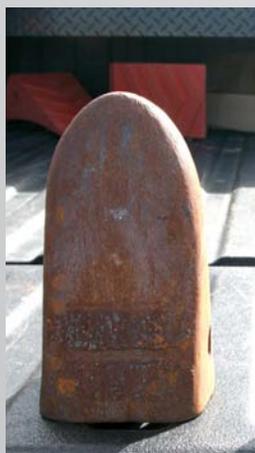
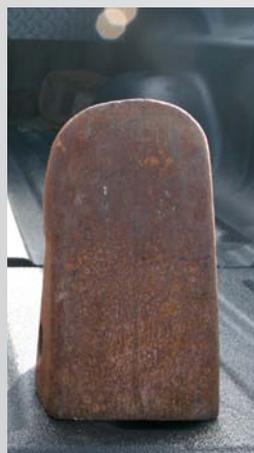
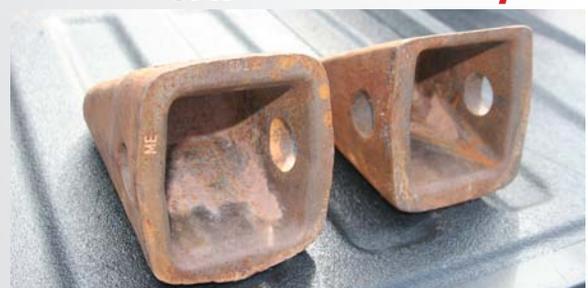
590 HRS

At 590 hours the tips were removed. The CAT tip has maintained profile better than Hensley tip. ARM remains on CAT tip, protecting the pocket from wearing out.
