2013 CAT
140M2
MOTOR GRADERS

INSPECTION DETAILS

Inspection Type	Consignment
Inspection Form	Standard
Inspection #	10199459
Inspection Status	Created
Created	04/29/25 16:47:08
Updated	04/29/25 18:44:35
Created By	Gabriel, James P.
Inspector	Gabriel, James P.
Transmission Serial #	ZBE00728
Engine Serial #	MYC04575
Serial #	M9D01627
SMU / Hours	6,835
Location	Queen Creek , AZ 85142, United States

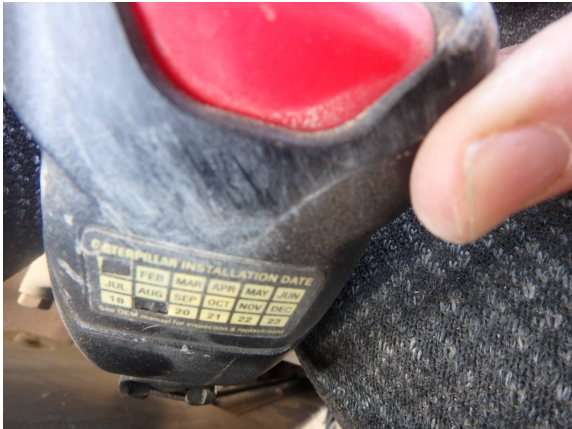
Seat Belt / Date

●
Seat belt date tag expired.

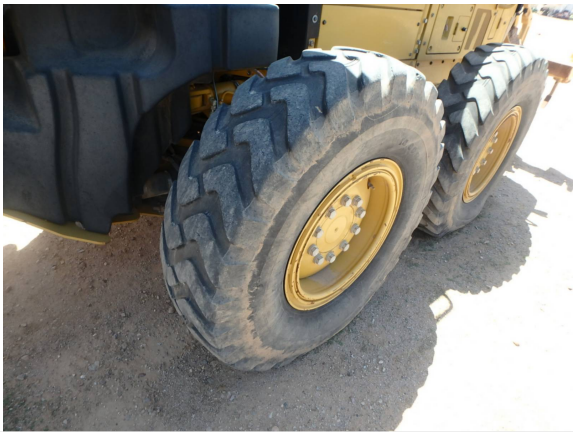
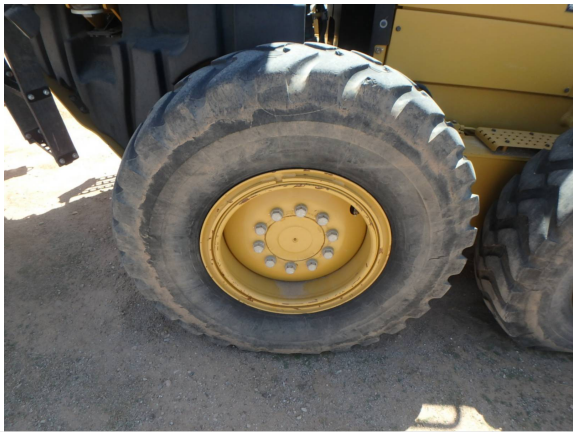
Make / Serial#	Tread Depth in 1/32"	% Life Remaining	Recapped	Tread Cuts/Chunks	Side Cuts Section
Left Center	Michelin	17	54.84	NO	NO	NO

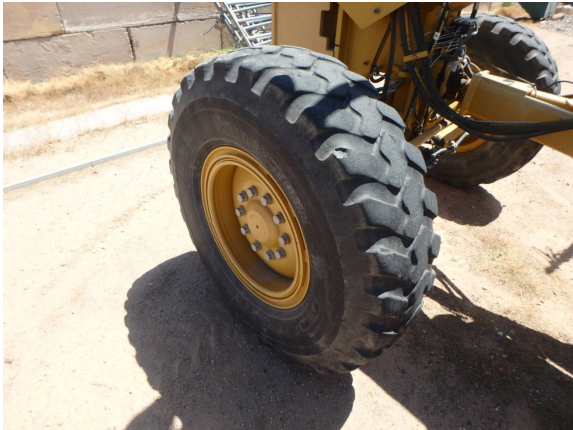
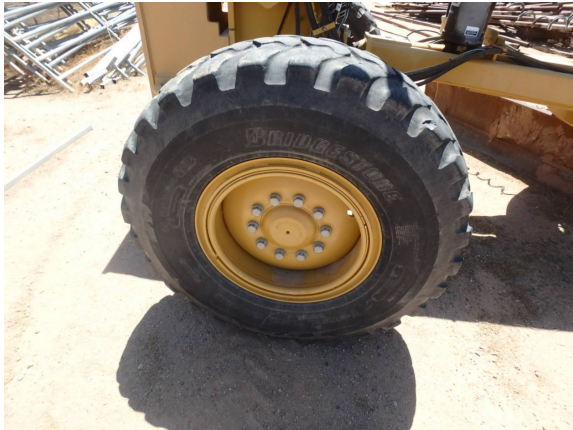
Make / Serial#	Tread Depth in 1/32"	% Life Remaining	Recapped	Tread Cuts/Chunks	Side Cuts Section
Left Front	Bridgestone	15	48.39	NO	YES	NO

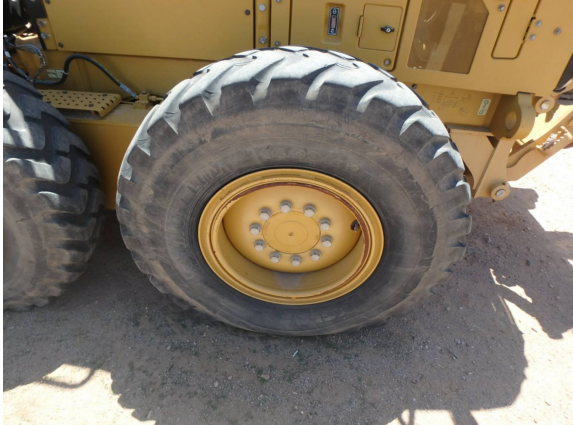
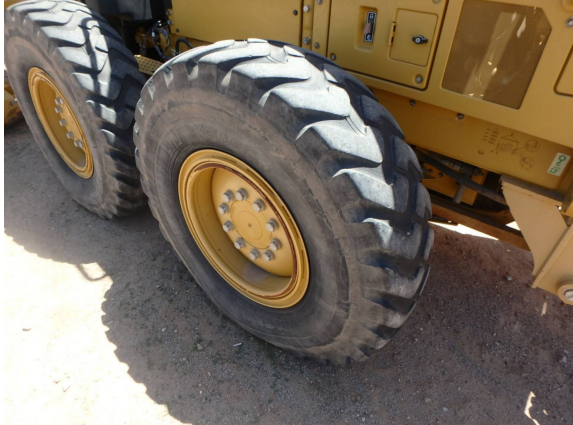
Make / Serial#	Tread Depth in 1/32"	% Life Remaining	Recapped	Tread Cuts/Chunks	Side Cuts Section
Left Rear	Michelin	13	41.94	NO	NO	NO

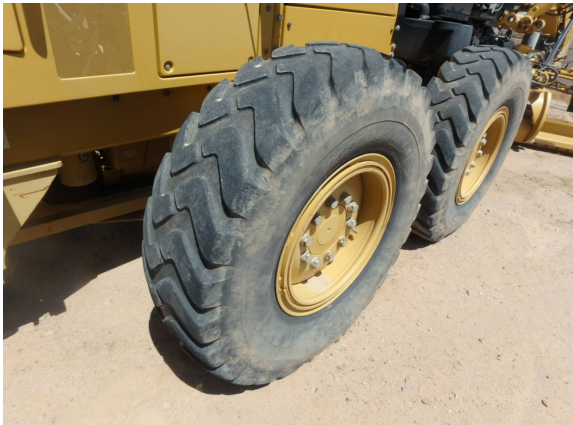
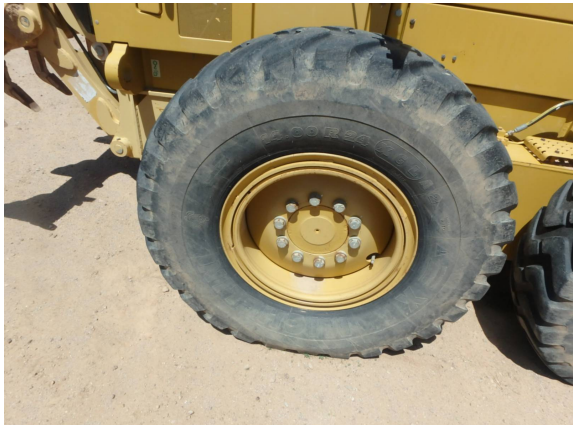
Make / Serial#	Tread Depth in 1/32"	% Life Remaining	Recapped	Tread Cuts/Chunks	Side Cuts Section
Right Center	Michelin	16	51.61	NO	NO	NO

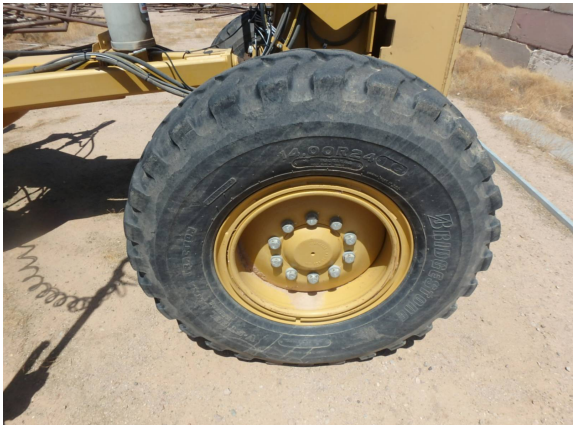
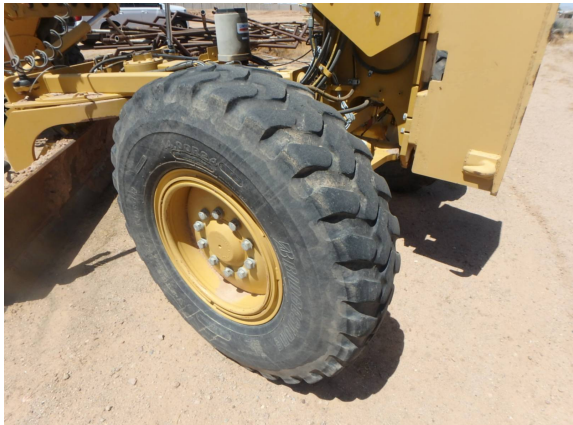
Make / Serial#	Tread Depth in 1/32"	% Life Remaining	Recapped	Tread Cuts/Chunks	Side Cuts Section
Right Front	Bridgestone	16	51.61	NO	NO	NO

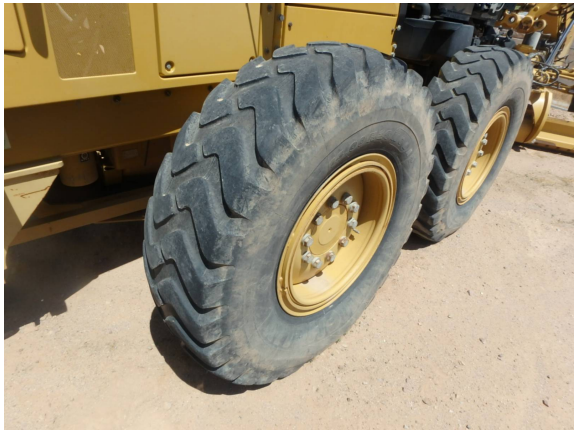
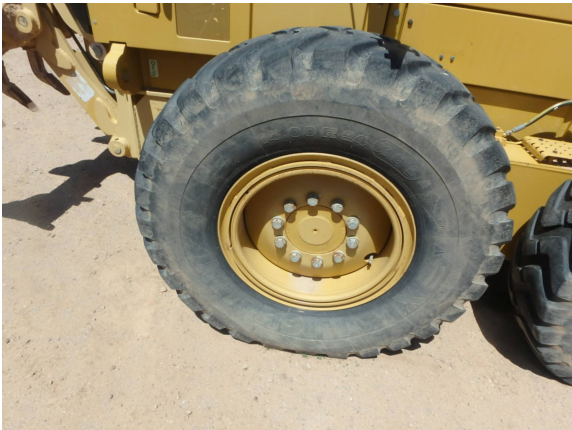
Make / Serial#	Tread Depth in 1/32"	% Life Remaining	Recapped	Tread Cuts/Chunks	Side Cuts Section
Right Rear	Michelin	15	48.39	NO	NO	NO
