2020 CAT
14013
MOTOR GRADERS

INSPECTION DETAILS

Inspection Type	Marketing
Inspection Form	Standard
Inspection #	10181517
Inspection Status	Completed
Created	02/11/25 16:36:59
Updated	03/06/25 11:21:26
Created By	Calderas, Marco
Inspector	Calderas, Marco
Reviewers	Calderas, Marco
Salesperson	Schultis, Derrick R.
Stock #	E201798
Serial #	N9400359
SMU / Hours	5,242
Location	Eloy, AZ 85131, United States

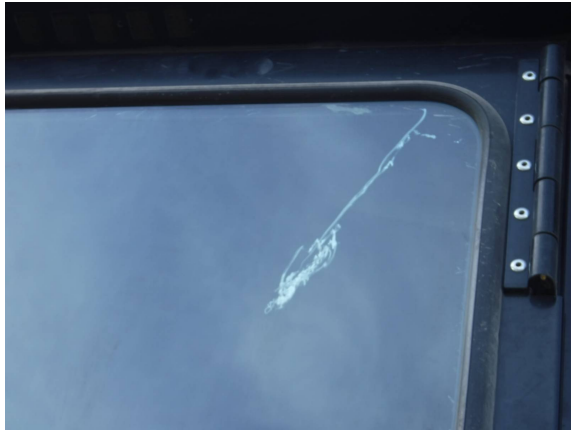
Air Conditioner ●●●	📷1 Armrests ●●●	Cab Filter / Heat Vent Louvres ●●●
Dash Console ●●●	Door Latches / Hinges / Seals ●●●	Floor Boards / Mats ●●●
Gauges ●●●	Headliner ●●●	Heater / Defroster ●●● 📷1
Hour Meter - GAUGES, OPERATION STATION, CONSOLE ●●●	Hydraulic Controls ●●●	Interior Lights ●●● 📷1
Interior Plastic / Fabric ●●●	Mirrors ●●●	Monitoring Display ●●●
Pans/Guards ●●●	Radio ●●●	Seat Cushions / Suspension / Type ●●●
Switches ●●●	Transmission Controls ●●●	Windows ●●● 📷1 Window tint on left cab door is scratched

Window tint on left cab door is scratched

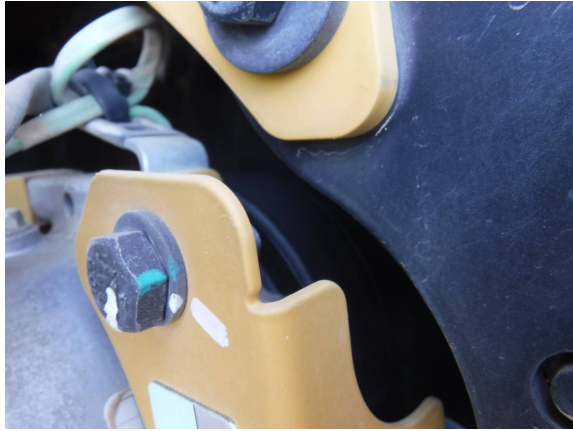
Belts / Pulleys - ENGINE

●●●

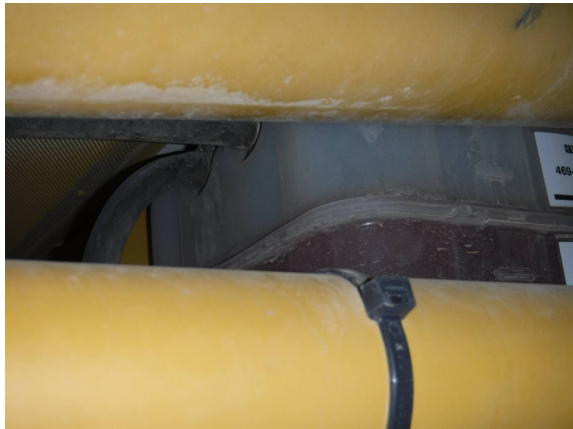
Anti-Freeze Level / Color / Condition

●●●

Red

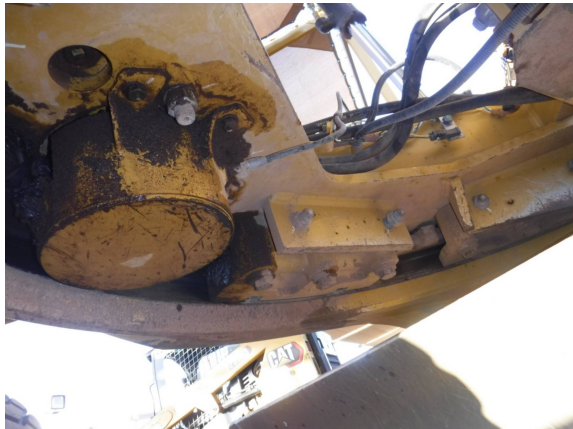
Circle Drive Box

●●●

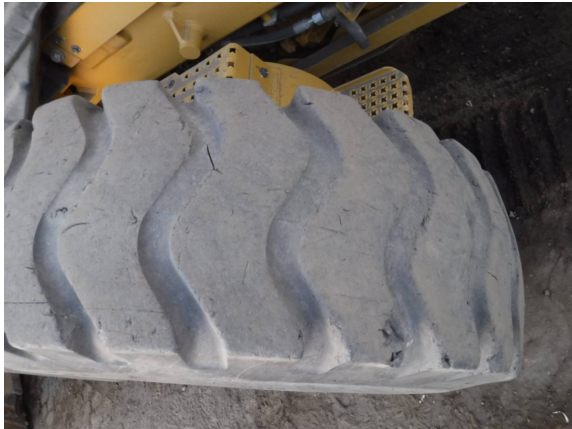
Make / Serial#	Tread Depth in 1/32"	% Life Remaining	Recapped	Tread Cuts/Chunks	Side Cuts Section
Left Rear	Maxum	16	48	NO	YES	YES

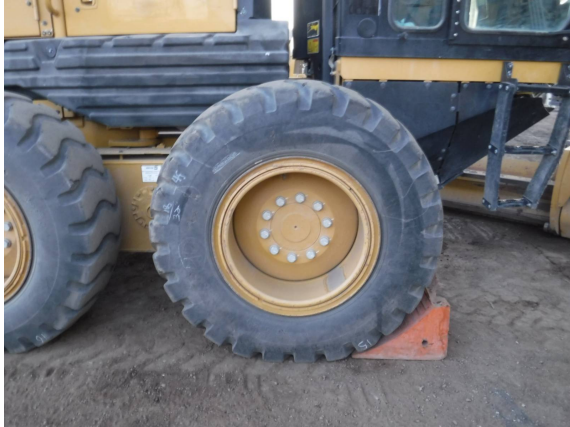
Make / Serial#	Tread Depth in 1/32"	% Life Remaining	Recapped	Tread Cuts/Chunks	Side Cuts Section
Right Center	Maxum	15	45	NO	YES	YES

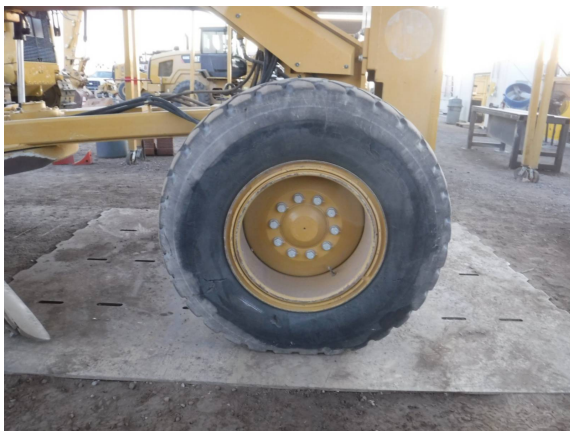
Make / Serial#	Tread Depth in 1/32"	% Life Remaining	Recapped	Tread Cuts/Chunks	Side Cuts Section
Right Front	Maxum	29	87	NO	YES	YES

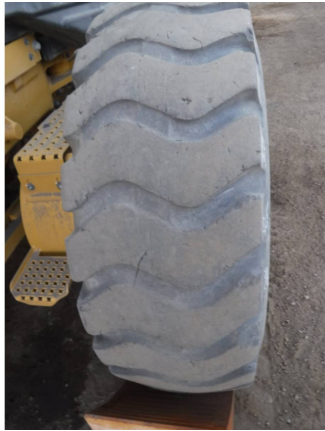
Make / Serial#	Tread Depth in 1/32"	% Life Remaining	Recapped	Tread Cuts/Chunks	Side Cuts Section
Right Rear	Maxum	16	48	NO	YES	YES
