2020 CAT 14015 MOTOR GRADERS

INSPECTION DETAILS

Inspection Type	Marketing
Inspection Form	Standard
Inspection #	10210754
Inspection Status	Completed
Created	06/19/25 18:19:38
Updated	07/07/25 10:22:20
Created By	Garcia, Jr
Inspector	Garcia, Jr
Reviewers	Calderas, Marco
Salesperson	Schultis, Derrick R.
Stock #	E205360
Serial #	EB200214
SMU / Hours	7,518
Location	Eloy, AZ, United States

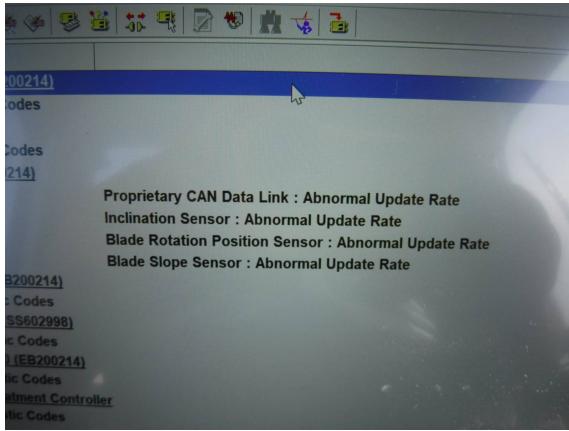
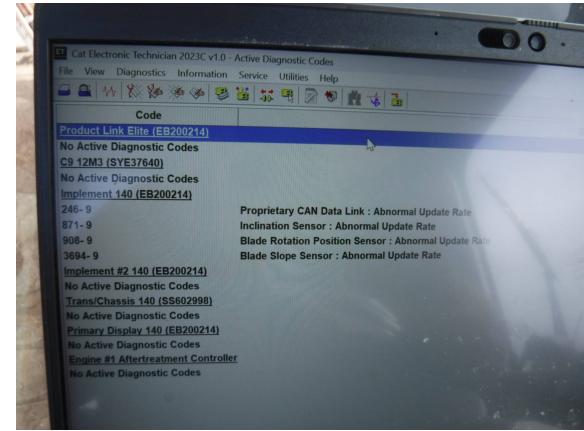
Logged / Active Codes

YES

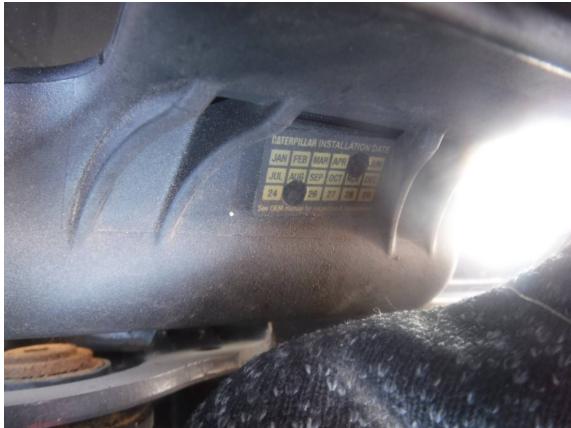
Seat Belt / Date

May 2025

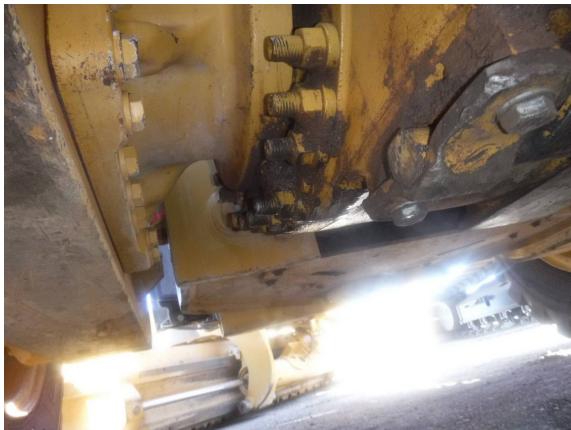
Cylinder Mounts / Pins

Has movement

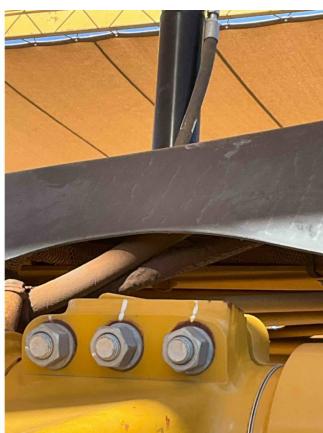
Hydraulic Lines / Fittings

Has wet lines under front cover.

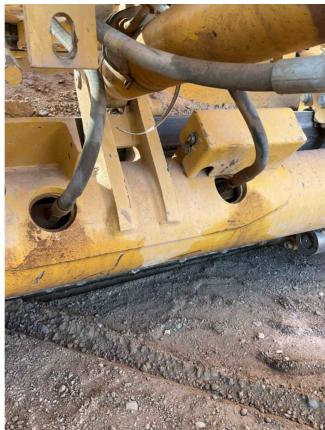
Side Shift Cylinder

Has oil residue at hoses.

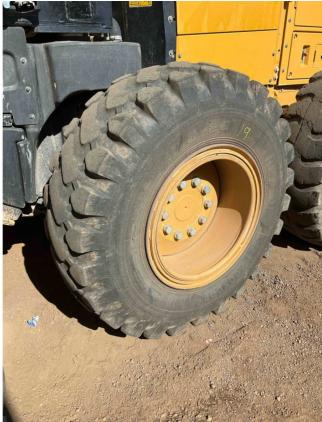
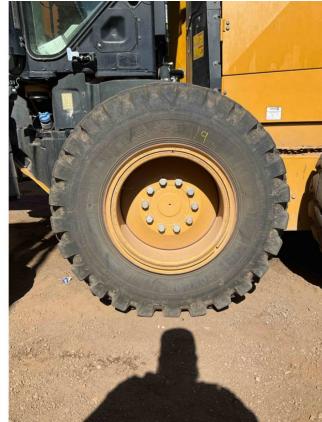
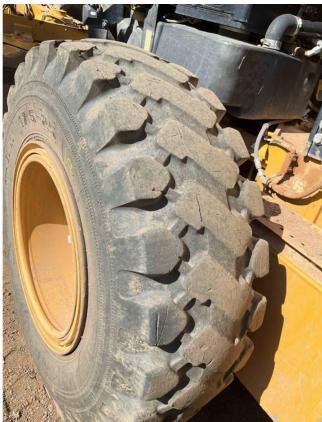
Make / Serial#	Tread Depth in 1/32"	% Life Remaining	Recapped	Tread Cuts/Chunks	Side Cuts Section
Left Center	Condor	19	54	NO	YES

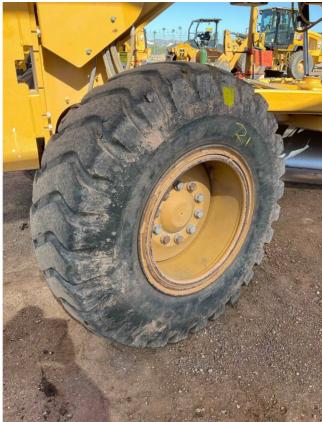
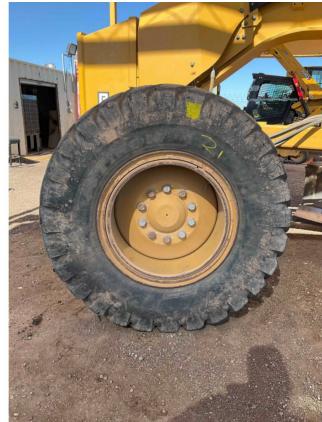
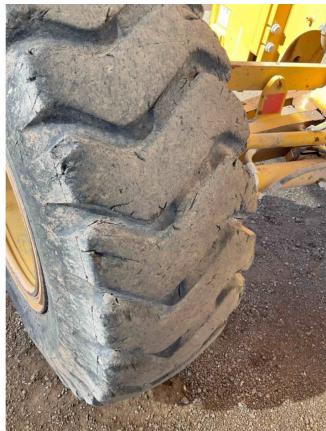
Make / Serial#	Tread Depth in 1/32"	% Life Remaining	Recapped	Tread Cuts/Chunks	Side Cuts Section
Left Front	Tiron	21	52	NO	YES

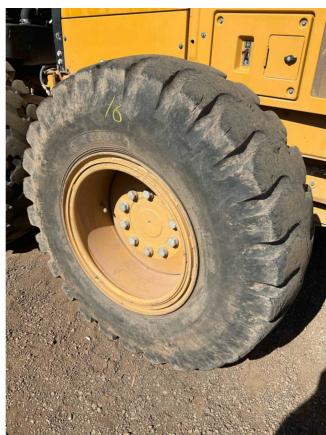
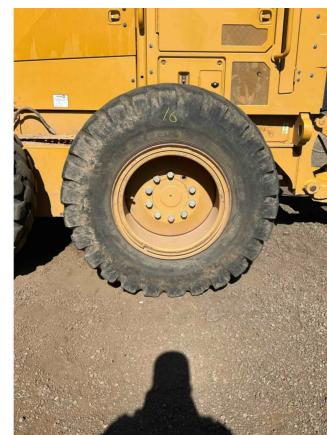
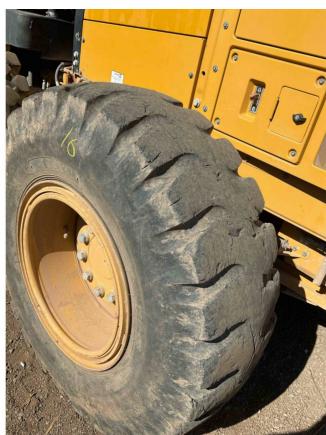
Make / Serial#	Tread Depth in 1/32"	% Life Remaining	Recapped	Tread Cuts/Chunks	Side Cuts Section
Left Rear	Ceat	16	47	NO	YES

Left rear missing lug bolt

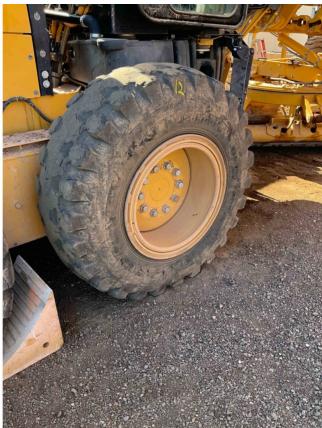
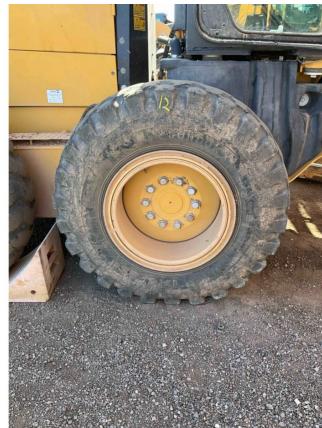
Make / Serial#	Tread Depth in 1/32"	% Life Remaining	Recapped	Tread Cuts/Chunks	Side Cuts Section
Right Center	Condor	12	18	NO	YES

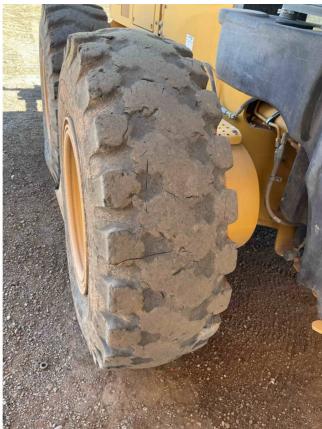
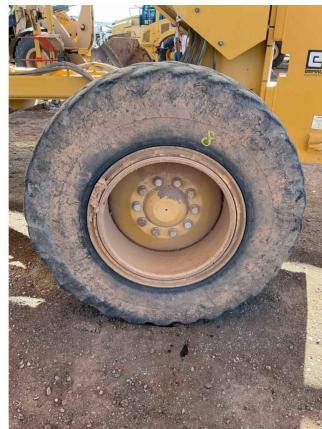
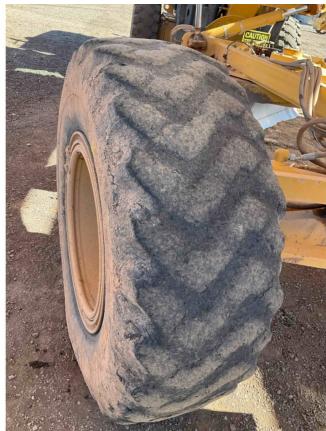
Make / Serial#	Tread Depth in 1/32"	% Life Remaining	Recapped	Tread Cuts/Chunks	Side Cuts Section
Right Front	Michelin	8	14	NO	YES

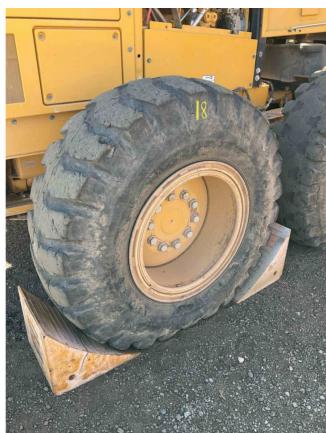
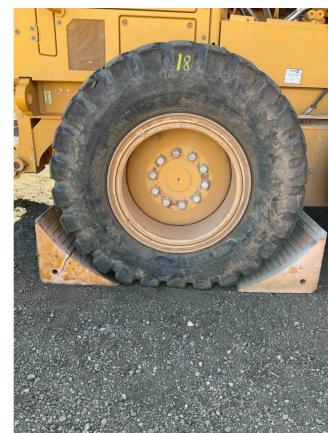
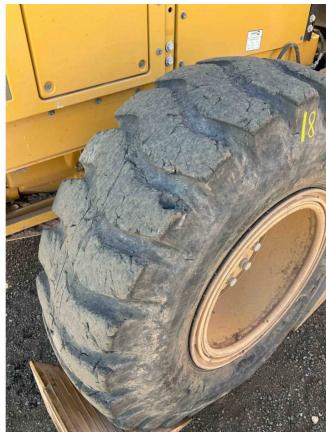
Make / Serial#	Tread Depth in 1/32"	% Life Remaining	Recapped	Tread Cuts/Chunks	Side Cuts Section
Right Rear Ceat	18	51	NO	YES	YES
