Water Wagon Inspection Report

Inspection Date: 4/30/2025

MACHINE DETAILS					
Manufacturer: AA		Model: 613C WW		S/N: 08LJ01391	
Year: 1996		Eng S/N: 98Z16181		Trans S/N: 9KE01129	
SMU/Hrs: 24461		Hours Date: 4/30/2025			
Last Schedule:		Last CTS:		Last PM:	
Date Oil Sample Sent to Lab: 5/2/2025		Oil Sample: ENG TRANS			
Recommendations:					
CONFIGURATION					
ECM Download:		ROPS:	Enclosed	Product Link:	Inquire for options on
Air Conditioning:	Yes	Retarder:	Yes	Cushion Hitch:	No
Transmission Guard:	Yes	Product Link:	No	Engine Tier Rating:	
Tire Size:	23.5-25	Tank Capacity:	5000 GAL.	Front Spray System:	No
Rear Spray System:	Yes	Side Spray System:	Yes	Hose Reel:	Yes
Water Cannon:	Yes	Comment:		Comment:	
GENERAL APPEARANCE					
	CODE	REMARKS			
Radiator Grill	Good				
Shroud	Good				
Engine Enclosure	Good				
Hood / Stack	Good				
Fenders	Fair	FENDERS HAVE DENTS, NO REPAIRS.			
Fuel Tank	Good				
Crankcase Guard	Fair	BELLY PAN HAS BEEN HIT AND DISFIGURED, MISSING HARDWARE.

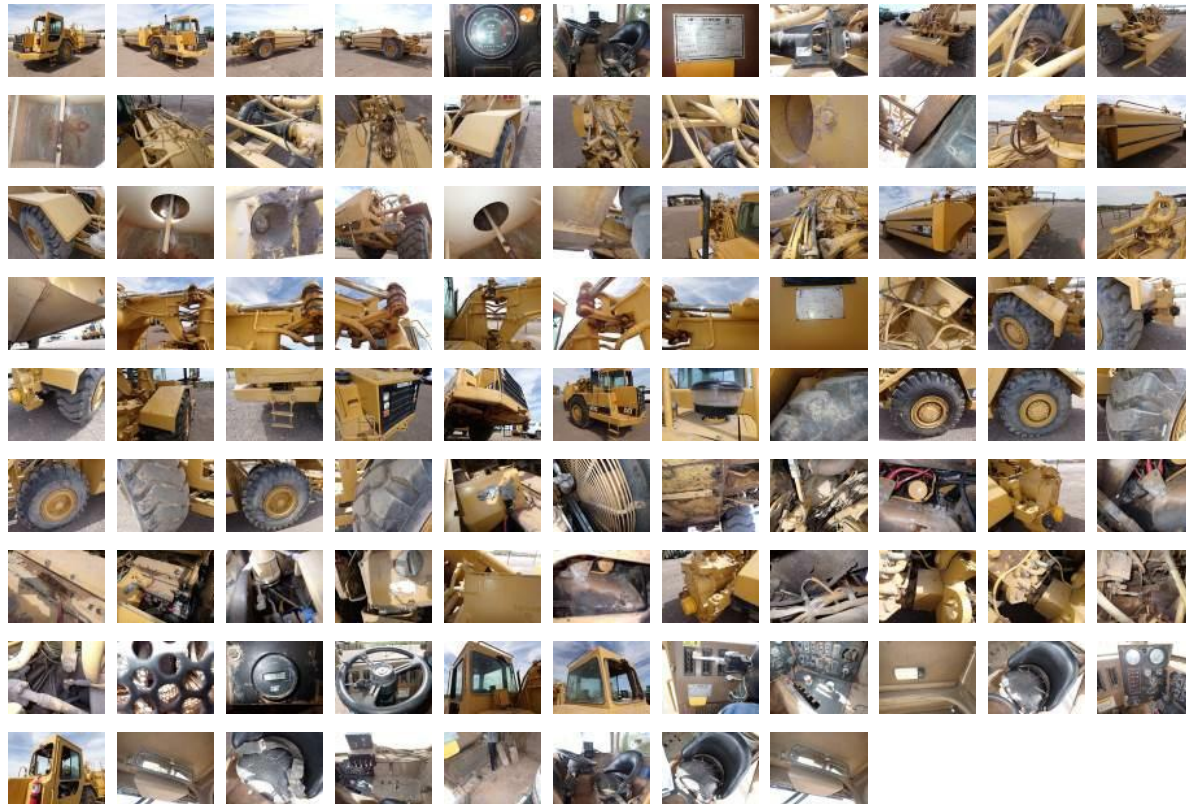
SERVICE		
	CODE	REMARKS
Service Needed	250 HR	NEEDS 250 HOUR SERVICE.
GENERAL REPAIRS AND REMARKS		
Repairs Needed: WATER MONITOR INOPERABLE AND DRIVE MOTOR LEAK, STEERING VALVE BODY AND IMPLEMENT PUMP LEAK, WATER PUMP LEAK, COOLANT LEAKS, ENGINE LEAK FROM VALVE COVER AND STARTER SHAFT SEAL, BELLY PANELS BENT AND SOME HARDWARE MISSING, AIR SUSPENSION SEAT INOPERABLE, CONSOLE DAMAGED, CONTROLS STIFF, WIRING DAMAGED, CAB FLOOR RUSTED AND FLOORMAT MISSING, SEAT BOTTOM CUSHION, SWITCHES, FRONT FENDER MUD GUARDS MISSING, LIGHTS INOPERABLE, PM1.		
General comments: MACHINE IN FAIR CONDITION WITH MULTIPLE REPAIRS NEEDED. TRANSMISSION SHIFTED FINE. ENGINE SEEMED TO BE IN GOOD RUNNING CONDITION. THERE WAS GLASS WINDOWS MISSING BUT CLIENT HAD A GLASS GUY GOING OUT THAT DAY TO REPLACE THE MISSING ONES.
