2022 CAT 74504 ARTICULATED TRUCKS

INSPECTION DETAILS

Inspection Type	Trade
Inspection Form	Standard
Inspection #	10266466
Inspection Status	Completed
Created	01/27/26 13:46:02
Updated	02/03/26 09:03:32
Created By	Willis, Joseph
Inspector	Willis, Joseph
Reviewers	Willis, Joseph
Salesperson	Schultis, Derrick R.
Stock #	E196889
Serial #	3T603174
SMU / Hours	4,294
Location	Eloy, AZ, United States

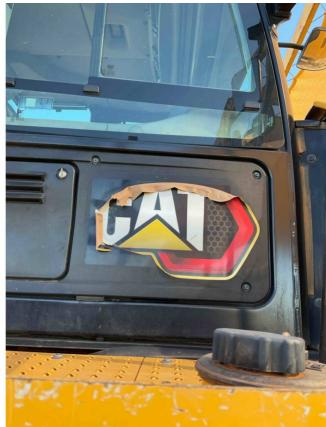
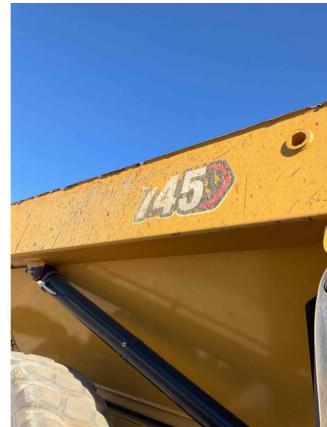
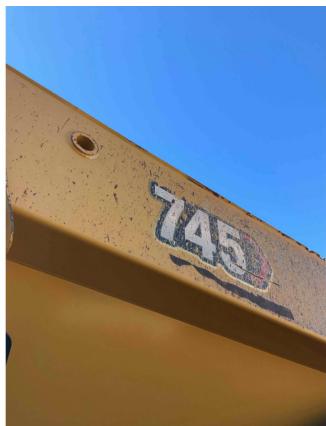
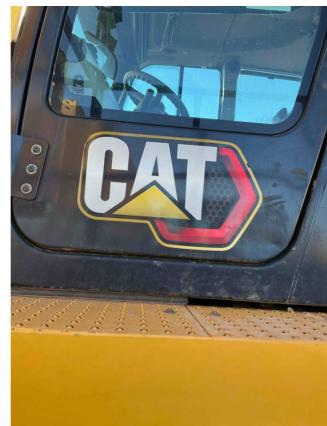
Decals

Peeling and scratched

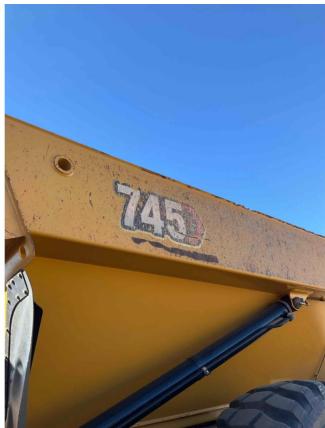
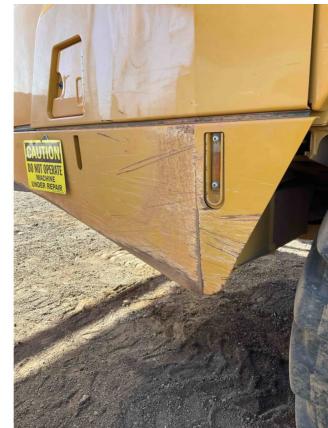
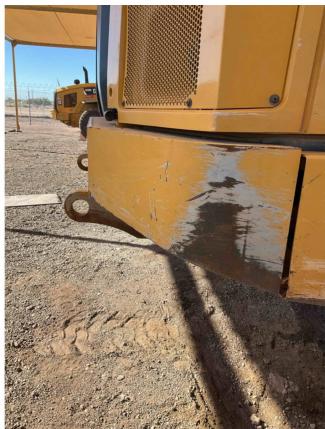
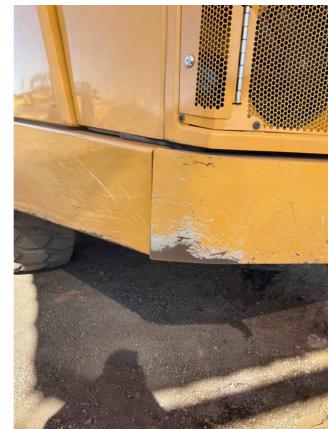
Slight fade and scratches

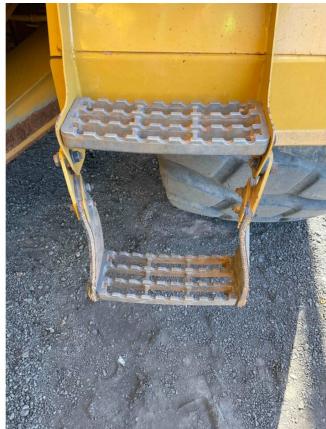
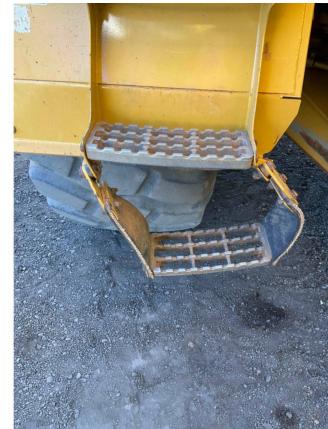
Steps / Ladder

Both sides had bent hanger brackets. Can be straightened

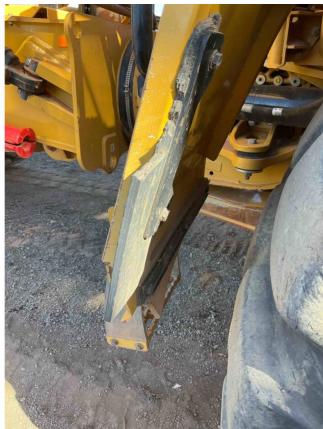
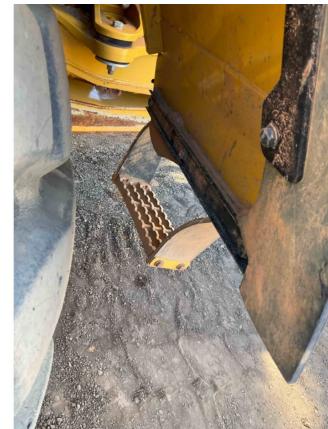
Notes - GENERAL APPEARANCE

Front mud flaps on tractor are ripped off

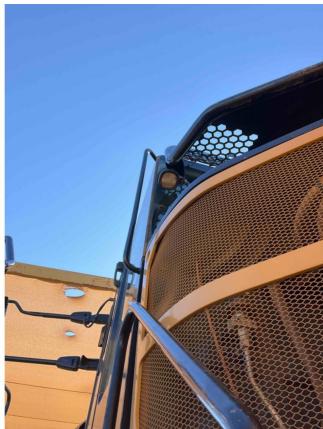
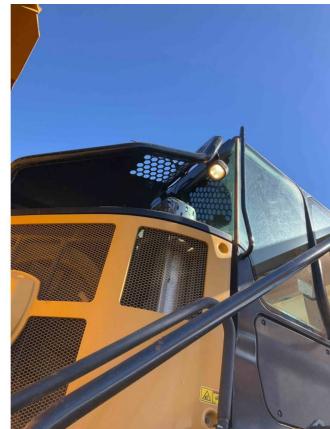
Work Lights

Left rear cab entry light is inop

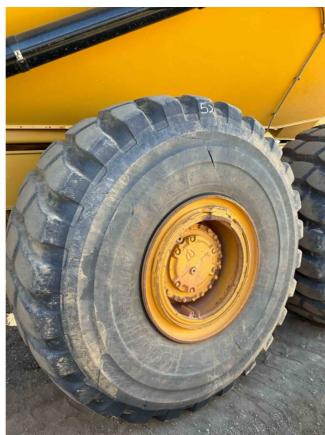
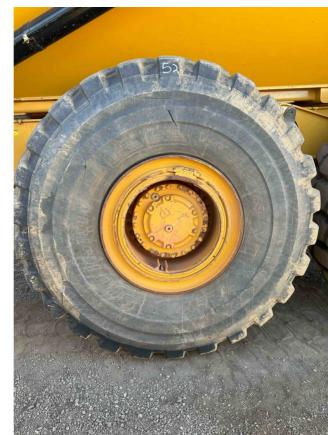
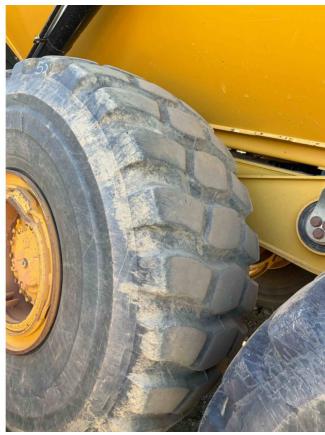
Make / Serial#	Tread Depth in 1/32"	% Life Remaining	Recapped	Tread Cuts/Chunks	Side Cuts Section
Left Center	Bridgestone	52	84	NO	YES

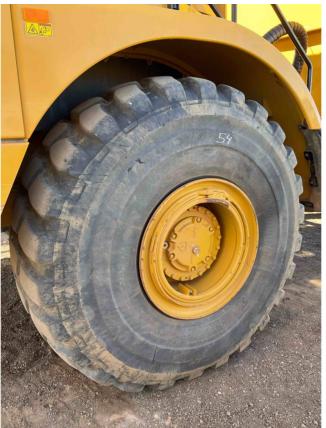
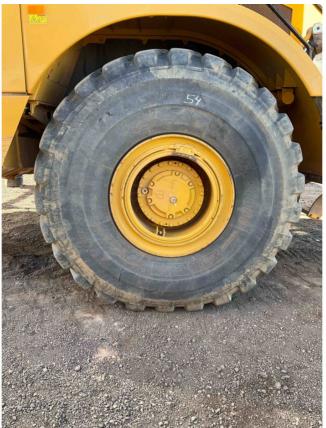
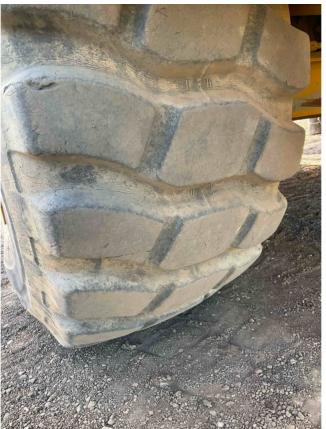
Make / Serial#	Tread Depth in 1/32"	% Life Remaining	Recapped	Tread Cuts/Chunks	Side Cuts Section
Left Front	Bridgestone	54	86	NO	YES

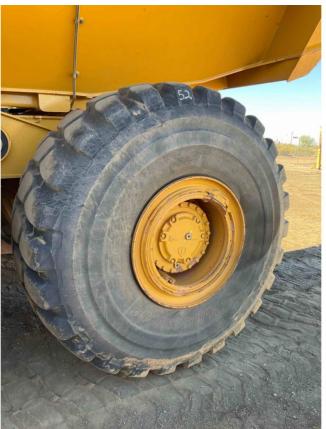
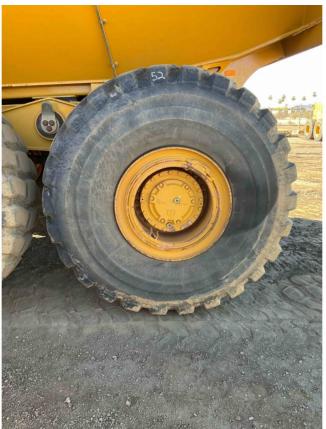
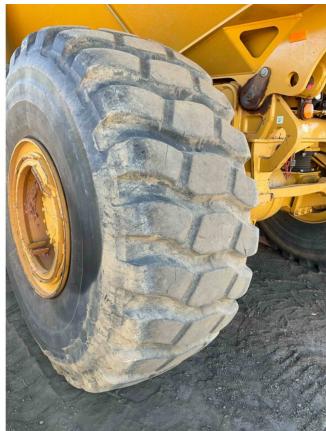
Make / Serial#	Tread Depth in 1/32"	% Life Remaining	Recapped	Tread Cuts/Chunks	Side Cuts Section
Left Rear	Bridgestone	52	84	NO	YES

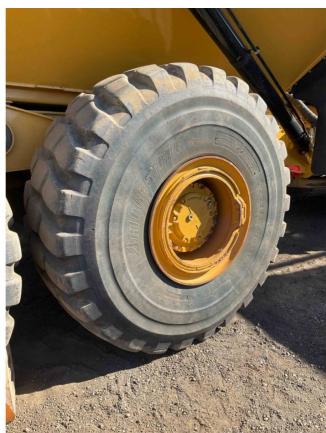
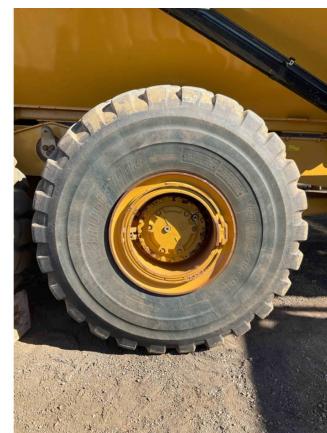
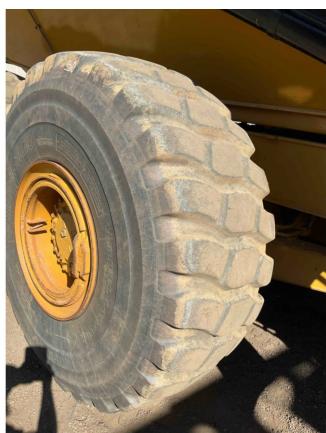
Make / Serial#	Tread Depth in 1/32"	% Life Remaining	Recapped	Tread Cuts/Chunks	Side Cuts Section	
Right Center	Bridgestone	50	80	NO	YES	YES

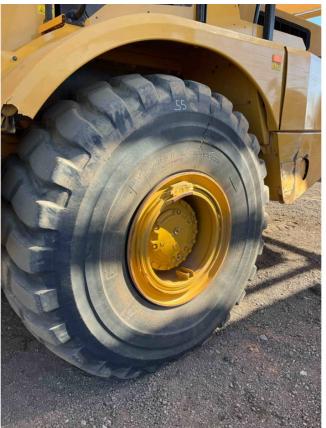
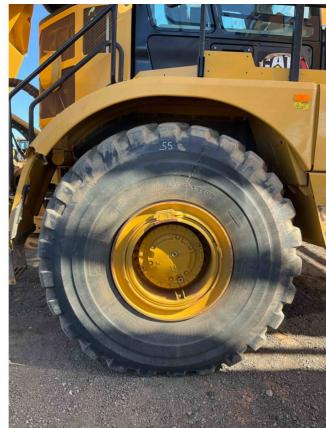
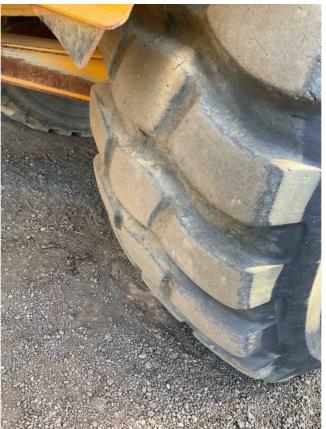
Make / Serial#	Tread Depth in 1/32"	% Life Remaining	Recapped	Tread Cuts/Chunks	Side Cuts Section
Right Front	Bridgestone	55	90	NO	YES

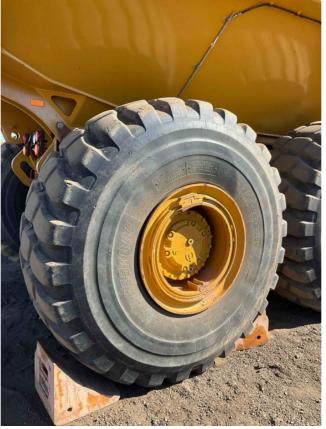
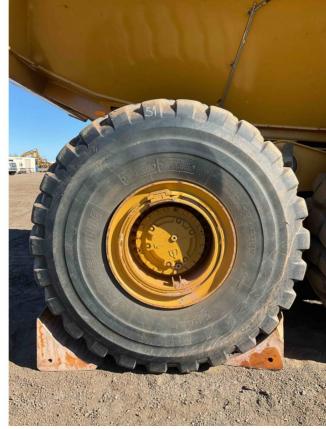
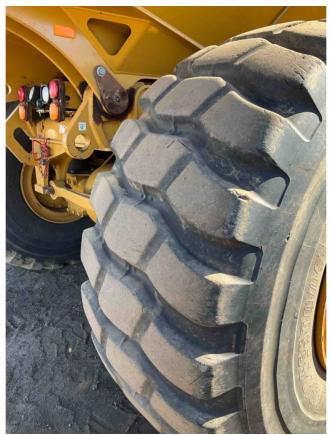
Make / Serial#	Tread Depth in 1/32"	% Life Remaining	Recapped	Tread Cuts/Chunks	Side Cuts Section
Right Rear	Bridgestone	51	82	NO	YES
