2013 CAT AP1000E ASPHALT PAVERS

INSPECTION DETAILS

Inspection Type	Consignment
Inspection Form	Standard
Inspection #	10176228
Inspection Status	Inspected
Created	01/20/25 17:25:53
Updated	01/22/25 10:29:01
Created By	Fuller, Scott U.
Inspector	Fuller, Scott U.
Reviewers	Fuller, Scott U.
Salesperson	Judd, Dillon
Last Preventative Maintenance	Jun 29, 2024
Serial #	T1F00209
SMU / Hours	9,749
Location	Las Vegas, NV, United States

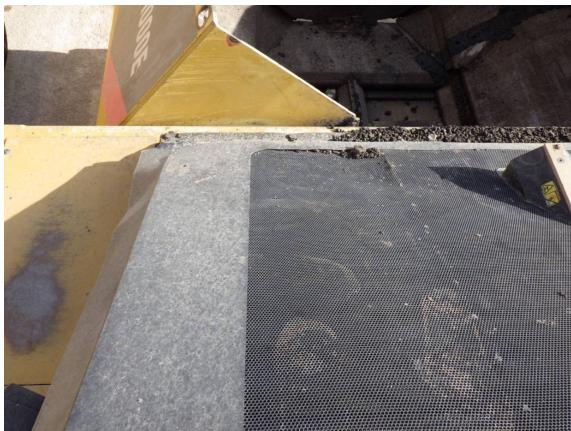
Radiator Grill & Shroud

Grill has multiple dents.

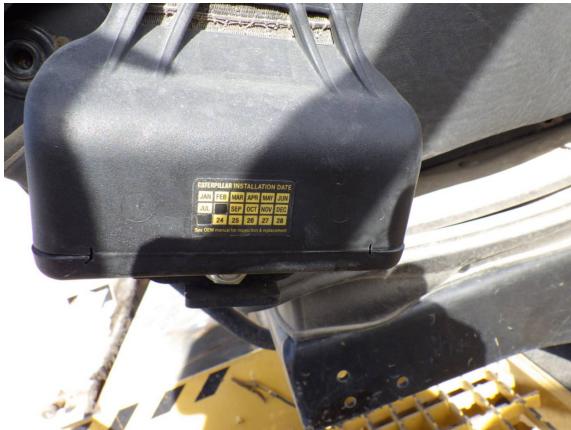
Both seat belts installed Aug.
2023

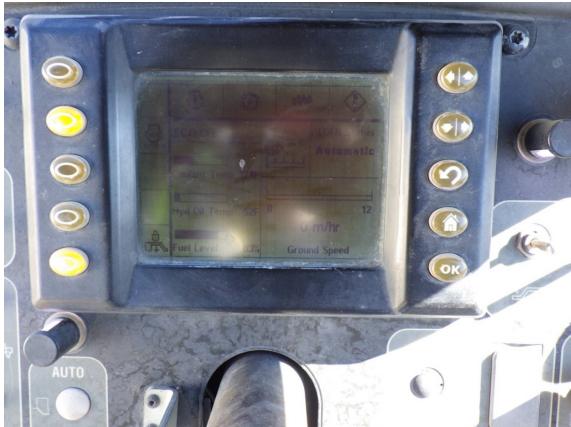
EMS Panel / Warnings

Monitor display is somewhat
discolored from heat.

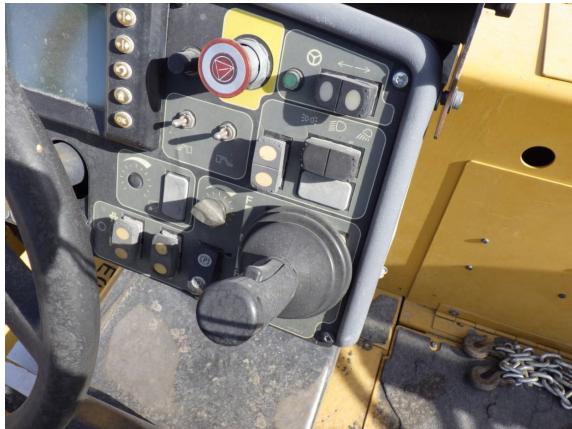
Several rocker switches are faded.

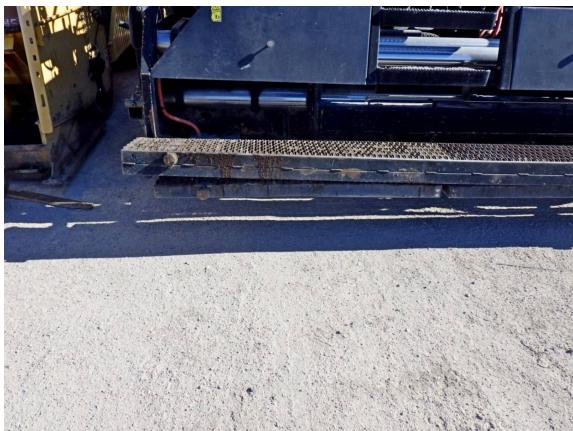
Notes - PAVER / SCREED / CONVEYOR

AS3301C Screed. Left step is bent.
