## 2007 CAT 140HNA MOTOR GRADERS

### INSPECTION DETAILS

Inspection Type	Consignment
Inspection Form	Standard
Inspection #	10188464
Inspection Status	Created
Created	03/12/25 17:27:53
Updated	03/12/25 20:48:33
Created By	Hallett, John L.
Inspector	Hallett, John L.
Salesperson	Harman, Nate
Transmission Serial #	EDB06915
Engine Serial #	3PD19752
Serial #	CCA03647
SMU / Hours	18,234
Location	Goodyear, AZ, United States

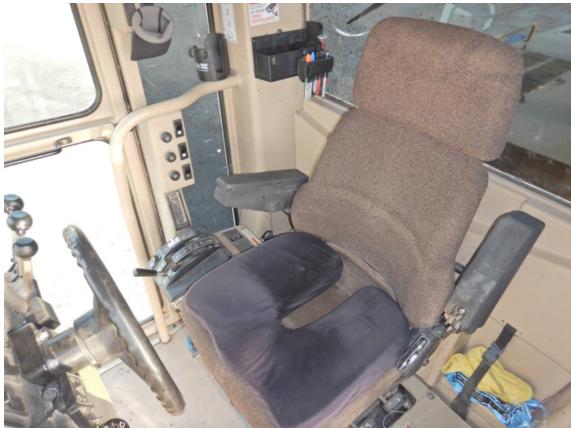
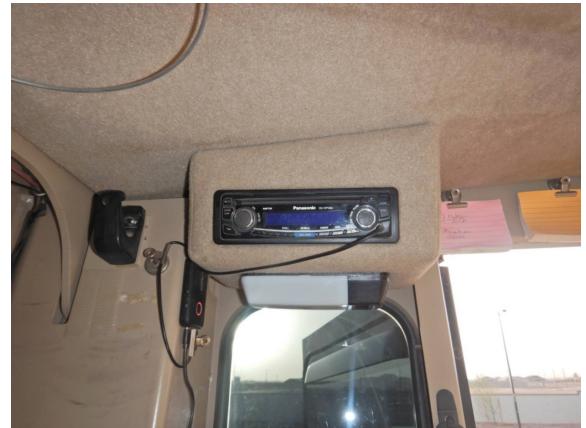
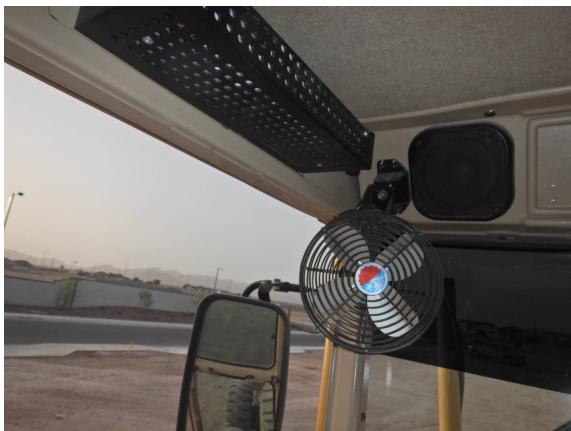
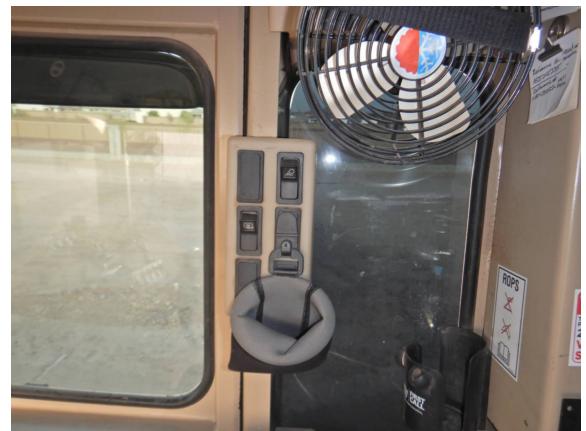
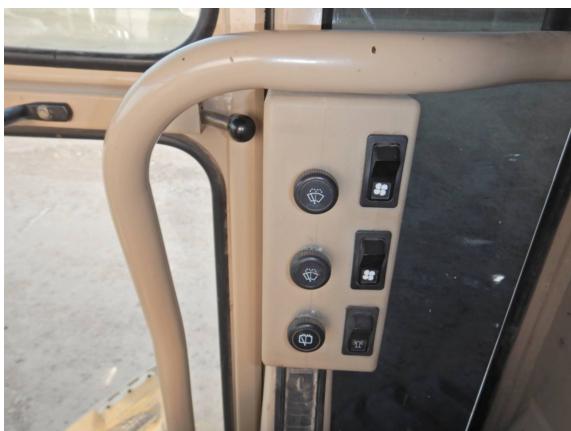
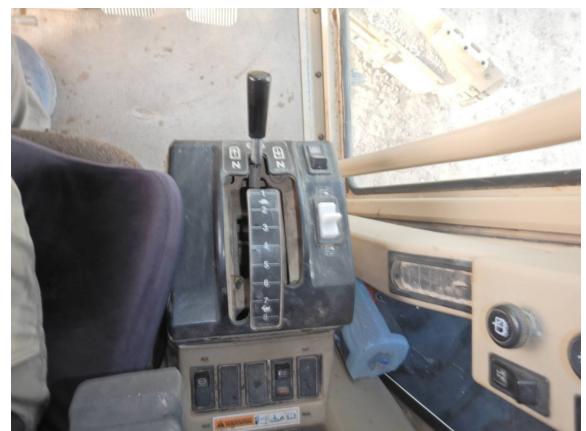
## Notes - GAUGES, OPERATOR STATION, CONSOLE

Good condition for age and hours

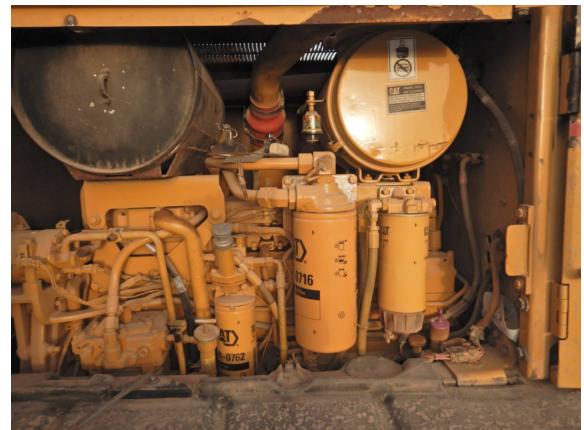
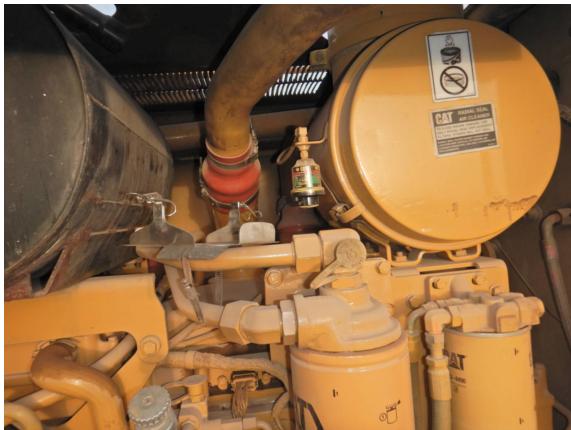
#### Notes - ENGINE

Engine is in good condition and operates normally.

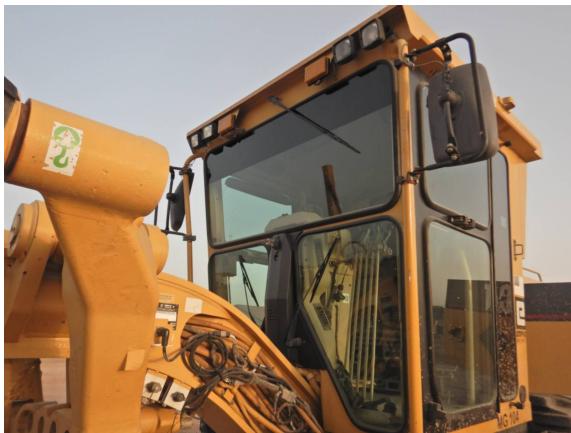
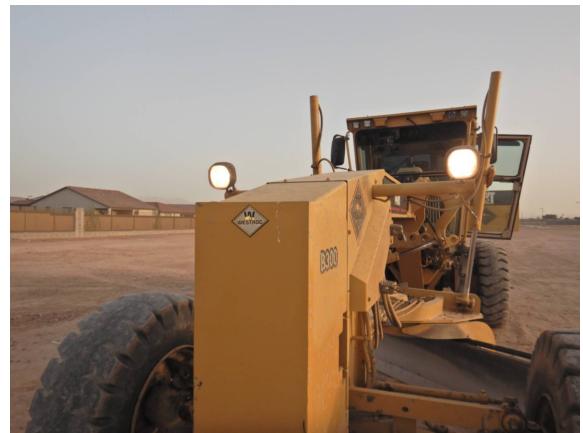
### Work Lights

Upper front lights are in-op

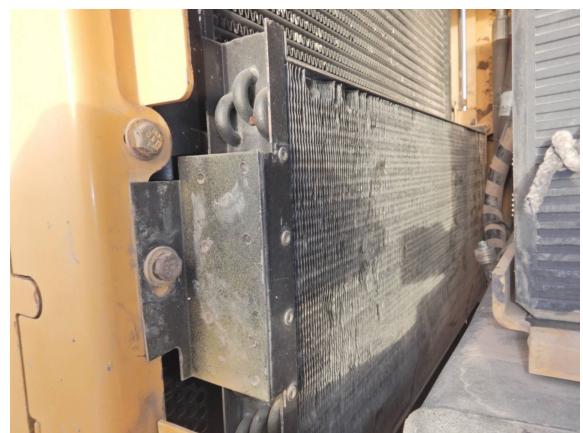
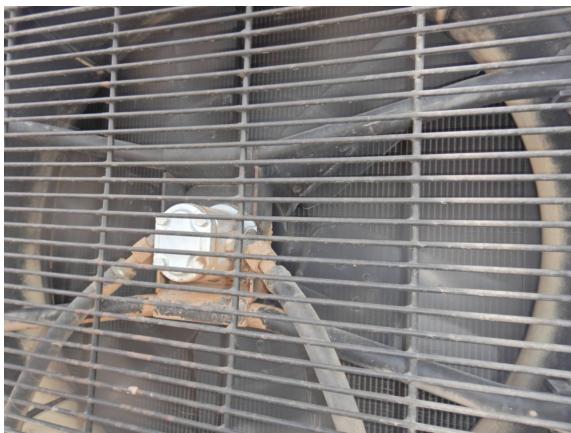
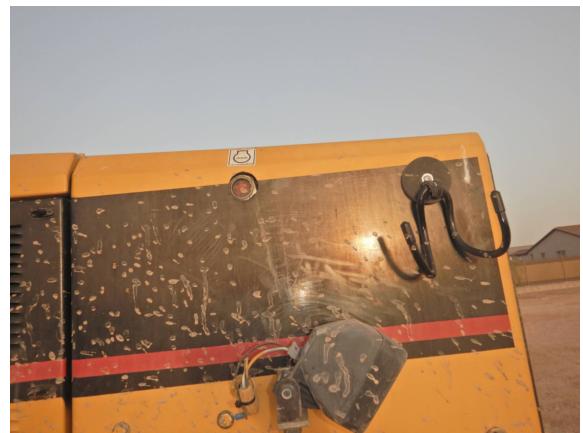
## Notes - COOLING SYSTEM

Cooling system operates normally with no defects found

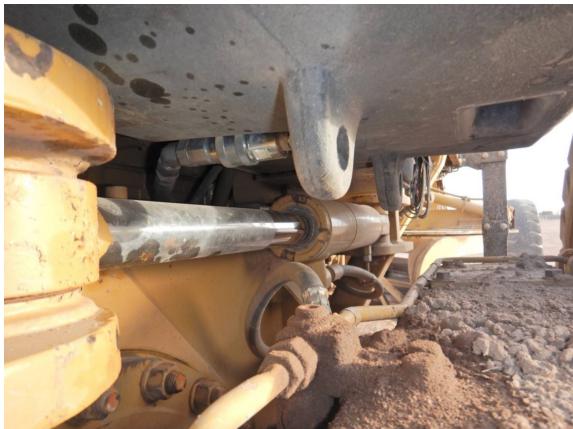
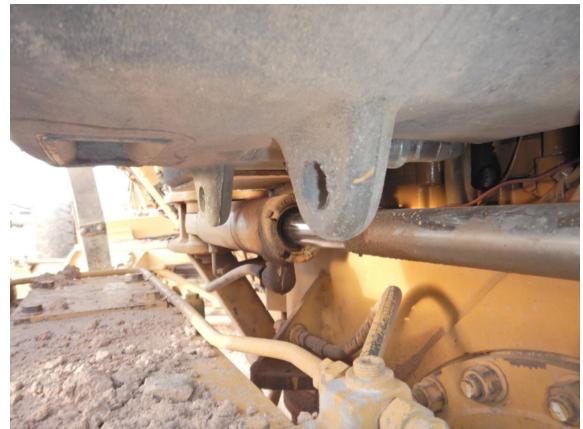
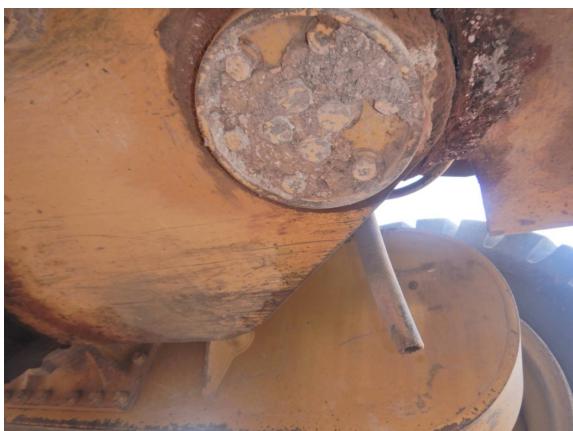
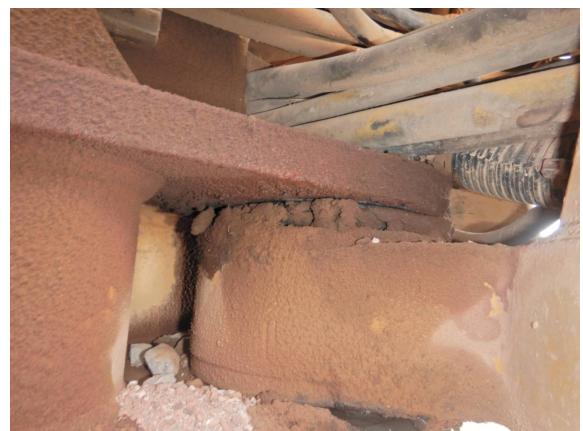
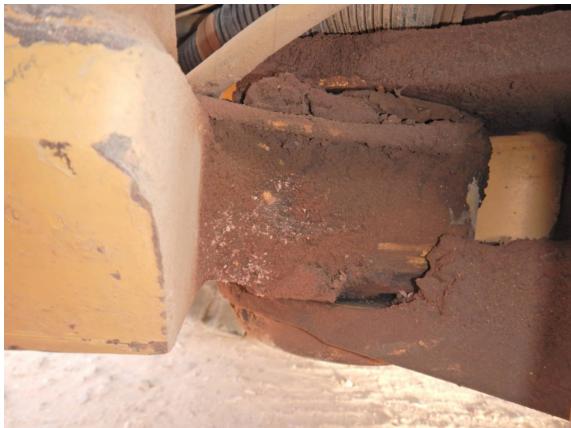
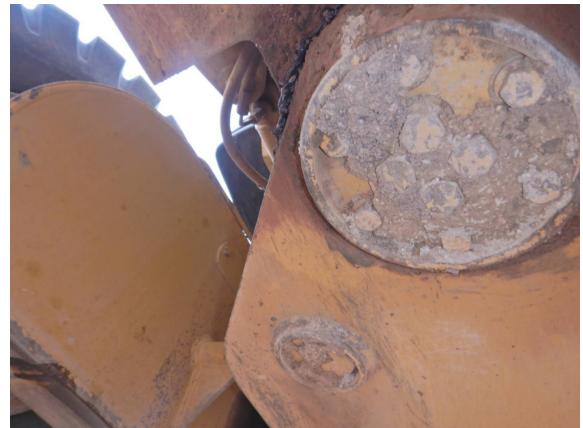
### Articulate P & B

Excessive movement in hitch.  
Hitch isolated from tandems.  
Movement stops when machine  
shifts off the ground.

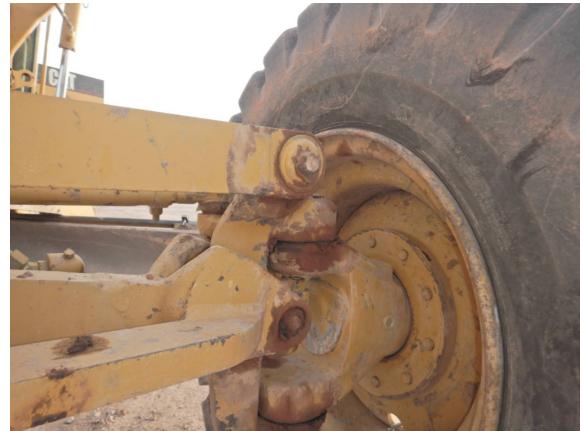
### King Pins

Visible play in bores

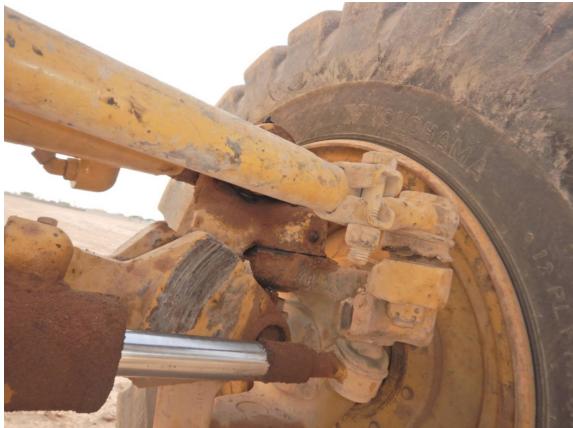
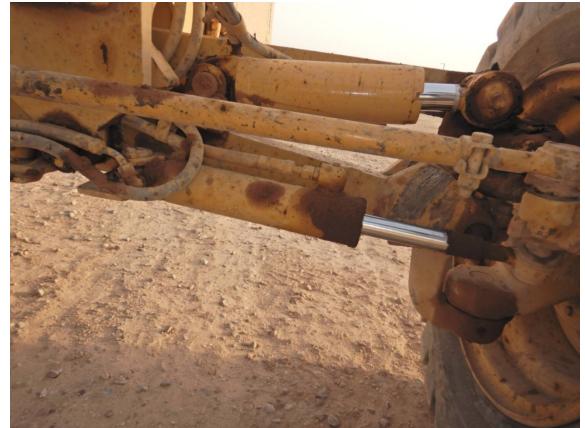
## Notes - STEERING

Steering in fair condition for age and hours

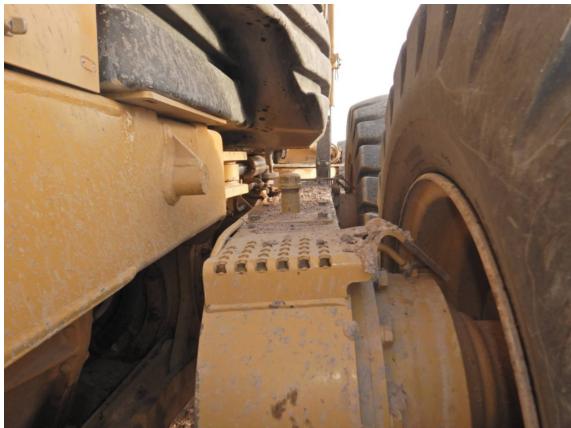
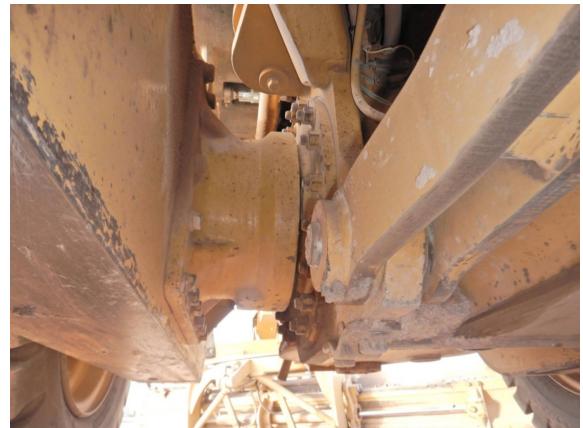
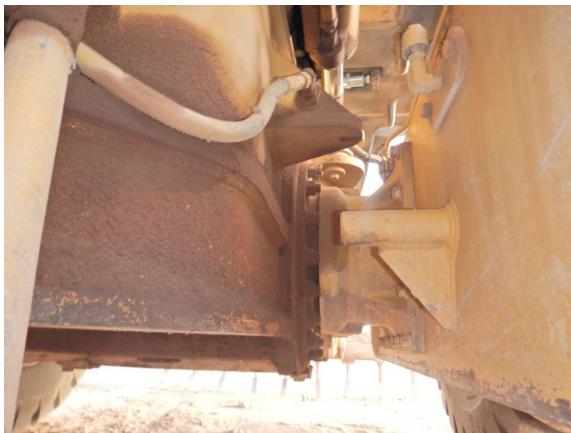
### Tandem Housing / Drive Chains

Housing leaks oil. No chain slap  
heard in tandem housings

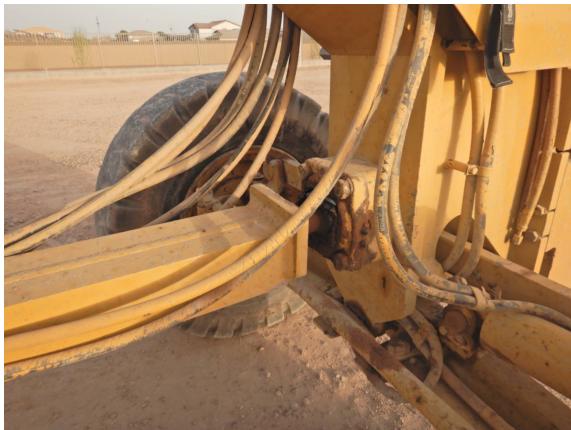
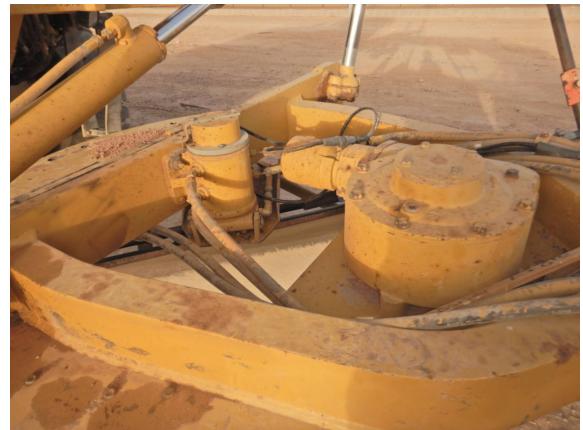
#### Notes - BLADE

Circle is in good condition.  
Operates smoothly without any  
excessive play or binding.

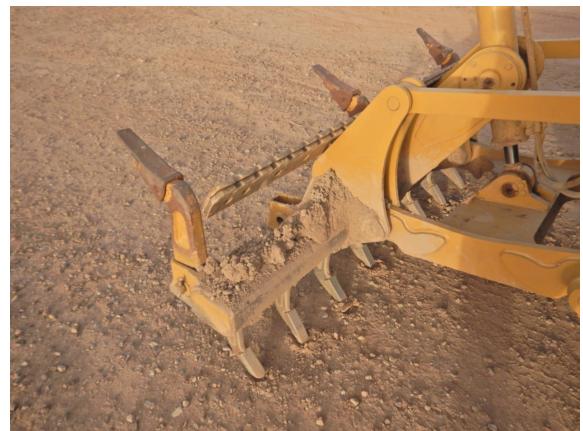
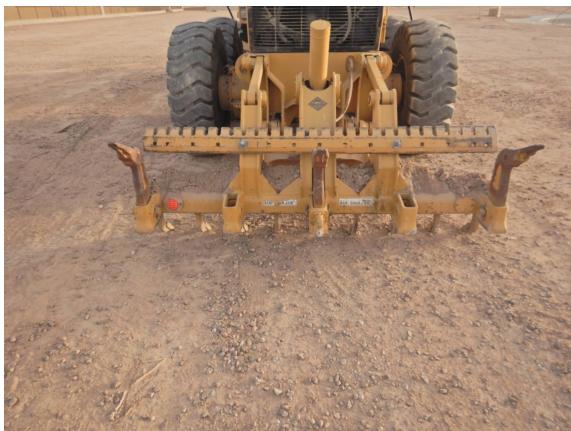
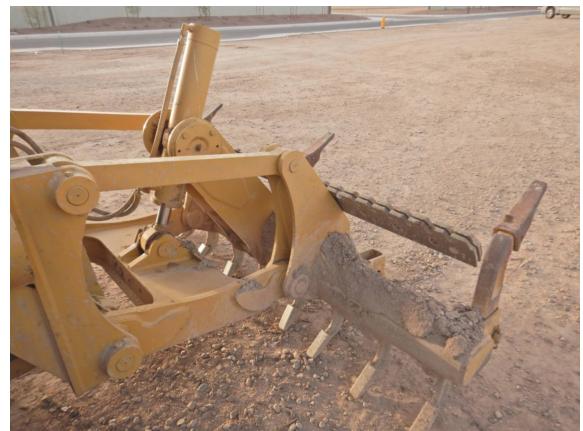
Ripper operates normally. Not defects found.

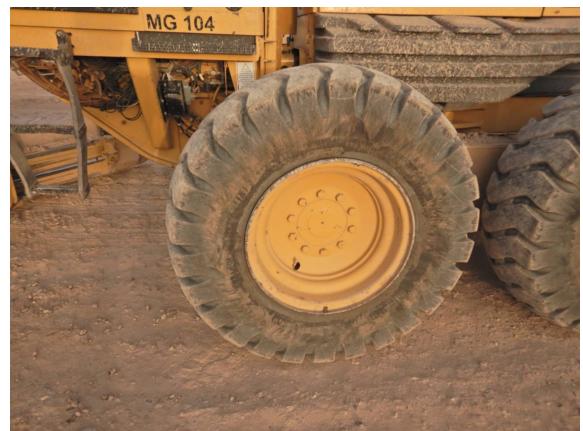
Make / Serial#	Tread Depth in 1/32"	% Life Remaining	Recapped	Tread Cuts/Chunks	Side Cuts Section
Left Center	Yokohama	20.00	57.14

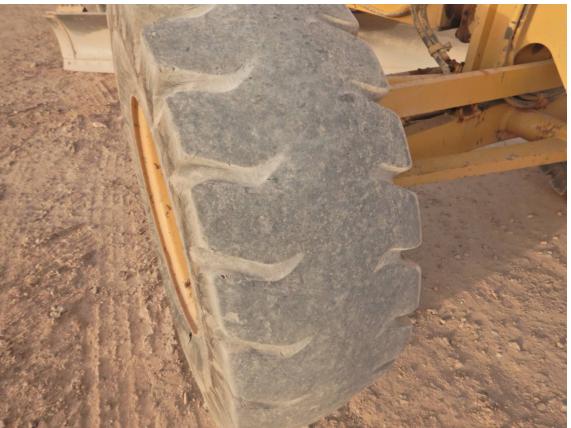
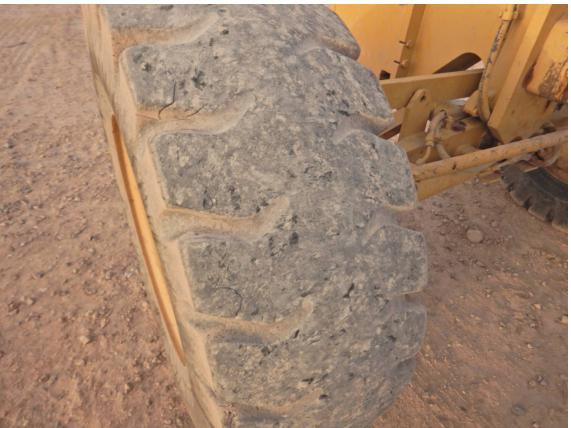
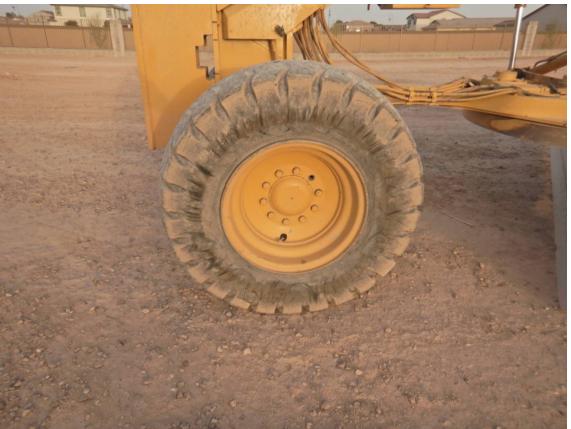
Make / Serial#	Tread Depth in 1/32"	% Life Remaining	Recapped	Tread Cuts/Chunks	Side Cuts Section
Left Front	Yokohama	8.00	22.86

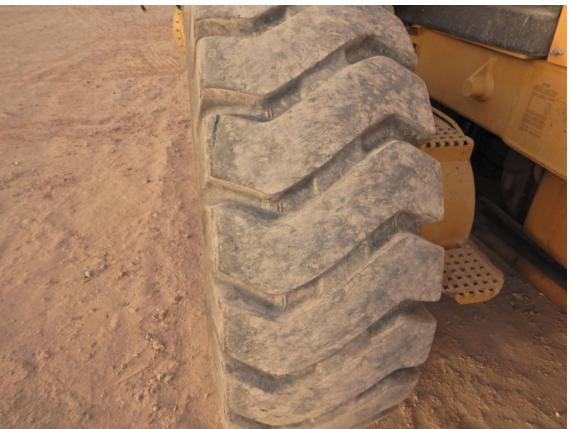
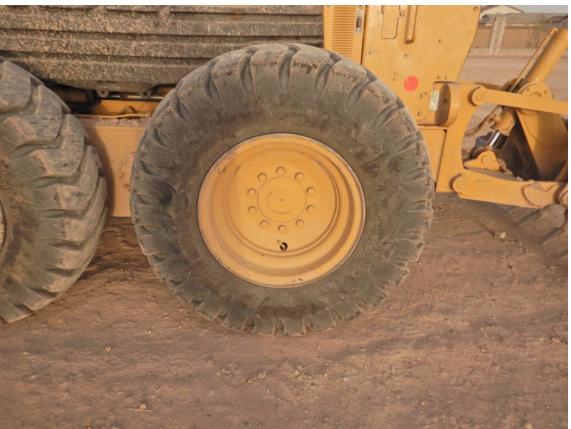
Left Rear	Yokohama	18.00	51.53

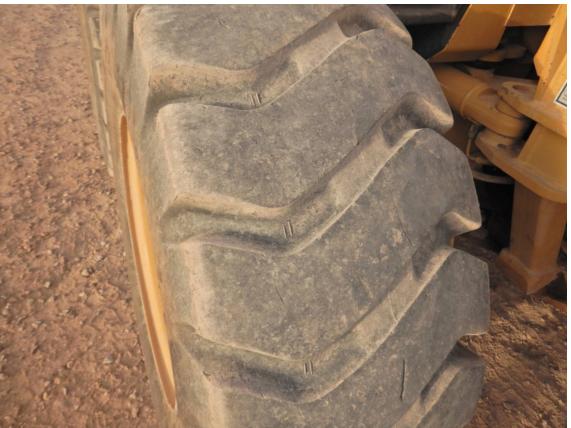
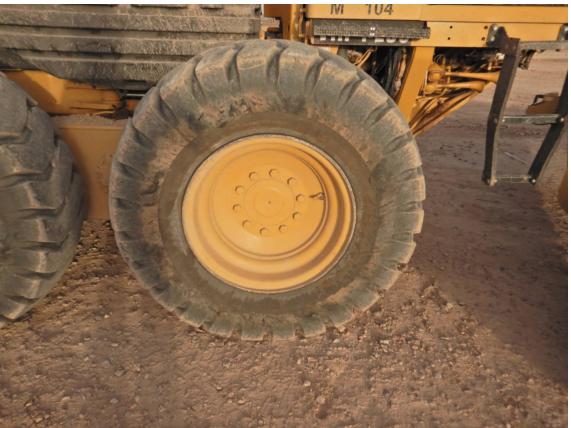
Make / Serial#	Tread Depth in 1/32"	% Life Remaining	Recapped	Tread Cuts/Chunks	Side Cuts Section
Right Center	Yokohama	18.00	51.43

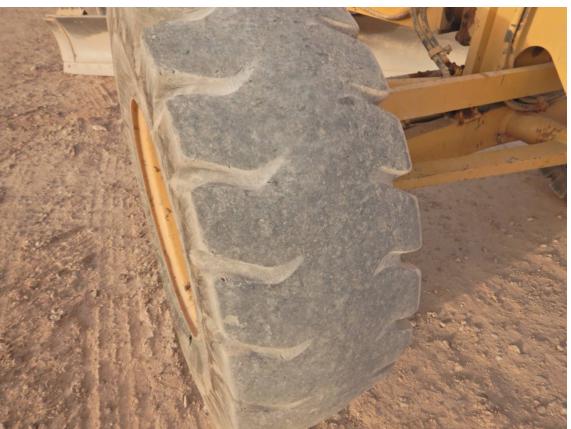
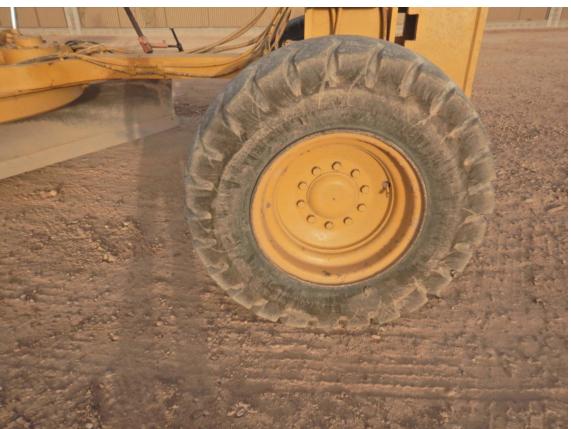
Right Front	Yokohama	8.00	22.86

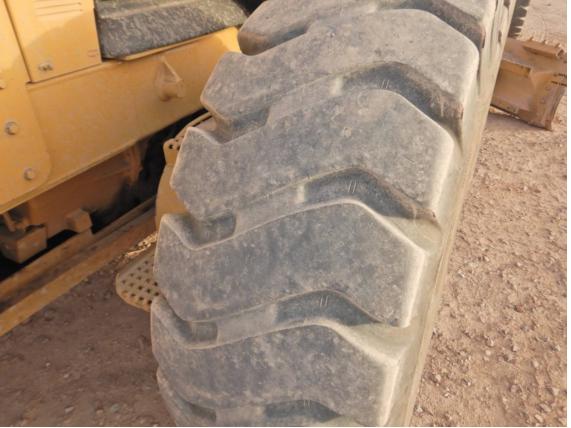
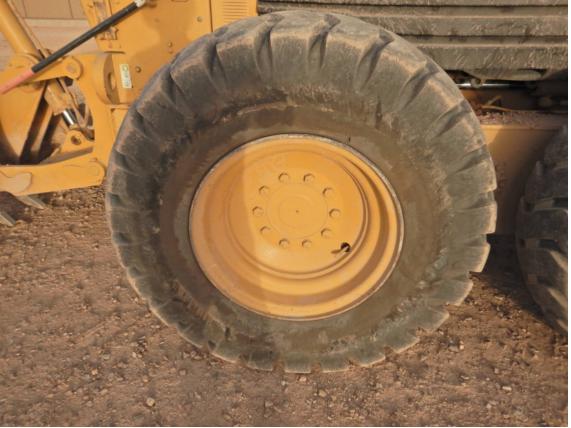
Right Rear	Yokohama	20.00	57.14
