2014 CAT 328DLCR TRACK EXCAVATORS

INSPECTION DETAILS

Inspection Type	Trade
Inspection Form	Standard
Inspection #	10211343
Inspection Status	Completed
Created	06/23/25 13:10:34
Updated	06/26/25 12:10:25
Created By	Calderas, Marco
Inspector	Calderas, Marco
Reviewers	Calderas, Marco
Salesperson	Schultis, Derrick R.
Serial #	RMX00885
SMU / Hours	7,271
Location	Eloy, AZ, United States

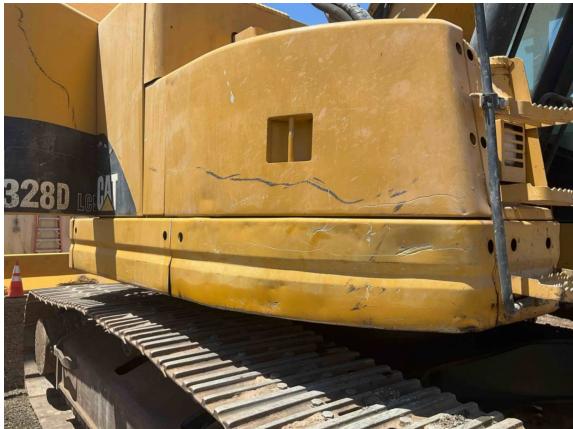
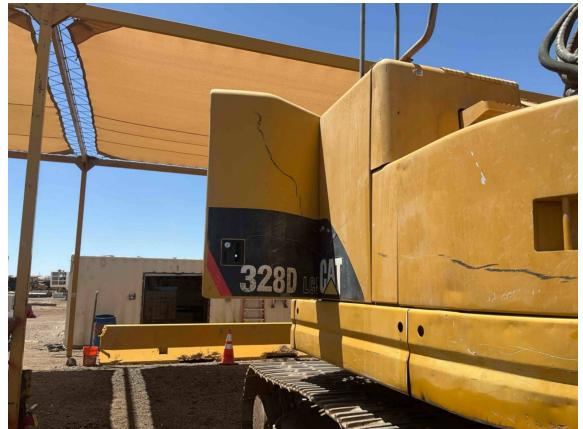
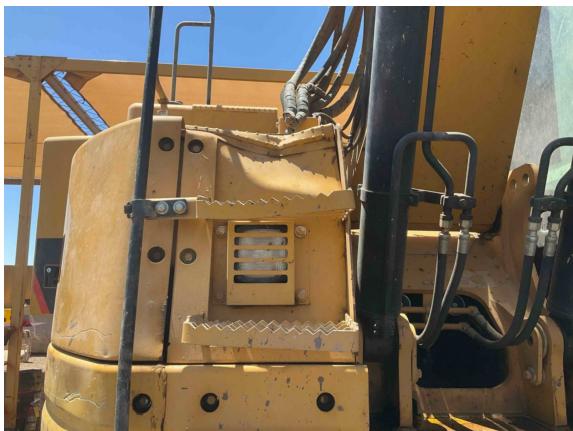
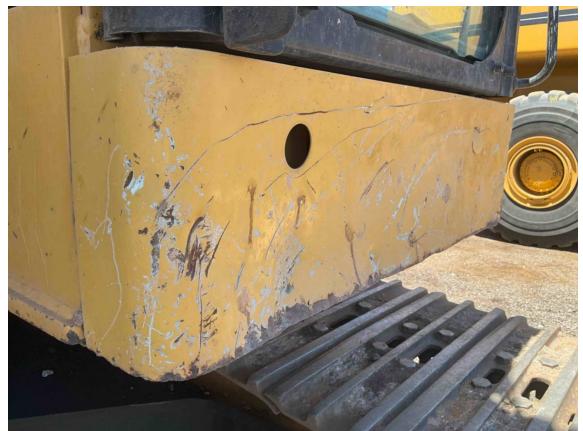
Body

Machine has dents and left side compartment door has holes.

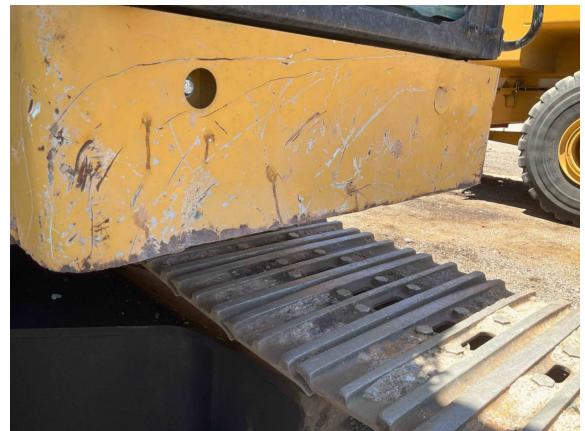
Fenders

Fender Is bent

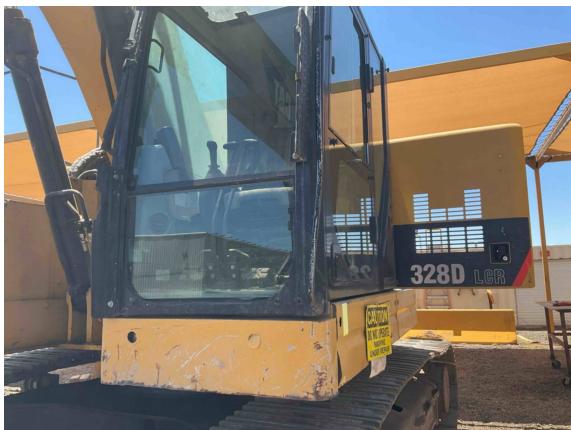
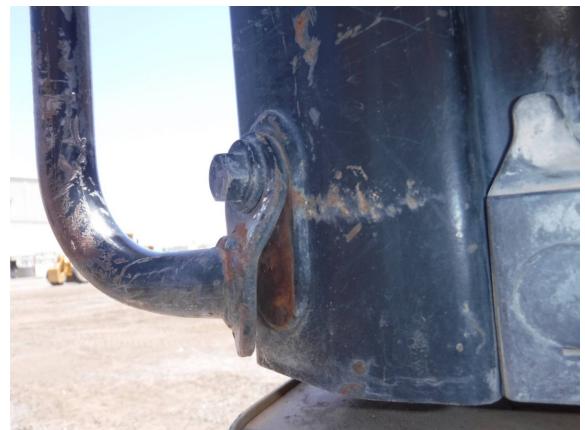
Front left grab iron is bent

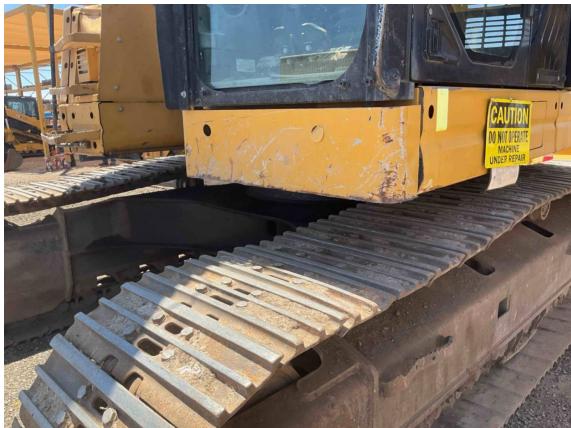
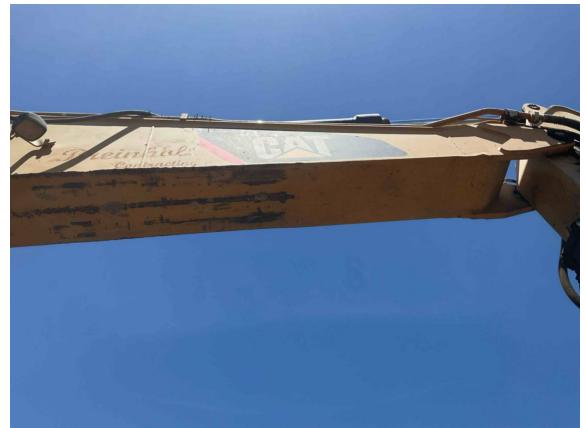
Paint

Has scratches

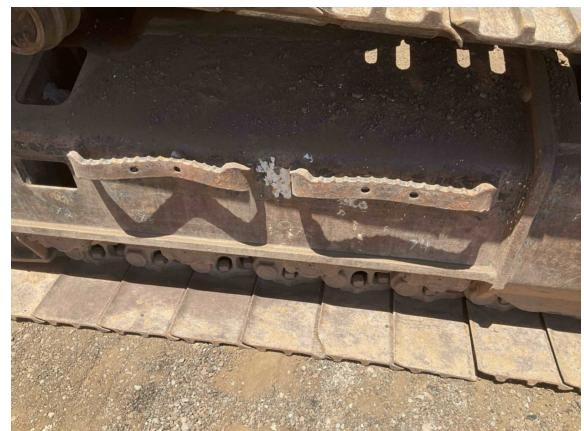
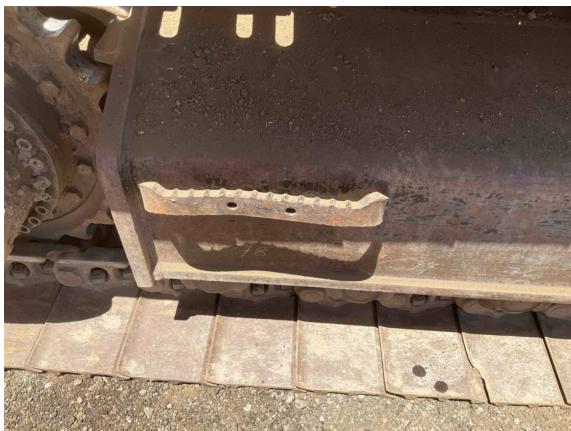
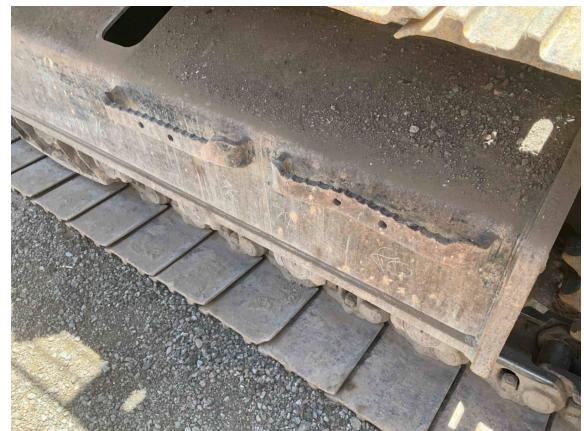
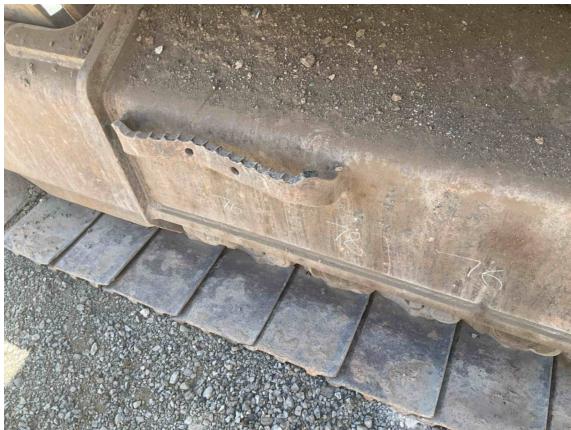
Steps / Ladder

● Cover GP Access steps and box
are bent.(Quoted all 3 steps)

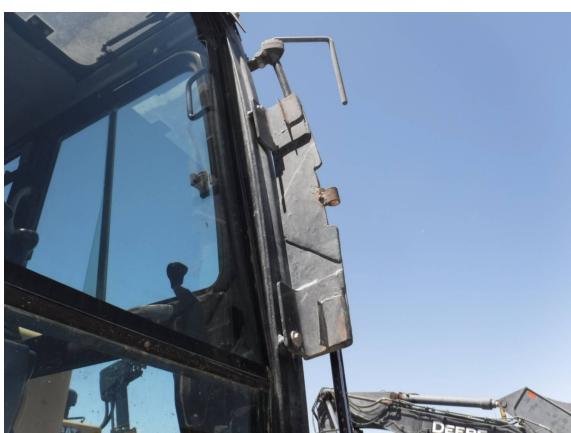
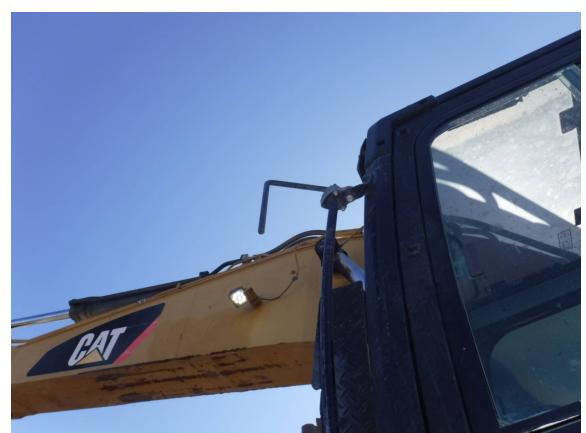
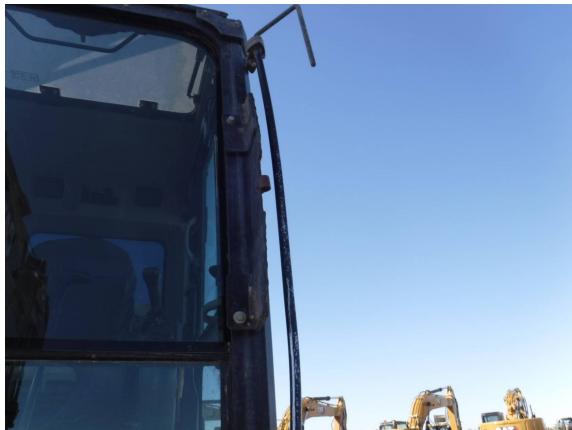
ROPS-Cab

● Cab has bracket plate from previous window guard.

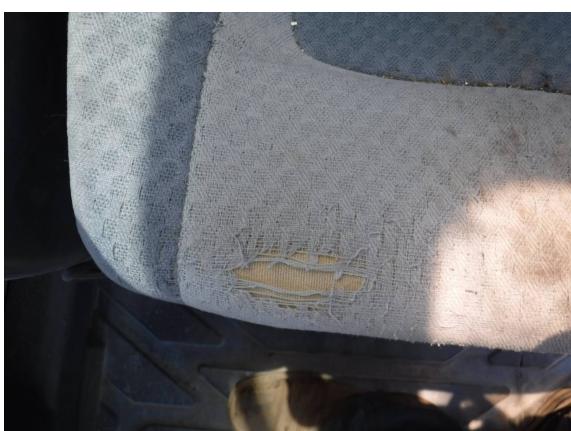
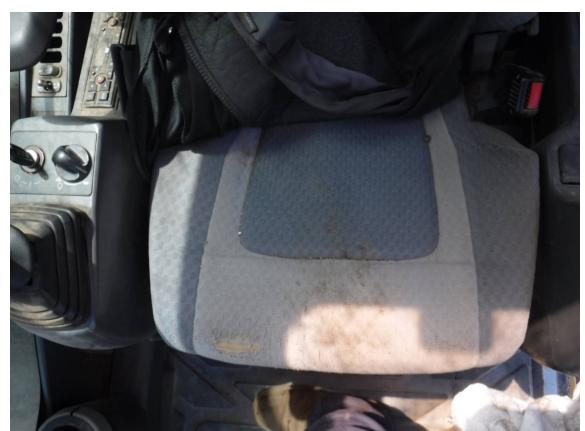
Seat Cushions / Suspension / Type

●
Bottom seat has holes

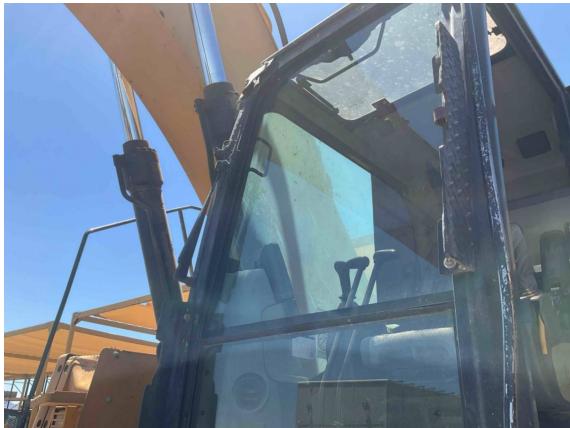
Windshield Wipers

Rear and front Wipers do not spray.

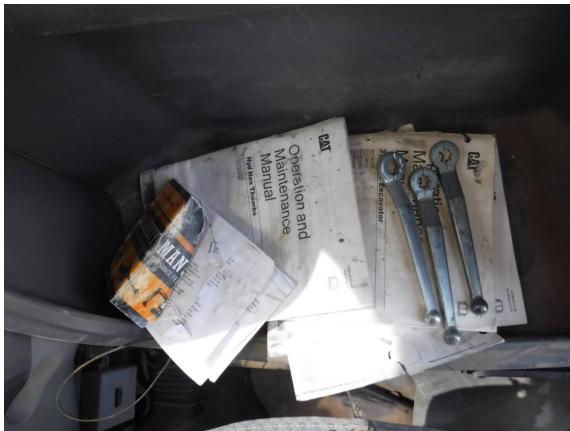
Current Safety Manual

Safety manual has first page torn

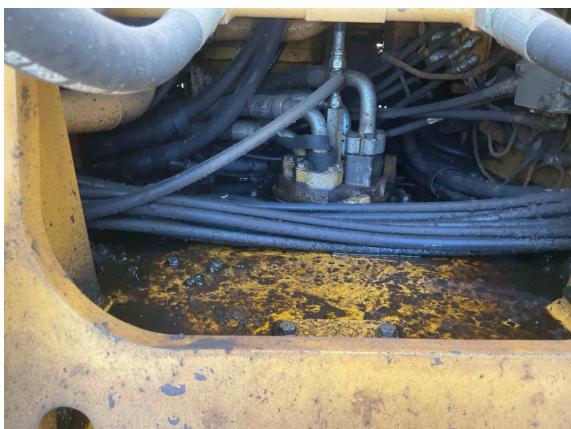
Hydraulic Swivel

Is wet with oil

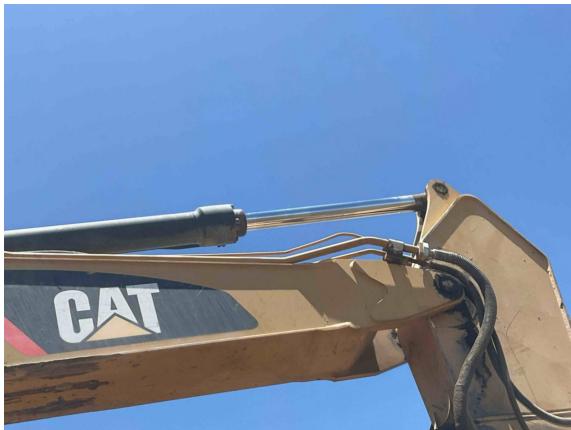
Stick Cylinder

Is wet with oil at head rod seals
