2024 CAT
42007XE
BACKHOE LOADER

INSPECTION DETAILS

| Inspection # | 10234325 |

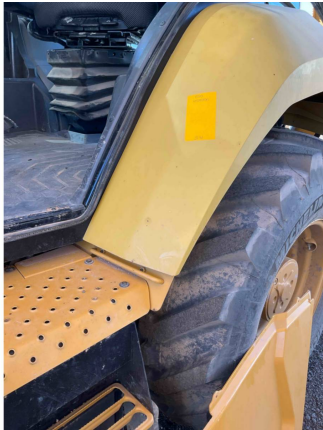
Discolored

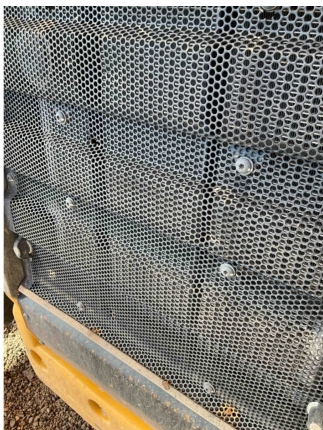
Radiator Grill

Has small dents and rips

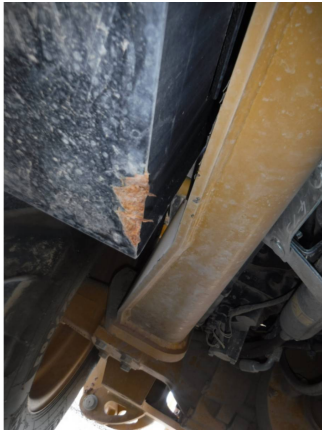
Sheet Metal

Right side storage box has dent in bottom section.
