2007 CAT
345CL
TRACK EXCAVATORS

INSPECTION DETAILS

| Inspection # | 10205878 |

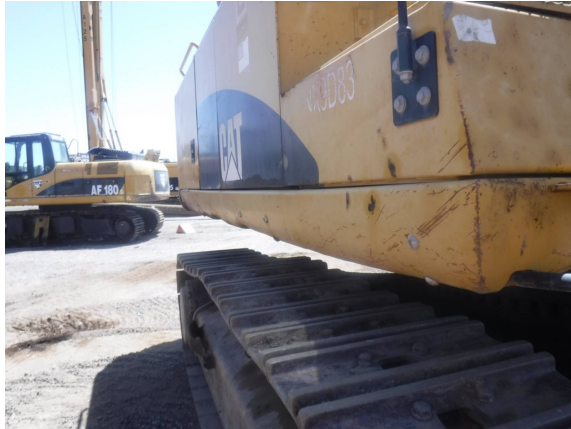
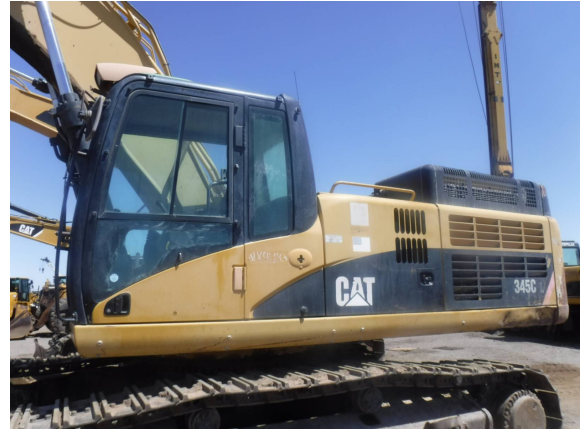
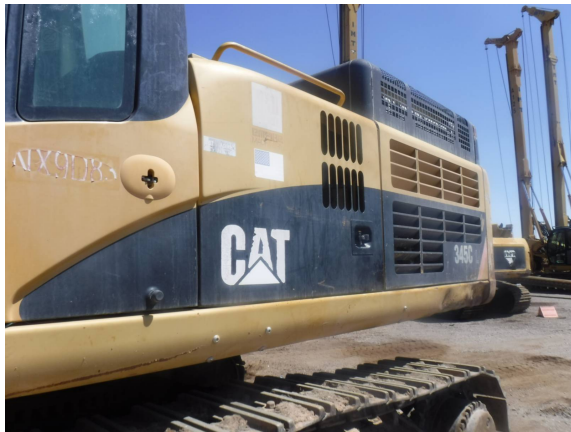
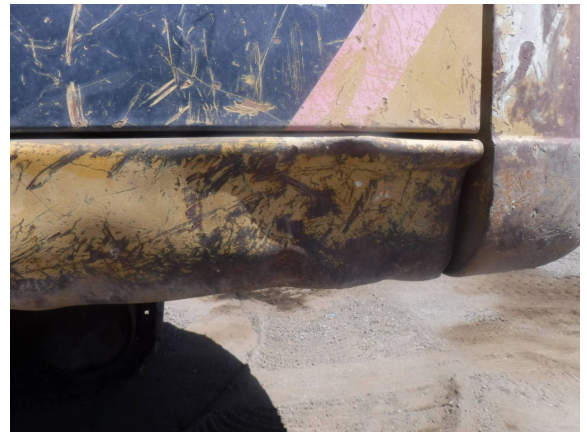
General

Paint is faded and dents along both sides of machine.

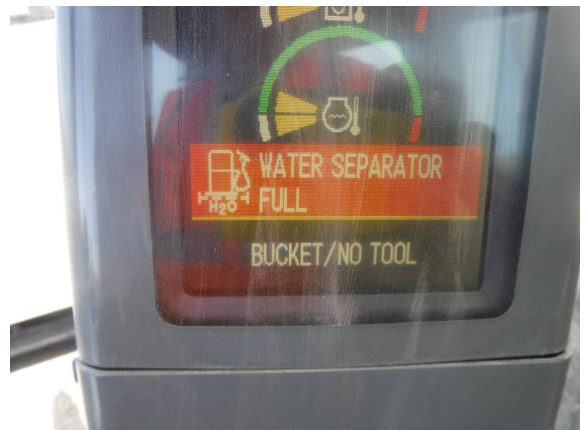
Logged / Active Codes

Check and advise. Active code:
High fuel/water level

Check and advise. Active code:

High fuel/water level

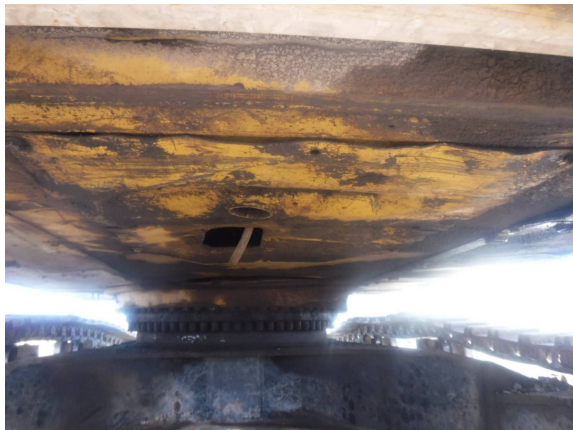
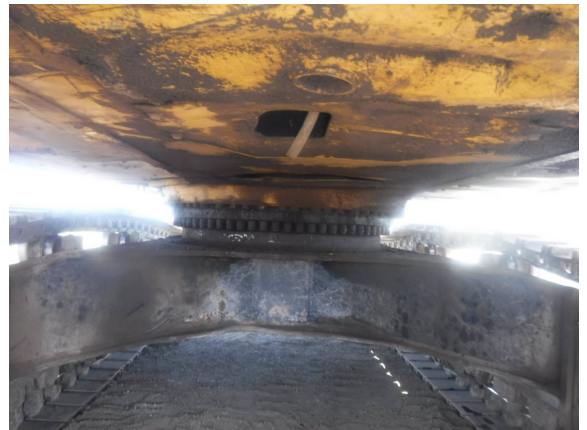
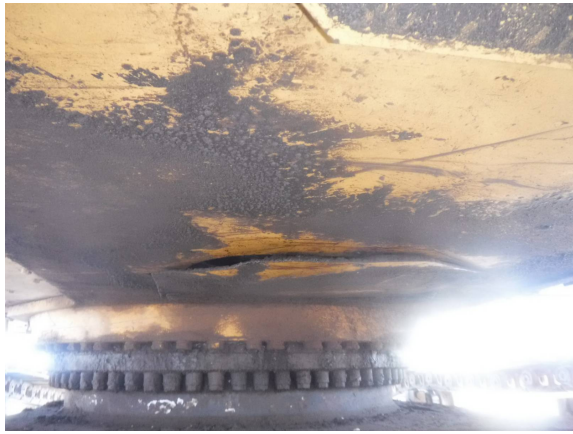
Guard is bent.

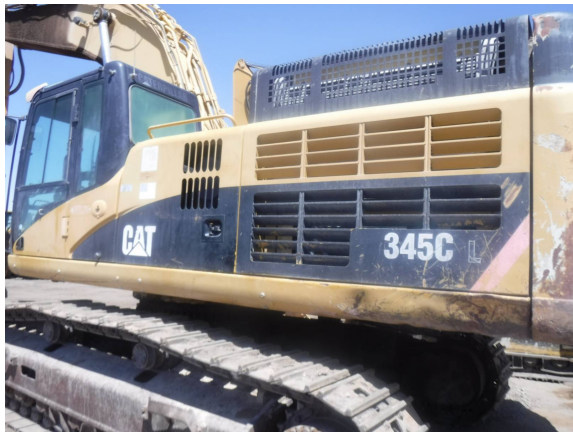
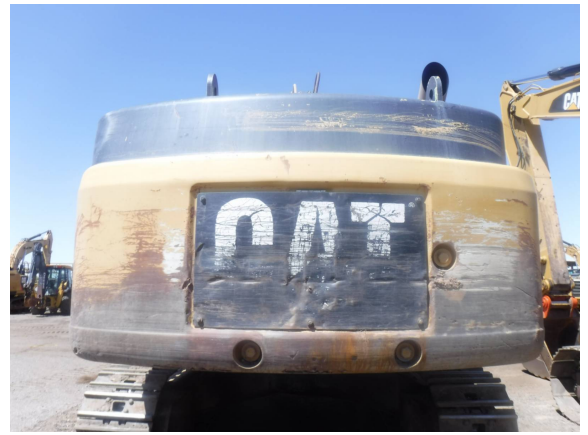
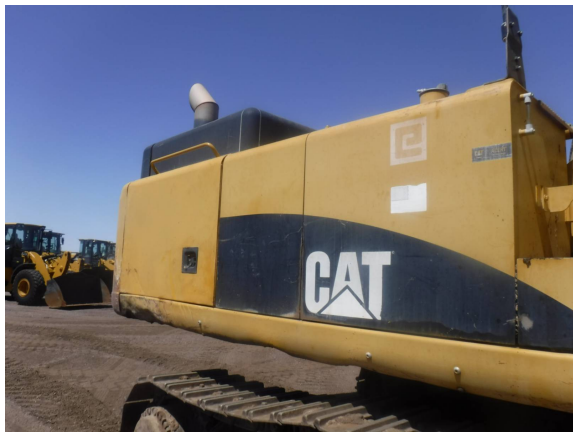
Decals are faded.

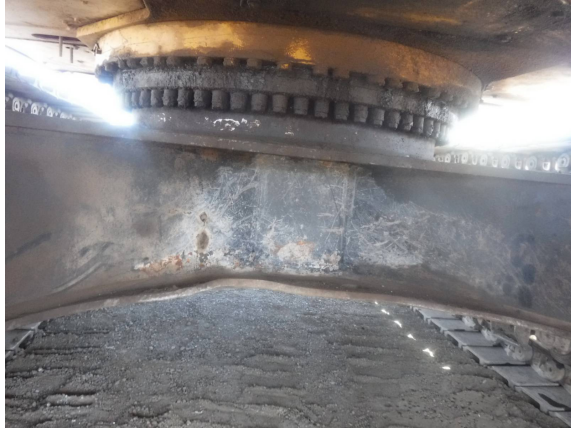
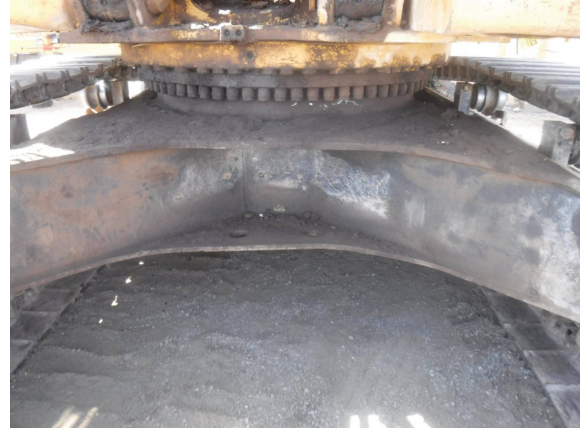
Draw Bar

Dent on front and rear

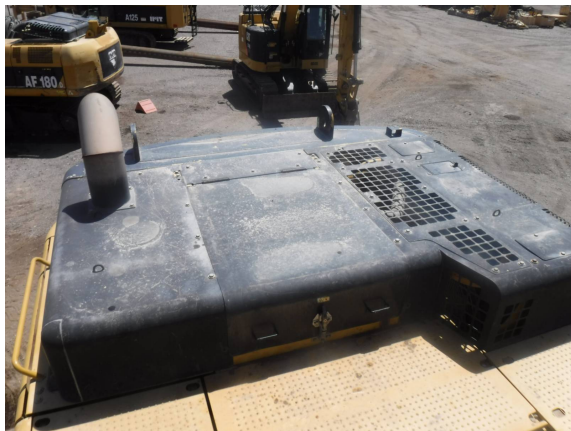
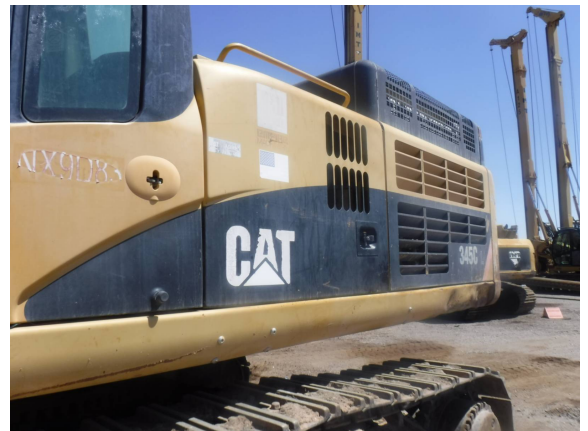
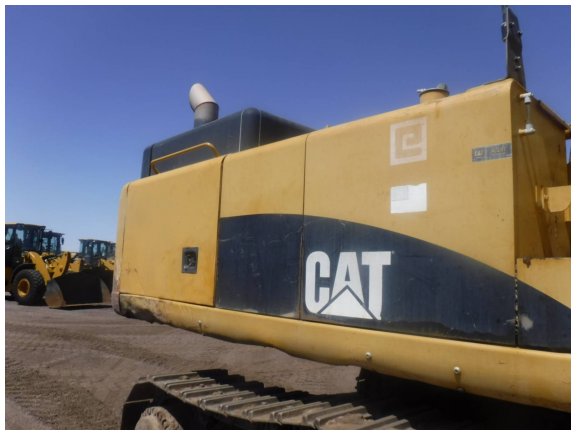
Engine Doors

Paint and decals are faded.

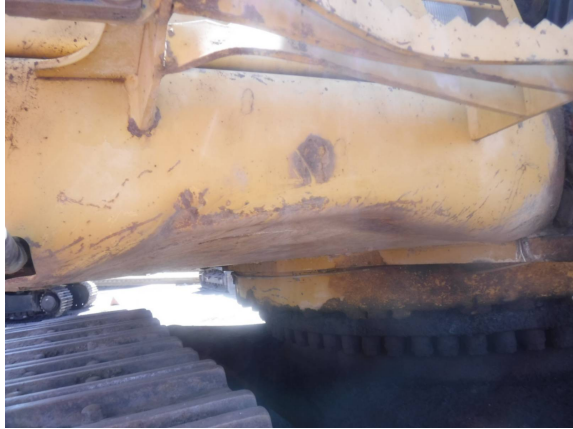
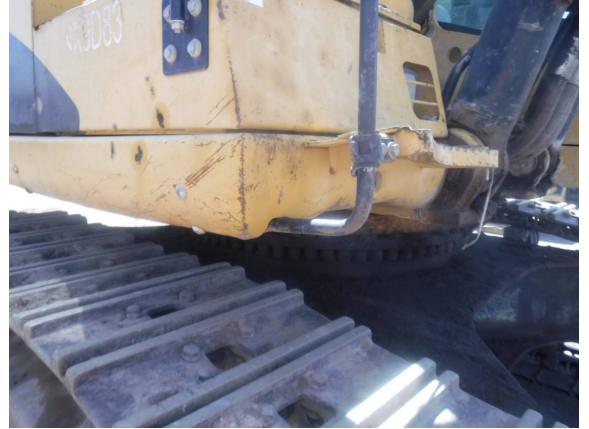
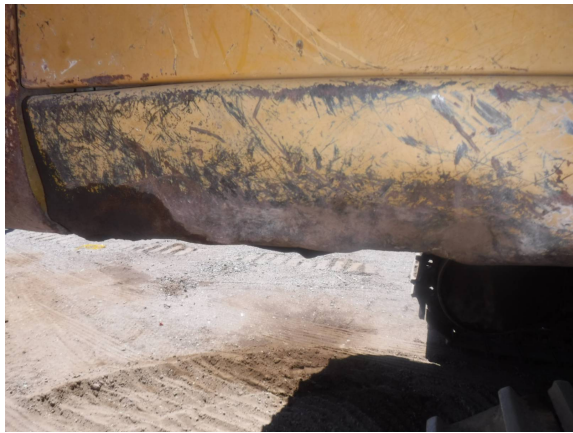
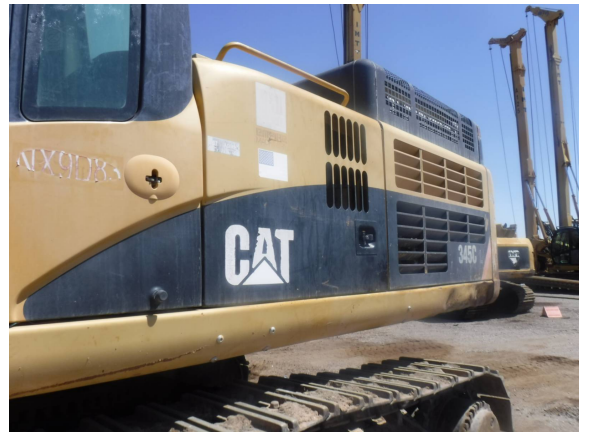
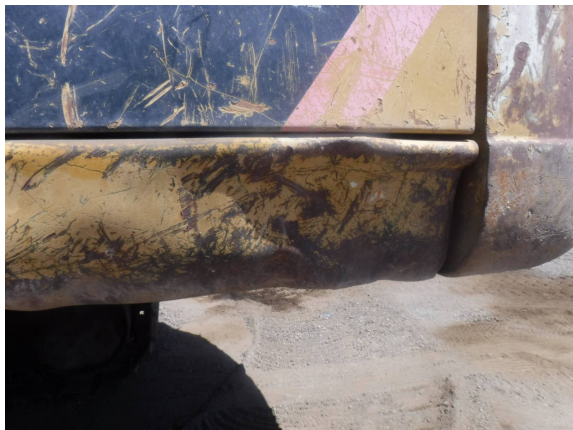
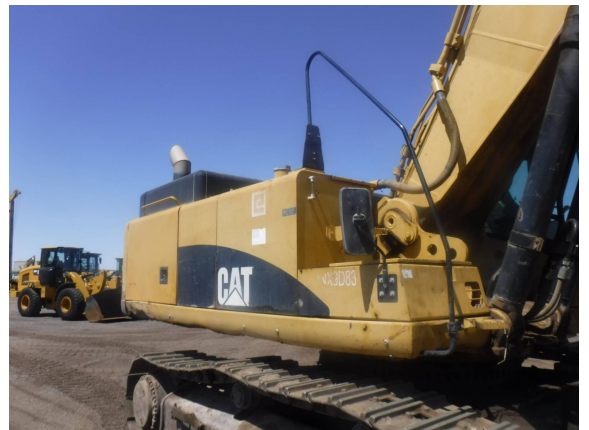
Fenders

Large dents on both sides

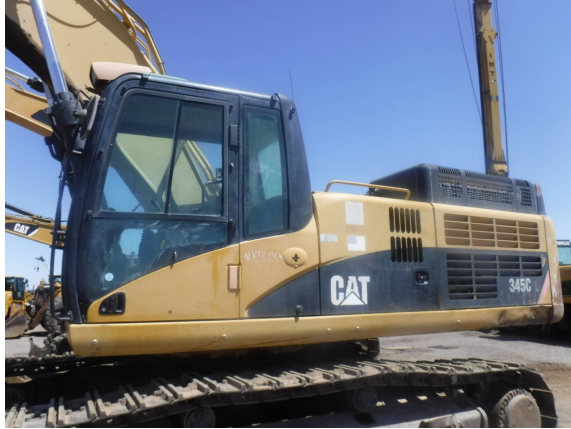
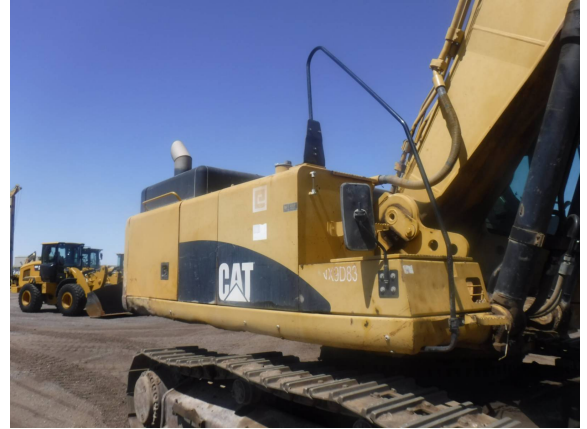
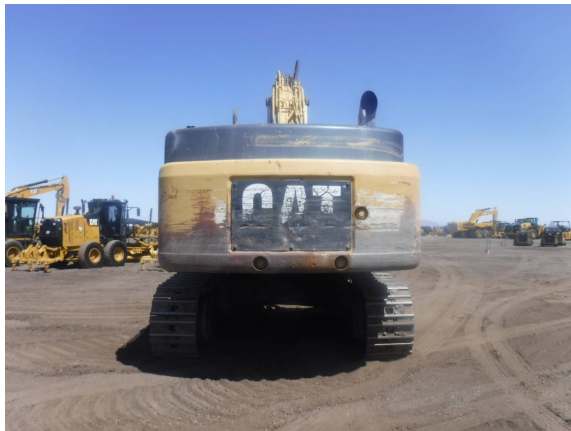
Paint is faded and scratched

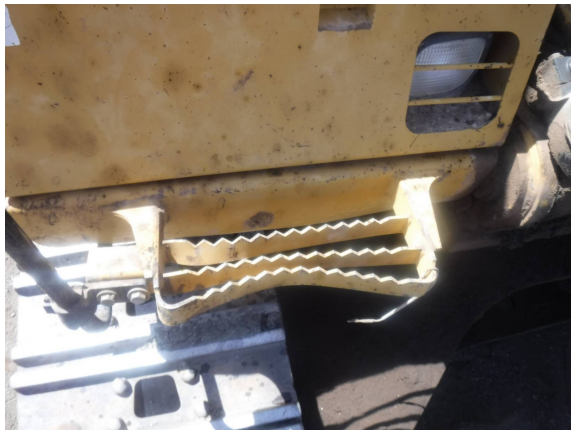
Steps / Ladder

Steps on right side of machine
is bent

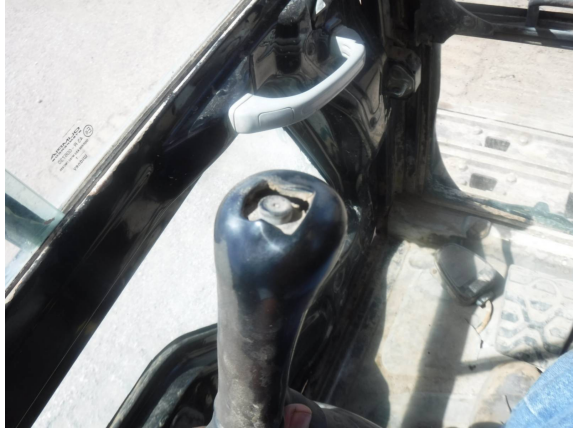
Horn

Cover over horn button is torn.

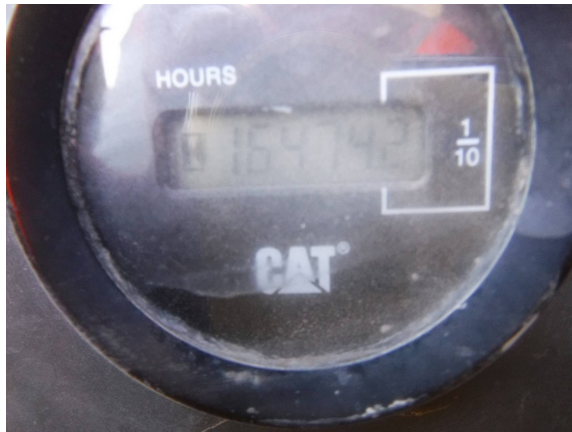
Hour Meter - GAUGES,
OPERATION STATION,
CONSOLE

●
Hour meter display is
scratched, difficult to read.

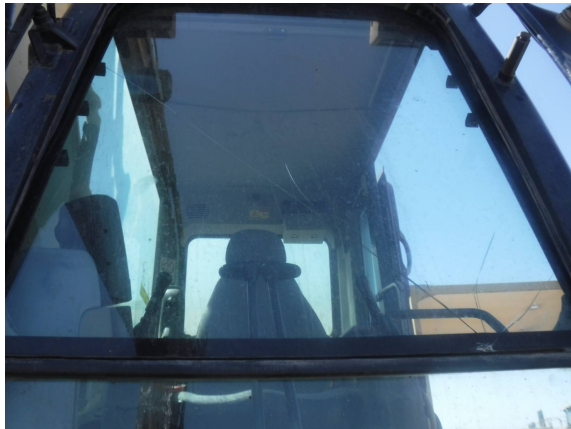
| WINDOW Front window will not latch. | 📷1 | WINDOW Rear windows and sunroof window are faded and hard to see through. Sunroof window struts are not working. | 📷4 | Windows Front window is cracked. | 📷3 |

● Front window will not latch.

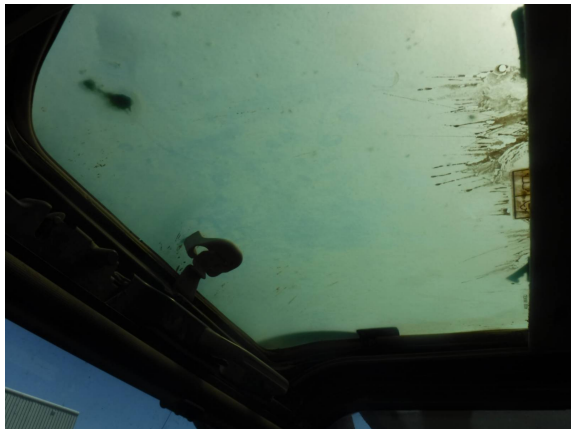
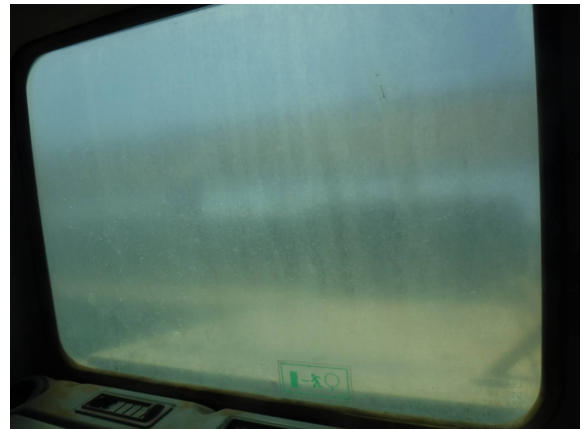
WINDOW

● Rear windows and sunroof window are faded and hard to see through. Sunroof window struts are not working.

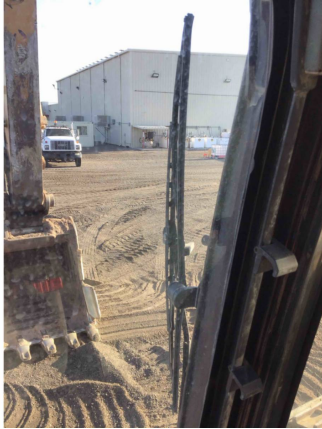
Windshield Wipers

Wipers are not working

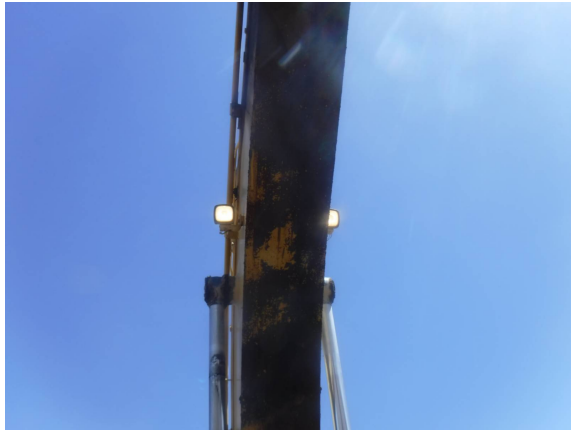
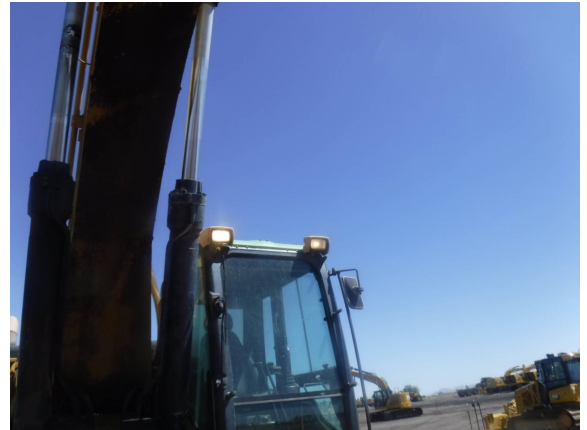
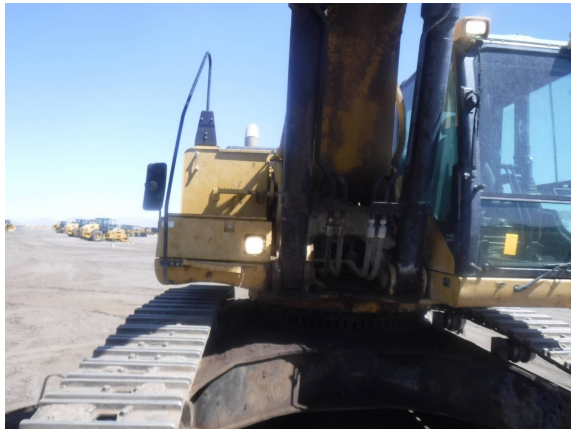
Wiring

Wires are installed through cab door.

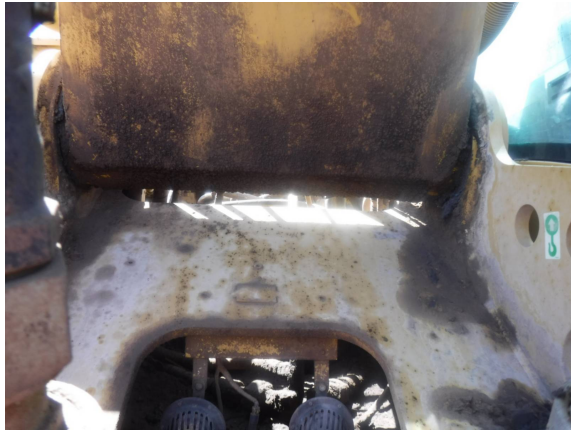
Pins & Bushings - BOOM

Movement at boom to frame
pin and bushings.

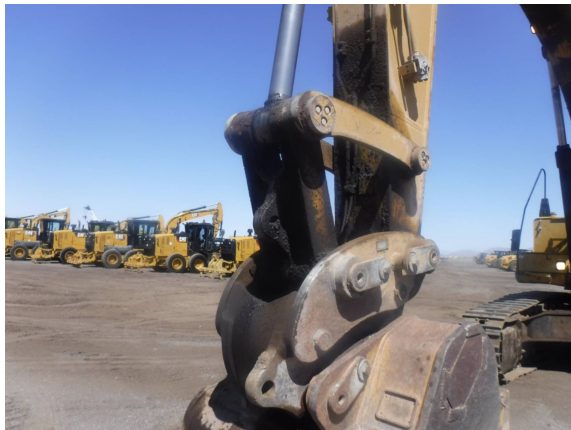
Bucket Linkage

Bucket linkage has movement

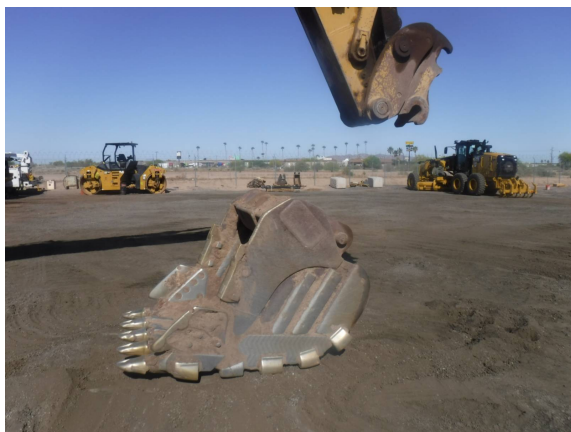
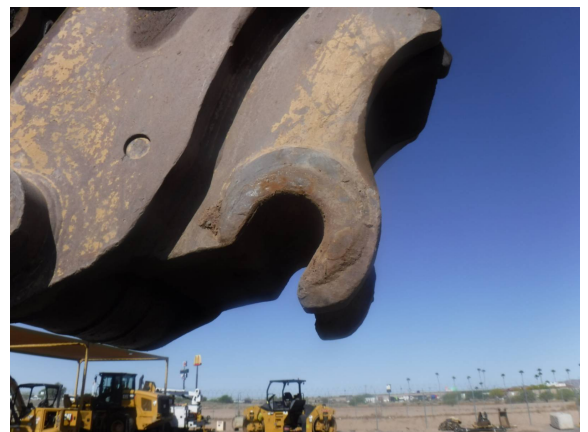
Quick Coupler

Quick coupler is in good working condition
