2022 CAT 259D3 COMPACT TRACK LOADER

INSPECTION DETAILS

Inspection Type	Trade
Inspection Form	Standard
Inspection #	10256168
Inspection Status	Completed
Created	12/08/25 14:57:06
Updated	12/11/25 09:32:09
Created By	Preskitt, Billy
Inspector	Preskitt, Billy
Reviewers	Preskitt, Billy
Salesperson	Schultis, Derrick R.
Stock #	E196732
Serial #	CW920348
SMU / Hours	1,184
Location	Eloy, AZ 85131, United States

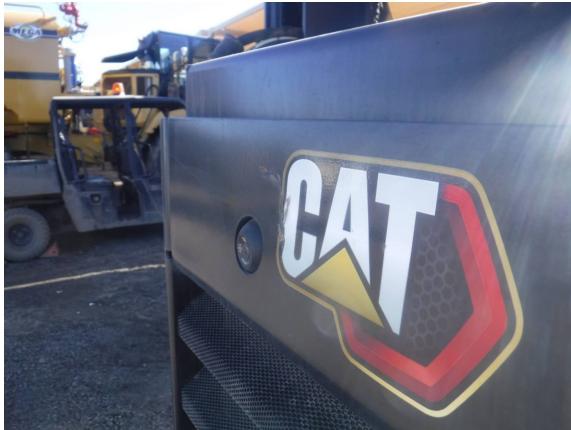
Engine compartment door is bent (opens and closes as it should)

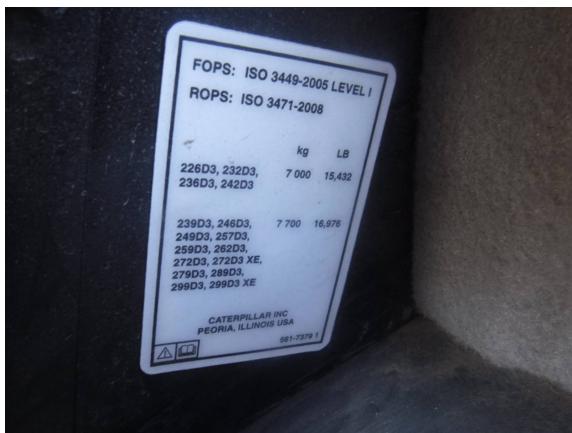
ROPS Certification Plate

YES

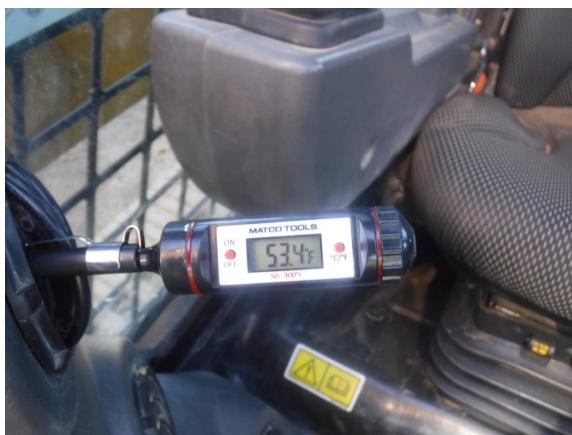
Air Conditioner

vent temp 53.4

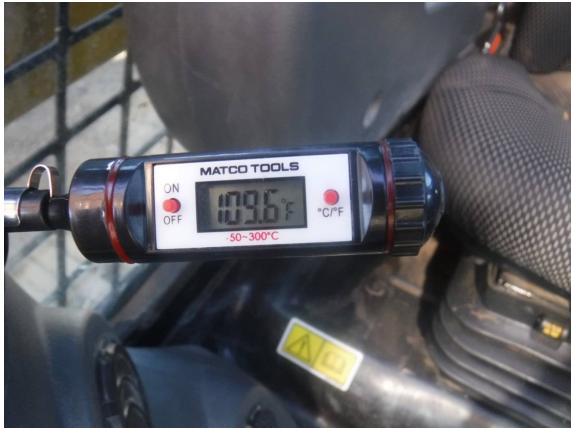
Heater / Defroster

vent temp 109.6

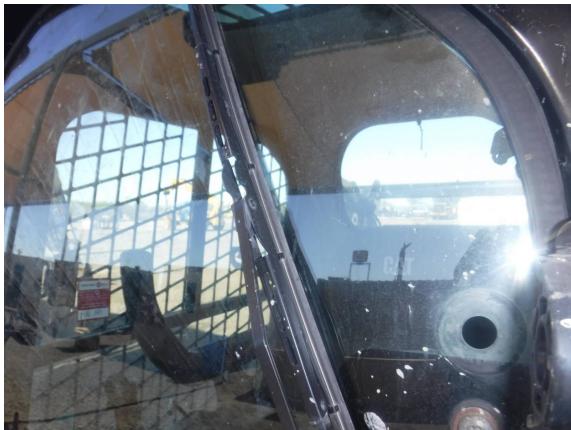
Windshield Wipers

Wiper blade is torn

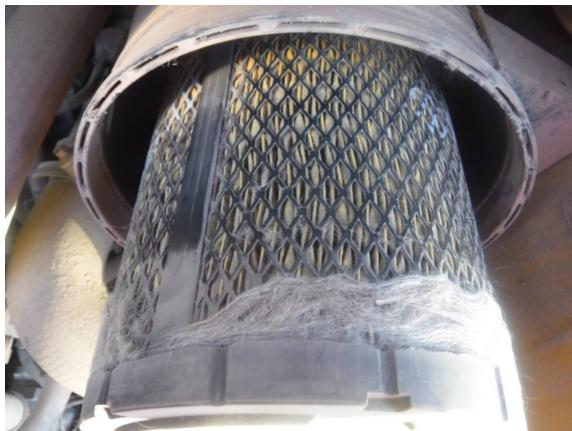
Intake / Air Filters

Part of service

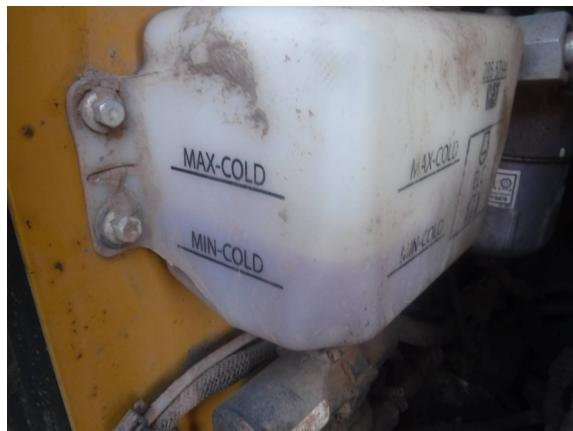
Anti-Freeze Level / Color /

Red

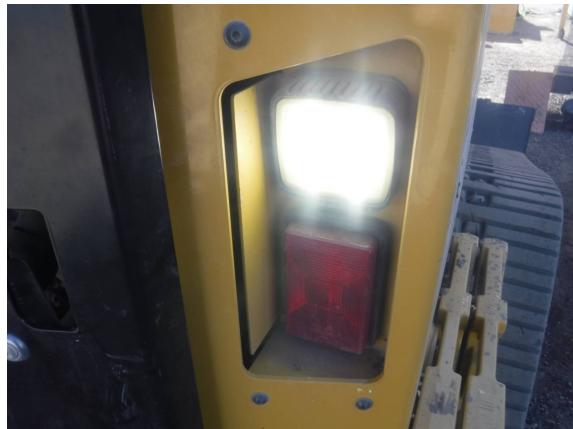
Lighting

Right rear tail light is not working

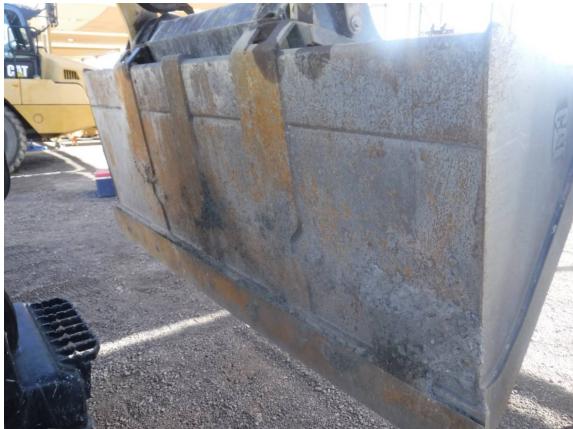
Bucket Bottom

Has dents

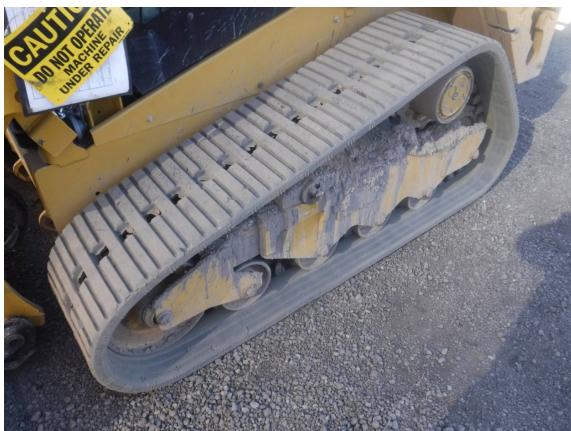
Track / Belt Condition

both Tracks have cuts
