2018 CAT 12M3AWD MOTOR GRADERS

INSPECTION DETAILS

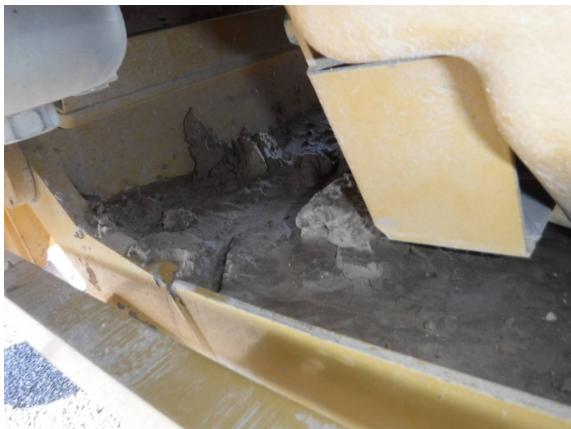
Crankcase Guard /

Full of dirt. Part of wash

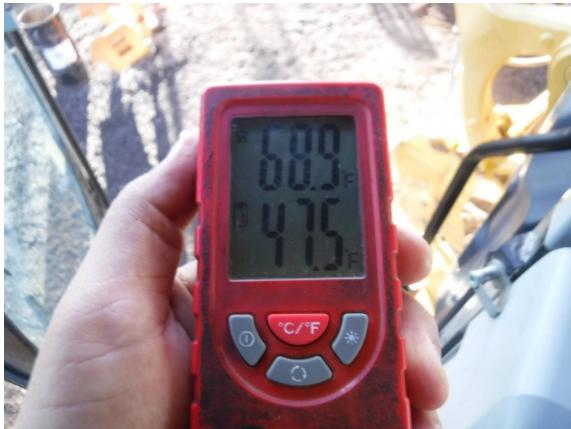
Air Conditioner

68 AMBIENT TEMP AND 47
VENT TEMP

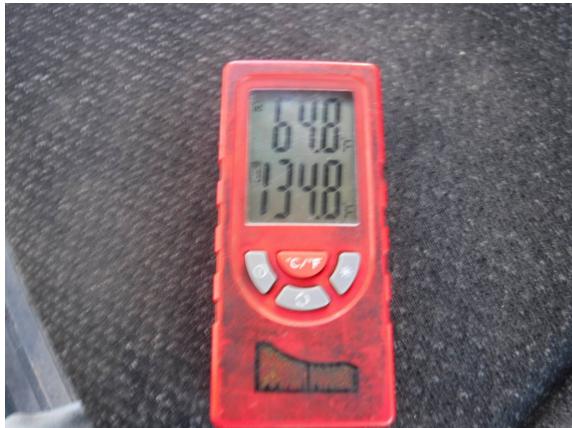
Heater / Defroster

64 AMBIENT TEMP AND 134
VENT TEMP

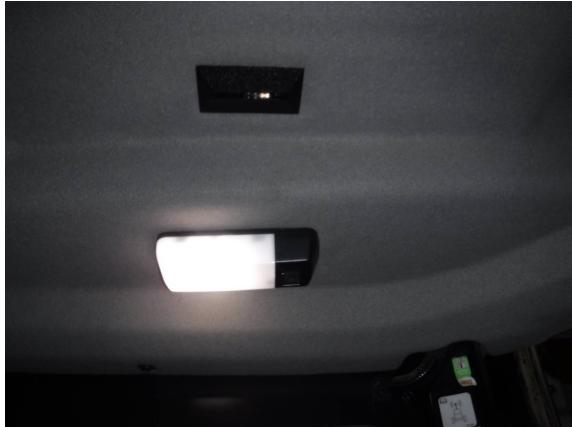
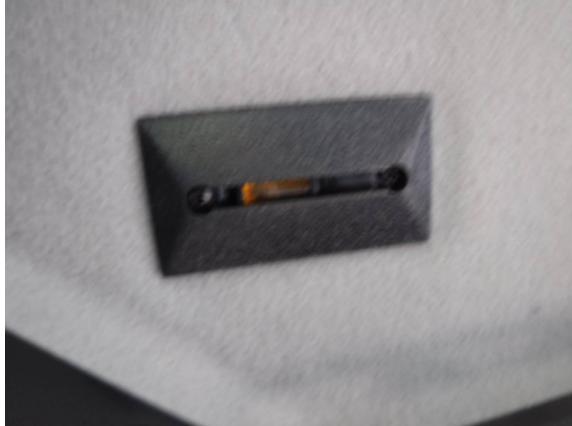
Small operator lights are inop

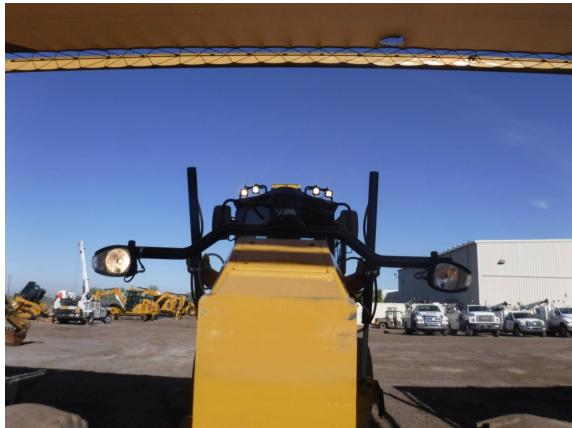
Work Lights

LEFT FRONT HEAD LIGHT IS
INOP

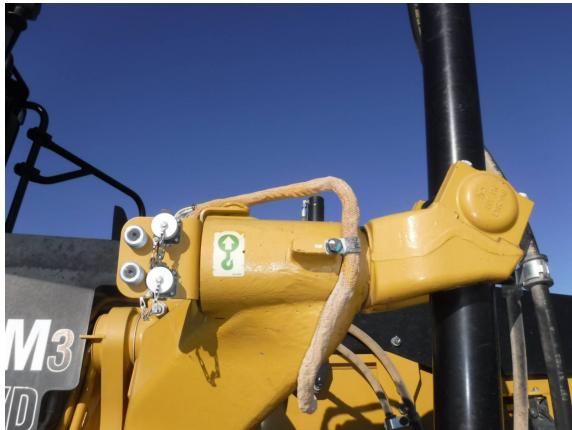
Cylinder Mounts / Pins

Has movement at yoke pins and fiber bushings

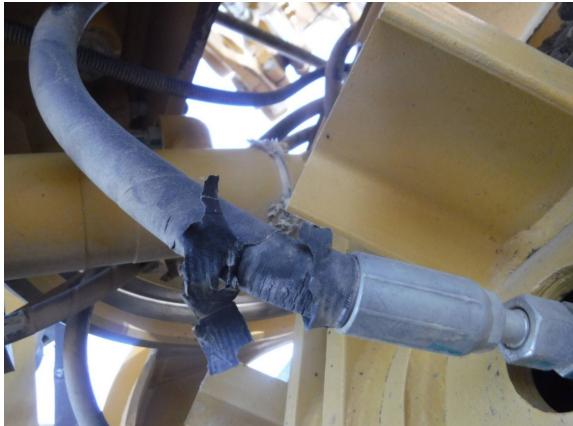
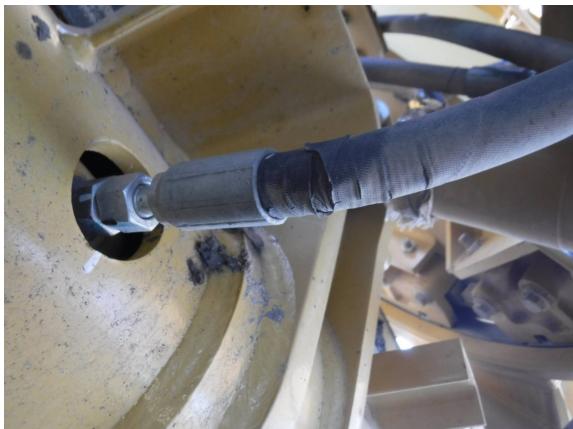
Hydraulic Lines / Fittings

Has slight peeling on side shift cylinder lines. Not down to metal. Outer cover only.

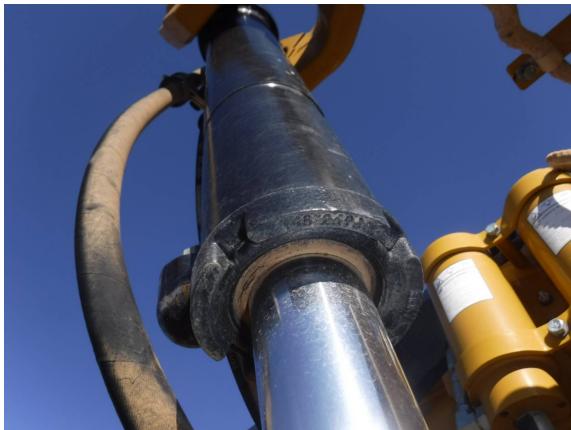
Cylinder Balls / Caps

Needs adjusted ALL 4

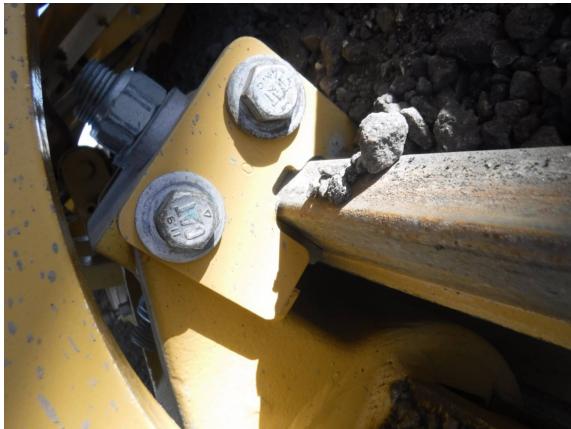
Moldboard Tip Brackets /

Needs adjusted

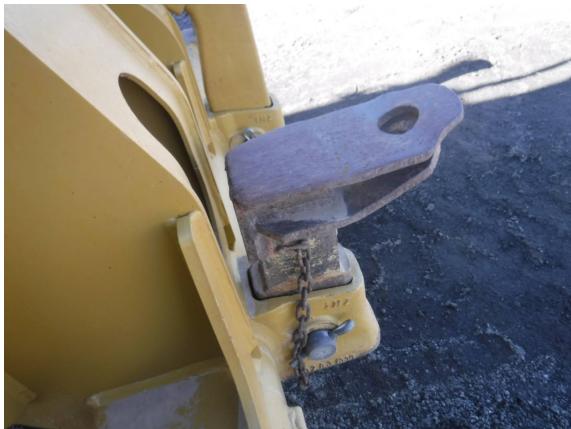
Shanks / Ripper (GET)

Center has home made hitch in shank pocket

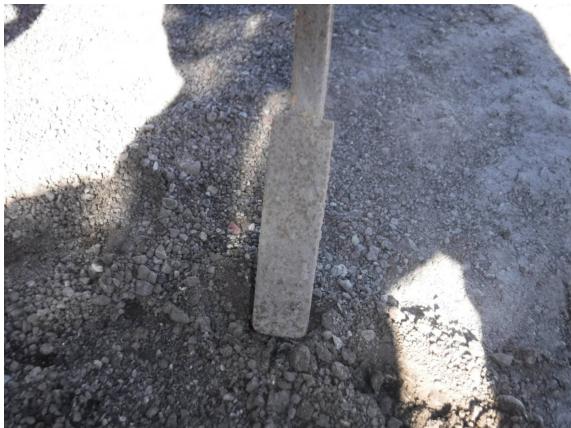
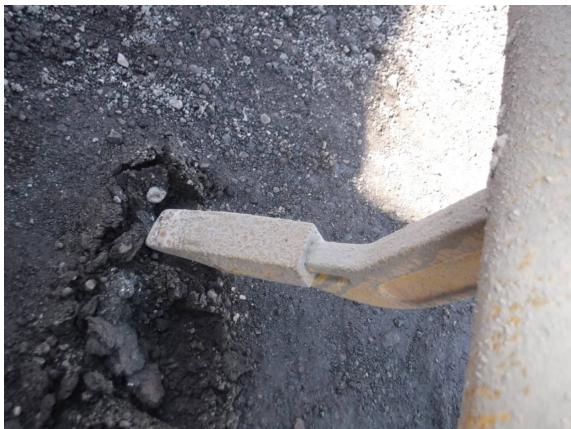
Shanks / Scarifier (GET)

3 SHANKS ONLY

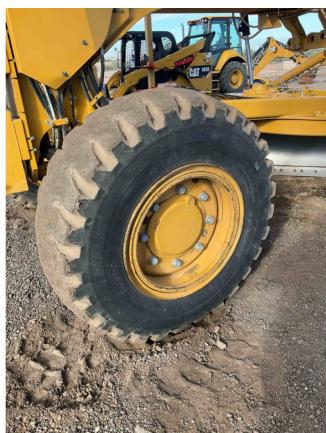
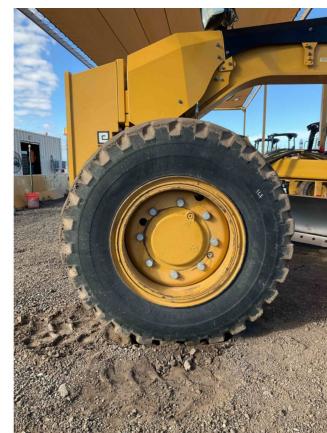
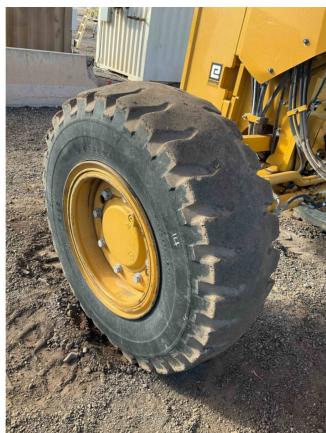
Make / Serial#	Tread Depth in 1/32"	% Life Remaining	Recapped	Tread Cuts/Chunks	Side Cuts Section
Left Front	Yokohama	14	34	NO	YES

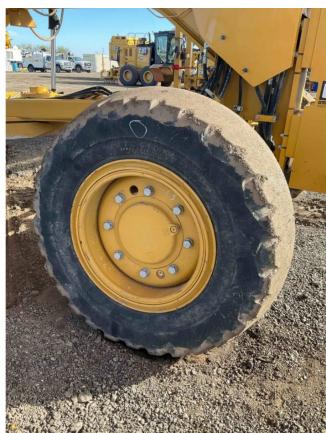
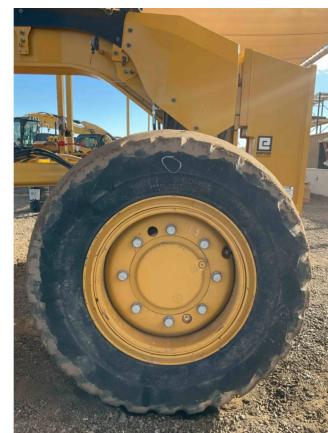
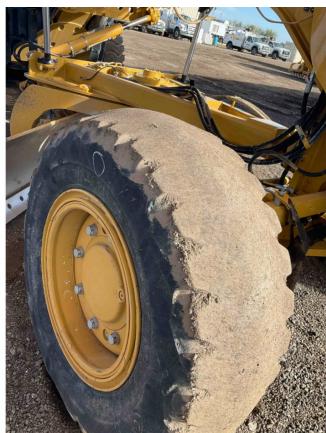
Make / Serial#	Tread Depth in 1/32"	% Life Remaining	Recapped	Tread Cuts/Chunks	Side Cuts Section
Right Front Firestone	0	0	NO	YES	YES

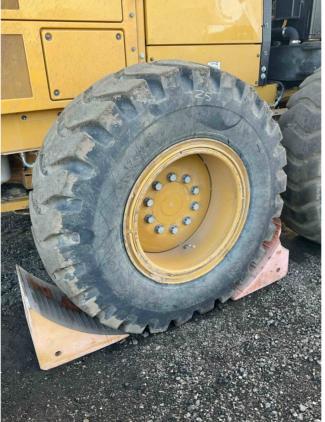
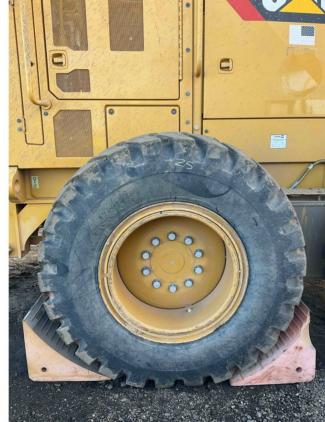
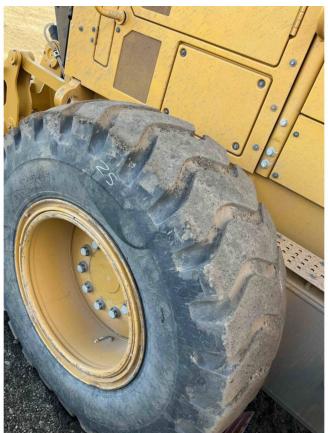
Make / Serial#	Tread Depth in 1/32"	% Life Remaining	Recapped	Tread Cuts/Chunks	Side Cuts Section
Right Rear	Maxam	25	65	NO	YES
