2017 JOHN DEERE 300GLC EXCAVATOR

INSPECTION DETAILS

Inspection Type	Trade
Inspection Form	Standard
Inspection #	10258416
Inspection Status	Completed
Created	12/16/25 14:24:06
Updated	12/30/25 11:18:30
Created By	Preskitt, Billy
Inspector	Preskitt, Billy
Reviewers	Preskitt, Billy
Salesperson	Schultis, Derrick R.
Stock #	E212183
Serial #	1FF300GXLHF730567
SMU / Hours	4,259
Location	Eloy, AZ 85131, United States

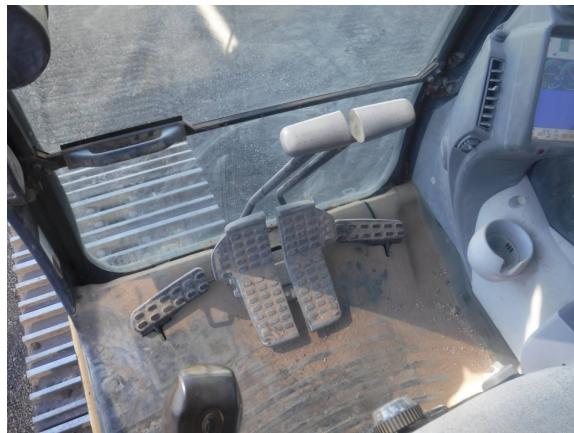
Vent/louver

left rear vent louver is broke

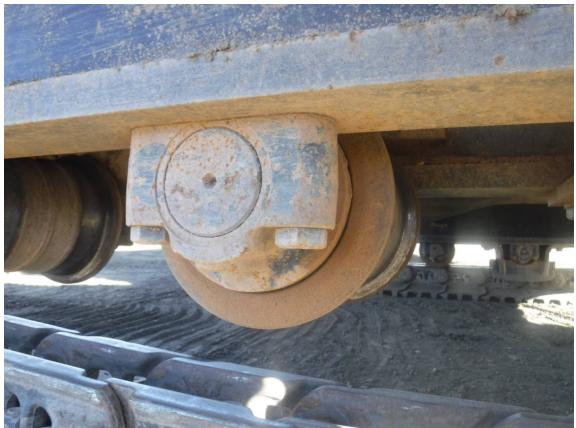
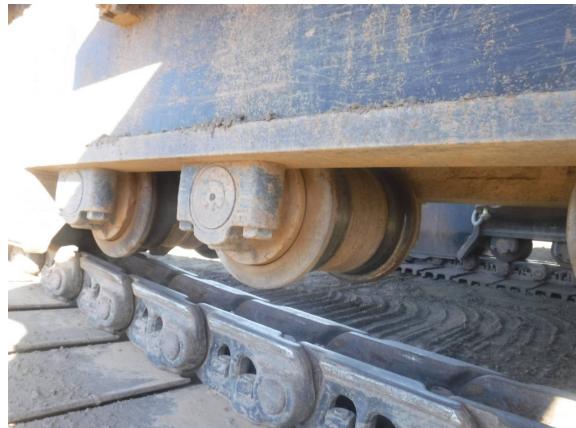
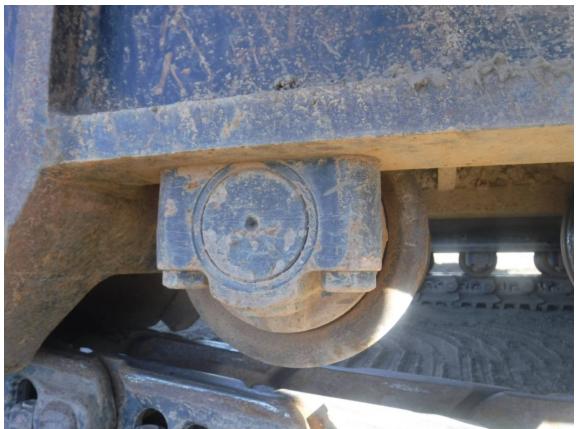
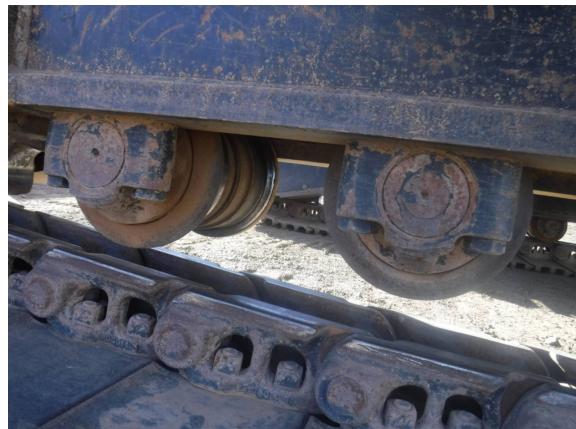
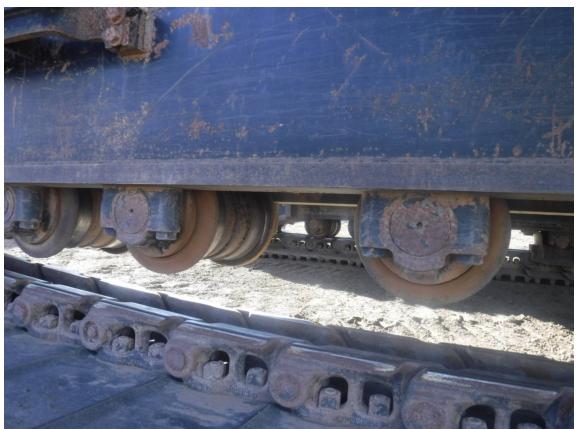
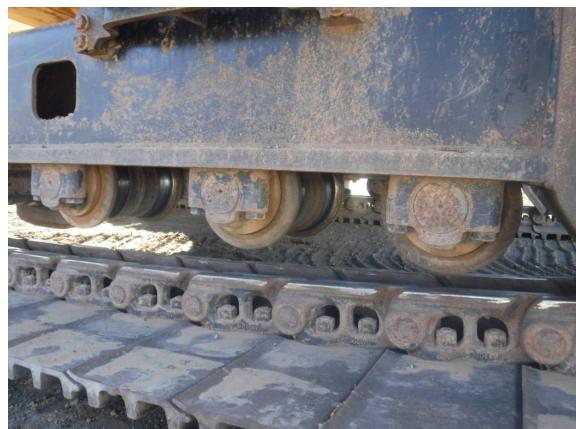
Notes - UNDERCARRIAGE 2

All track rollers are showing signs of leaking
