2016 CAT
336FL
TRACK EXCAVATORS

INSPECTION DETAILS

Inspection Type	Marketing
Inspection Form	Standard
Inspection #	10147652
Inspection Status	Completed
Created	09/09/24 16:08:34
Updated	09/20/24 16:37:06
Created By	Willis, Joseph
Inspector	Willis, Joseph
Reviewers	Willis, Joseph
Salesperson	Schultis, Derrick R.
Stock #	E189496
Serial #	RKB01933
SMU / Hours	5,245
Location	Eloy, AZ 85131, United States

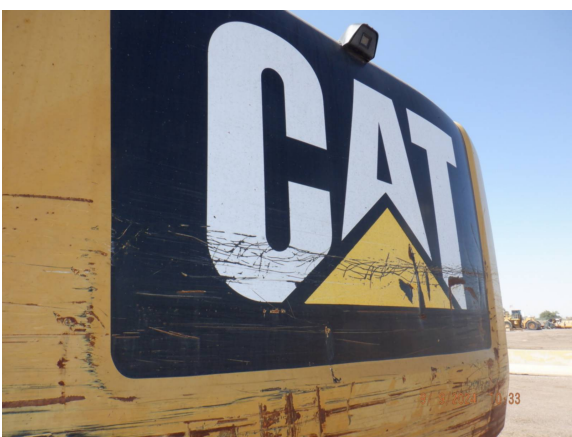
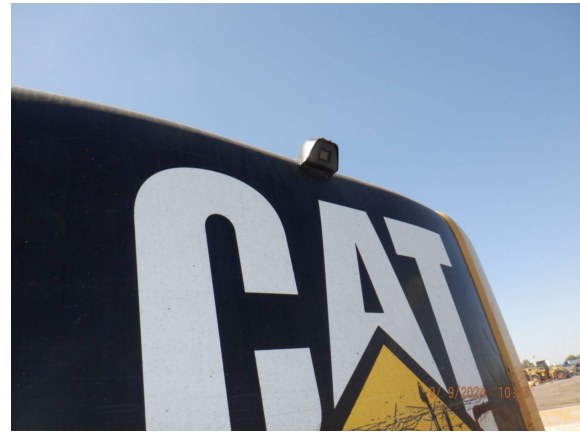
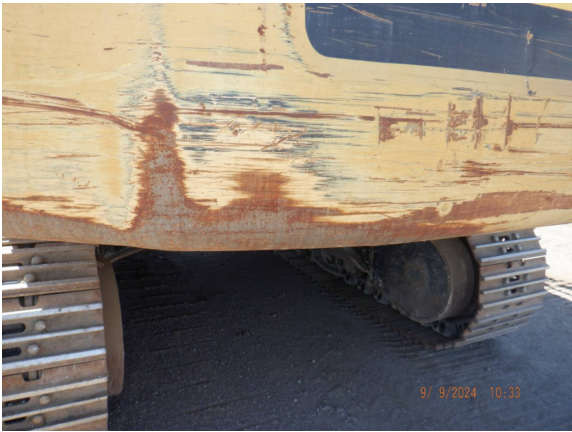
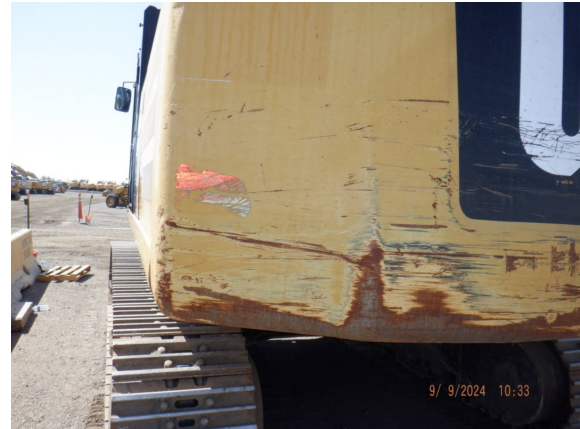
Counterweight

Has dents and scratches

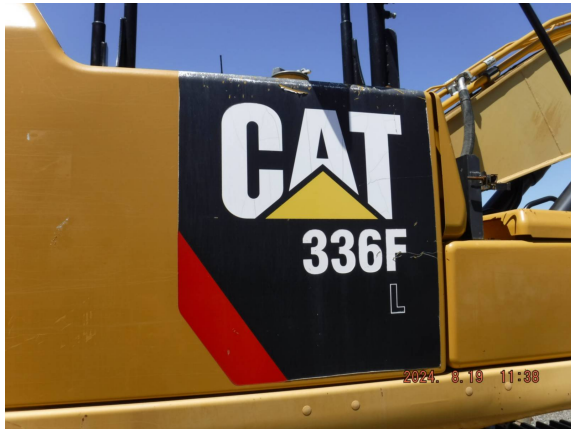
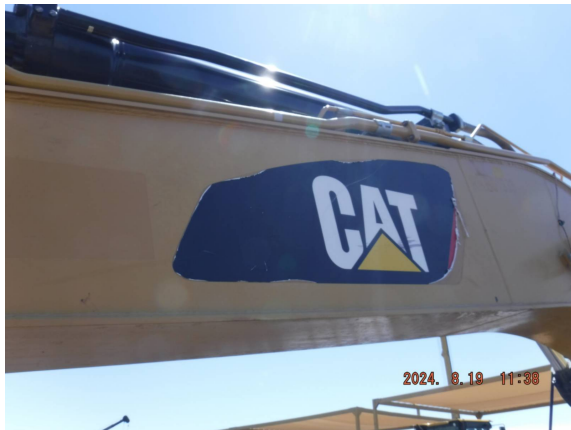
Crankcase Guard / Battery Box

engine guards are bent can be
straightened weld repair

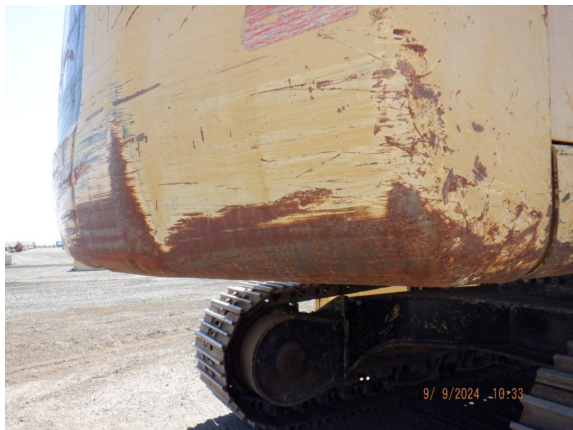
Has scratches

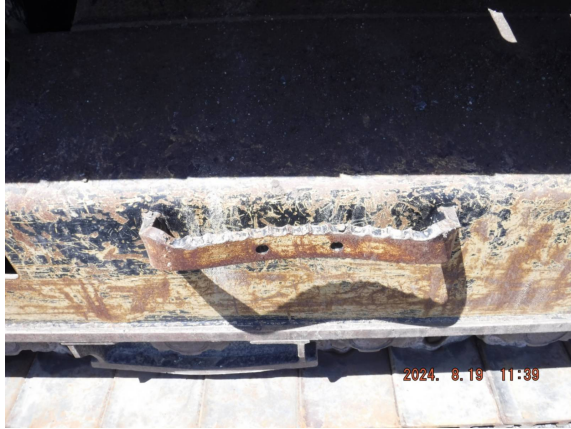
Right front lower step is bent.

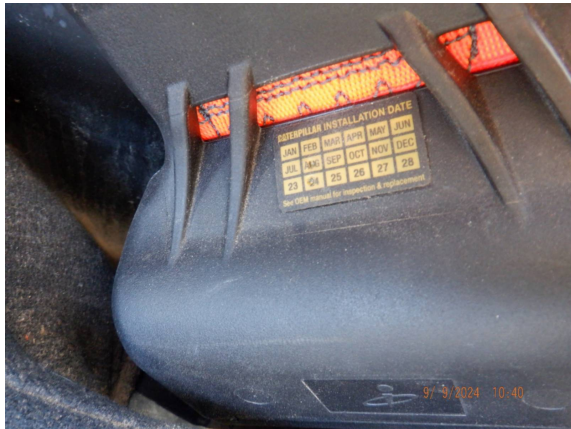
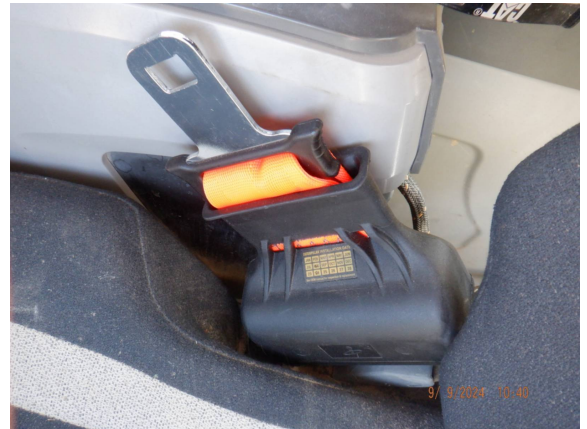
Seat Belt / Date

AUGUST 2024

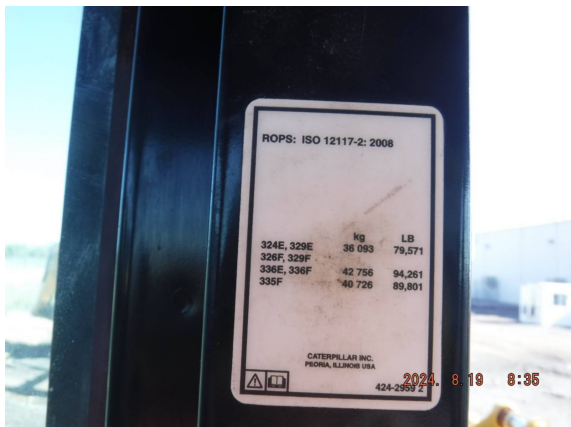
ROPS Certification Plate

YES

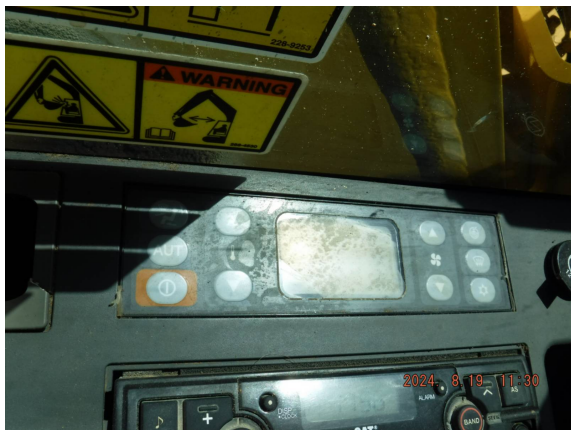
heater and a/c controller

controller is faded and not legible

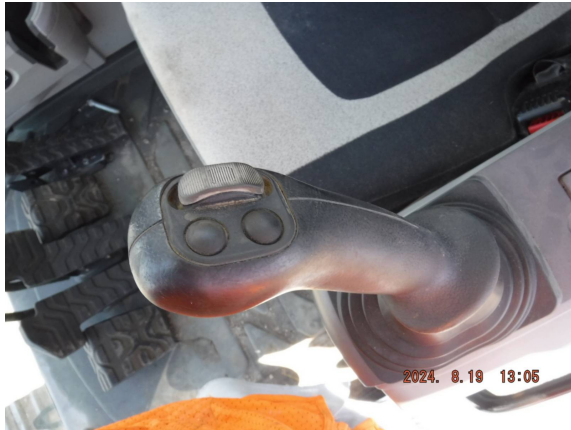
Hydraulic Controls

buttons on joysticks are not legible

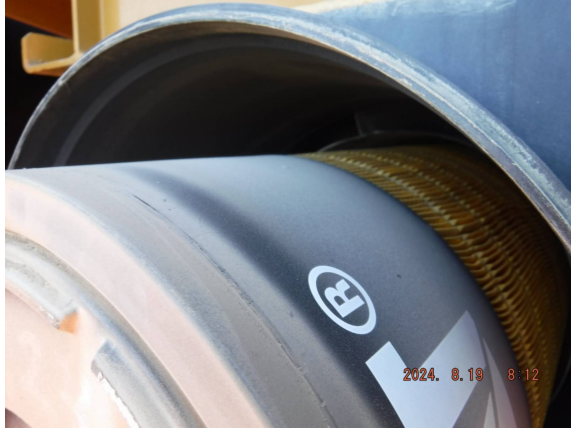
Intake / Air Filters

Part f service

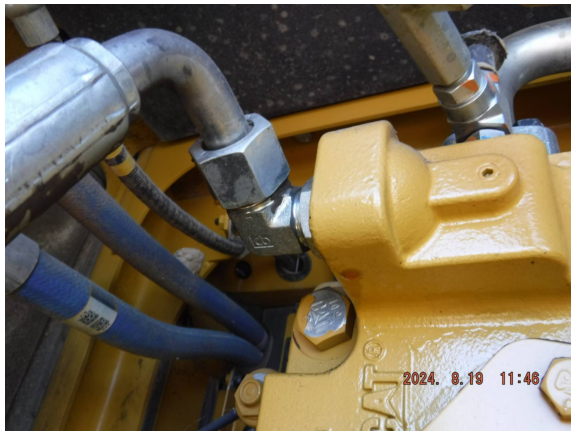
Hose Lines

Line on right side of stick is
bent both aux lines are missing
bolts on mounts (bolts are
broke off in hole)
