2016 CAT

950M

WHEEL LOADER

INSPECTION DETAILS

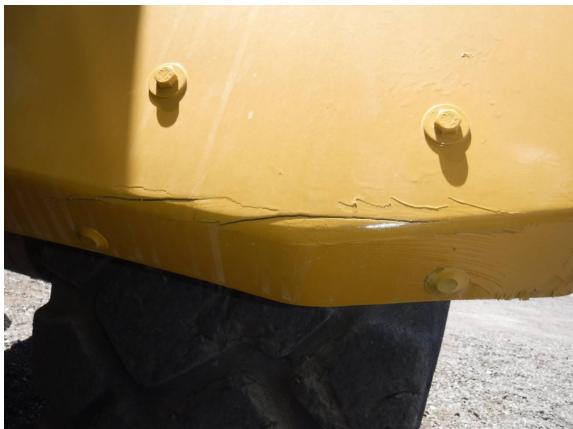
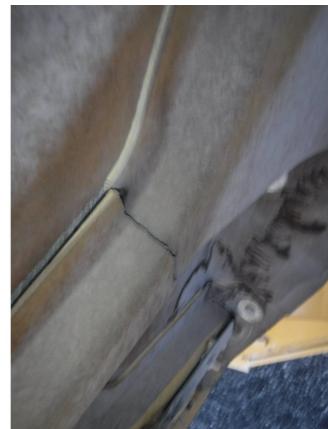
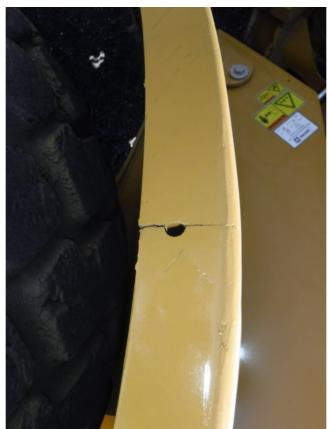
Front fenders are cracked

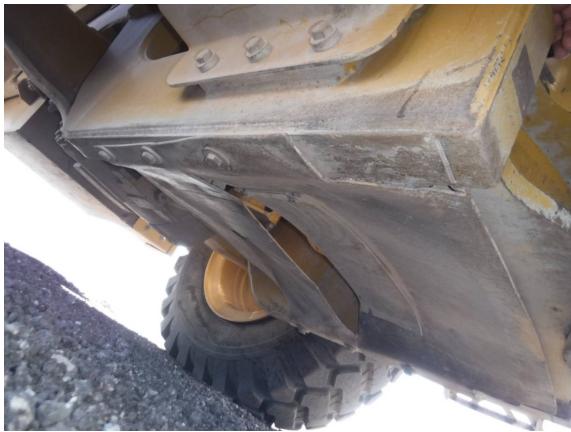
Belly pans are bent.

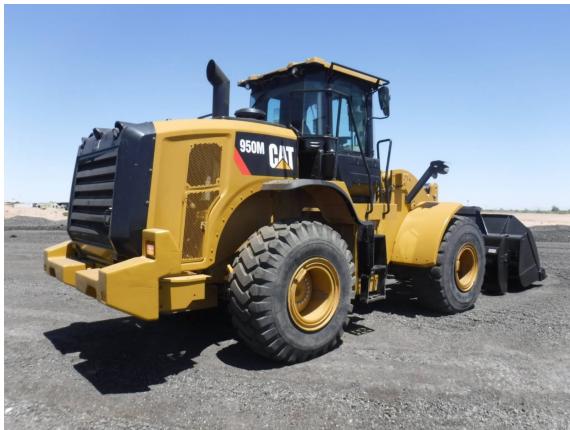
Paint

Has been painted

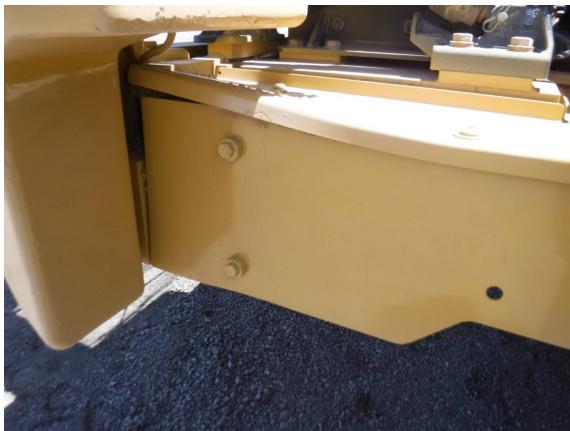
Sheet Metal

Right rear is bent upward.

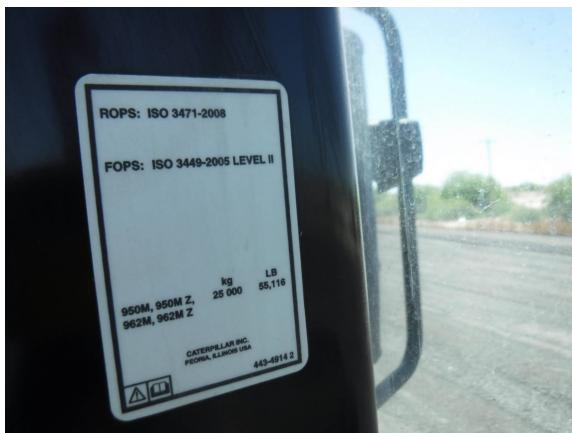
Safety Locks / Pins

Missing pin keepers on frame lock

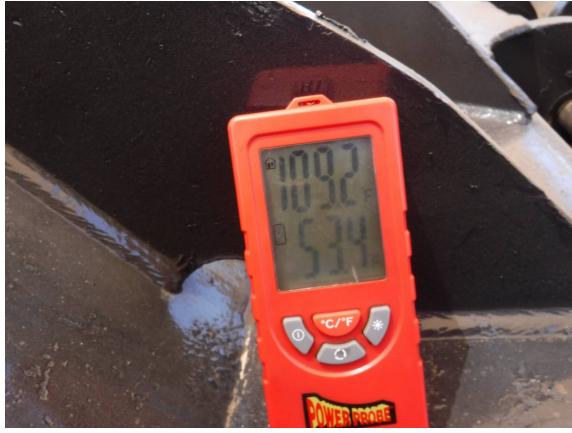
Door Latches / Hinges / Seals

Door strut is blown and seal is torn. Door pocket is cracked.(Door does not lock shut right) almost have to slam it to get it close

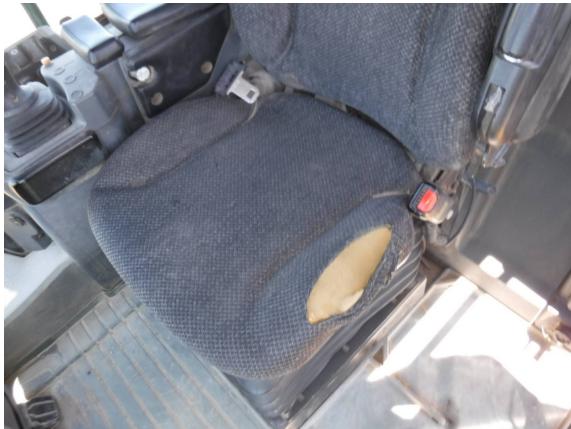
RIPPED CUSHION

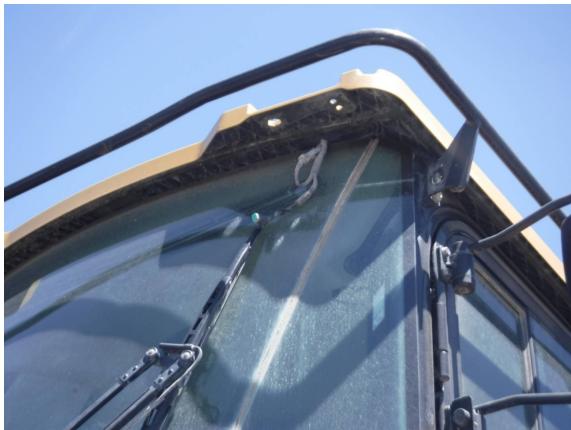
Windshield Wipers

Washer pumps are inoperable

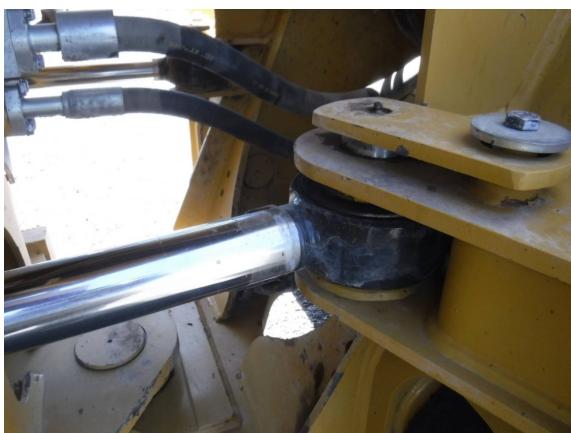
Steering Cylinder

Has movement at pins and bushings both cylinders rod and barrel ends

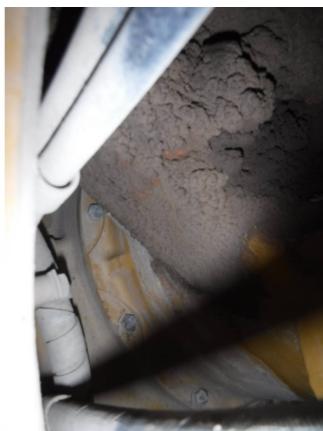
Tank

Has residue under tank area at right side behind transmission.

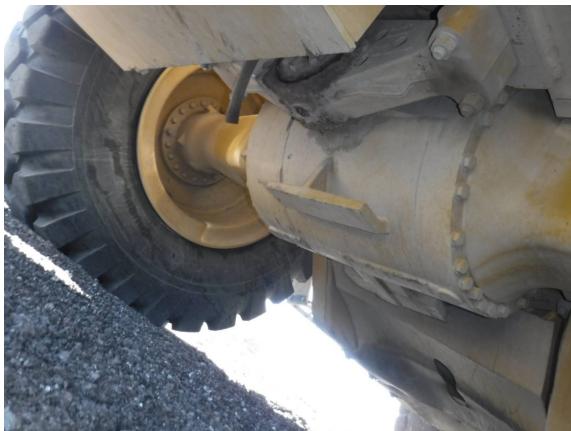
Trunion

Has movement

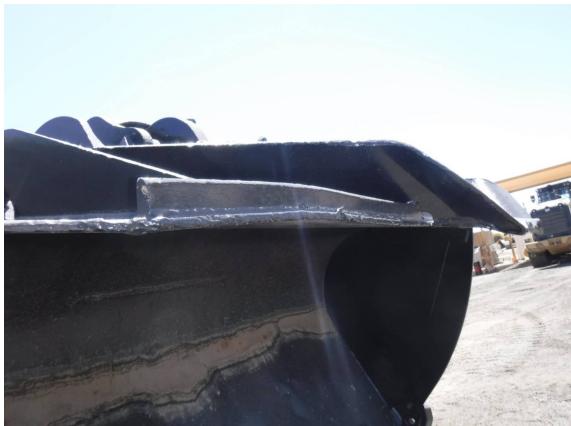
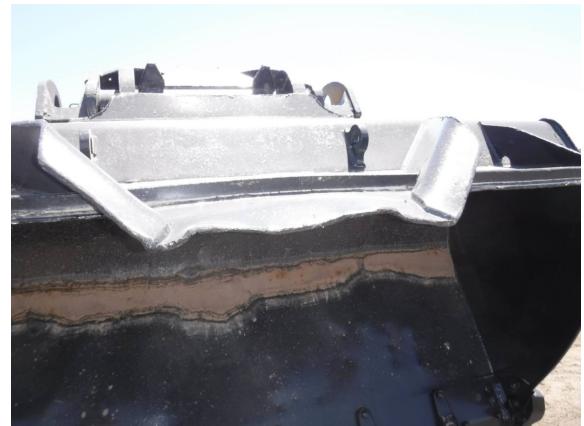
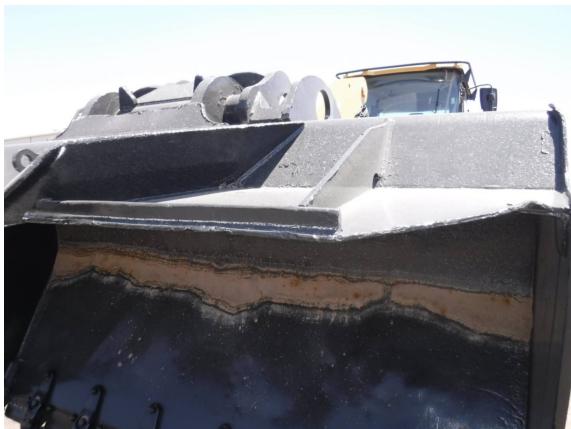
Notes - BUCKET

Bent spill guard

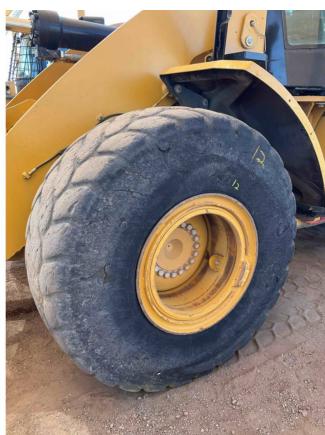
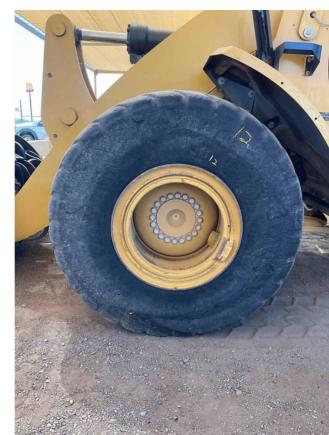
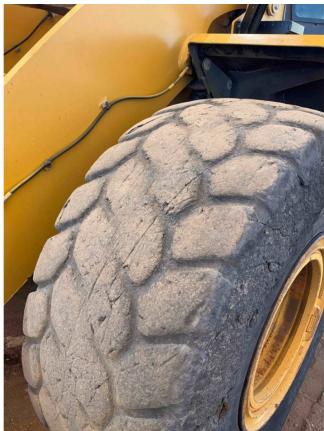
Make / Serial#	Tread Depth in 1/32"	% Life Remaining	Recapped	Tread Cuts/Chunks	Side Cuts Section
Left Front	Bridgestone	12	26	NO	YES

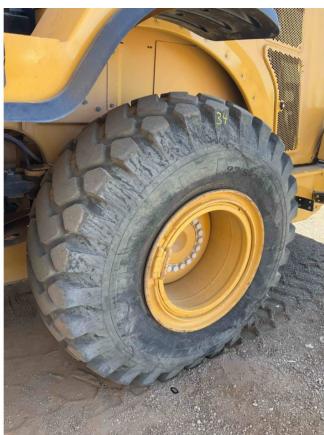
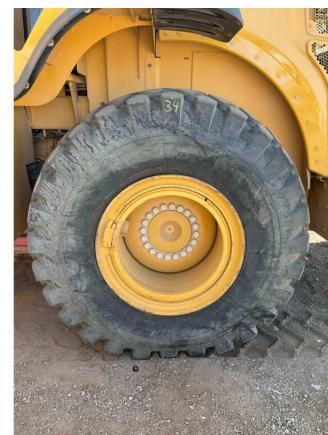
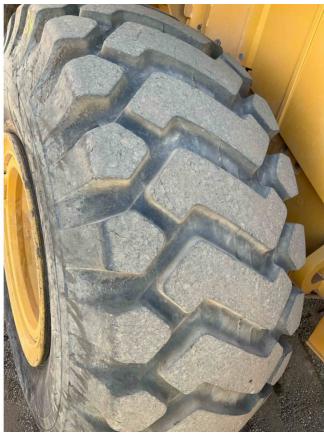
Make / Serial#	Tread Depth in 1/32"	% Life Remaining	Recapped	Tread Cuts/Chunks	Side Cuts Section
Left Rear	Road guider	34	90	NO	YES

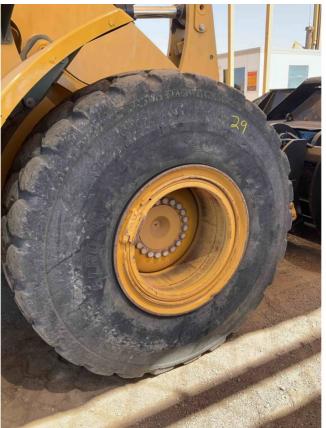
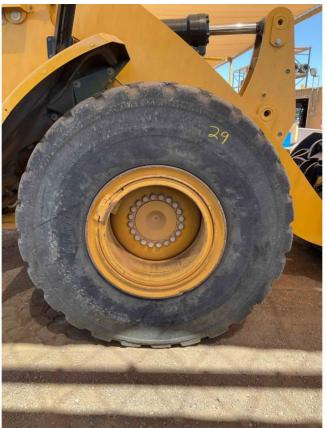
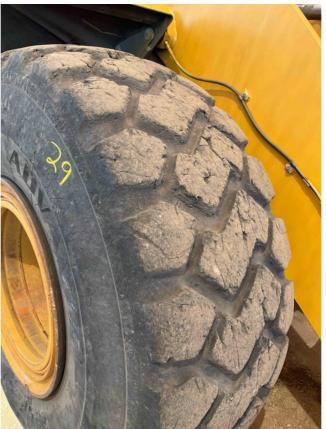
Make / Serial#	Tread Depth in 1/32"	% Life Remaining	Recapped	Tread Cuts/Chunks	Side Cuts Section
Right Front	Advance	29	58	NO	YES

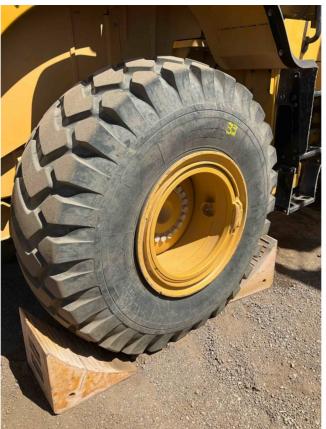
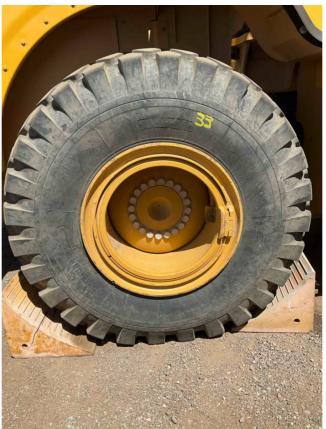
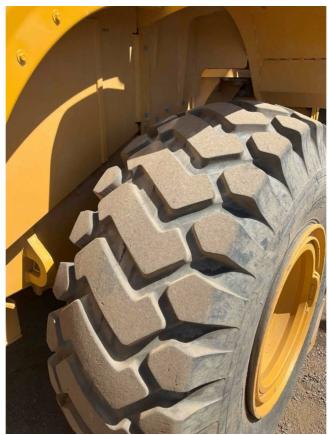
Make / Serial#	Tread Depth in 1/32"	% Life Remaining	Recapped	Tread Cuts/Chunks	Side Cuts Section
Right Rear	Road guider	33	88	NO	YES
